PROFESSIONAL SERVICE FEE

Vehicle No.	SMC 8521R
Insured Veh.	GBH 7157U
Claim No.	SNM21D201275/LKKDS
Policy No.	DMCVSNA00024252101
Accident Date	04/03/2021
Inspection Date	05/03/2021

ADJUSTMENT ON REPAIR COST FOR VEHICLE NO. SMC 8521R

PHOTOGRAPHS FOR VEHICLE NO. SMC 8521R

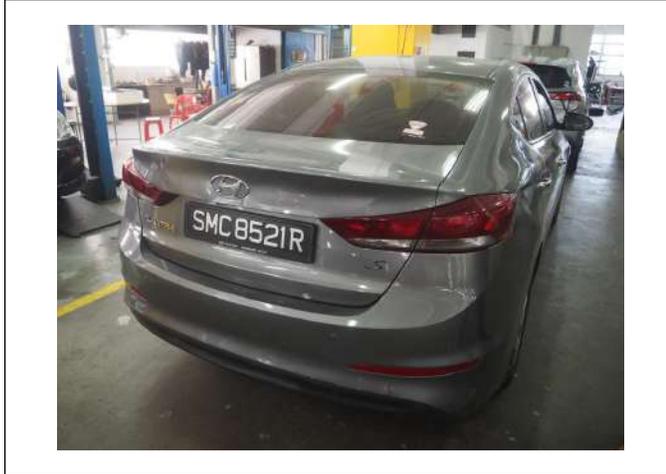
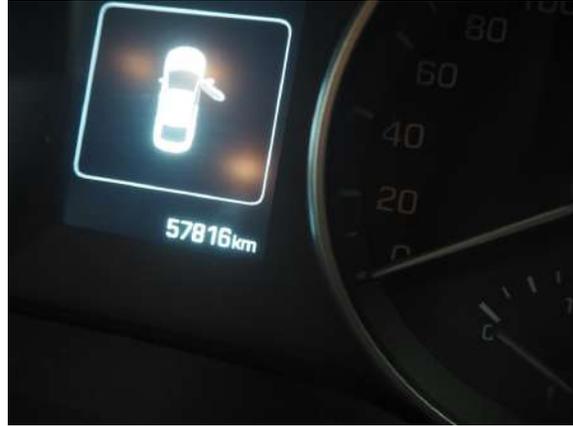
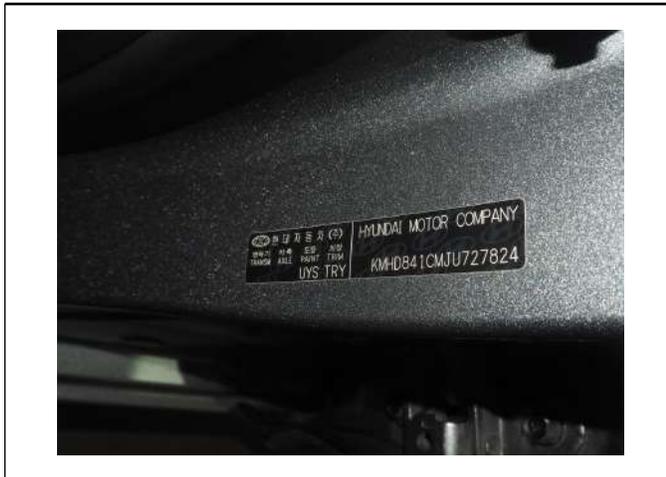
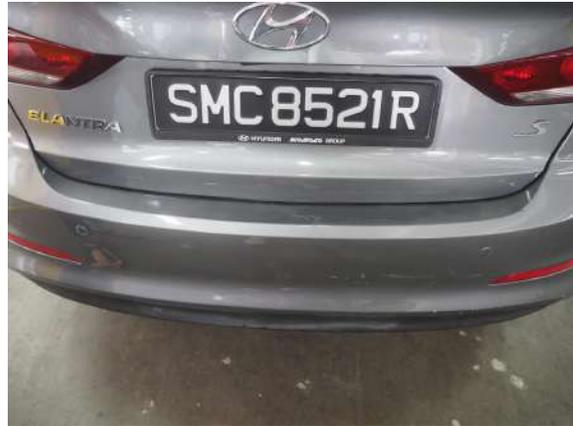
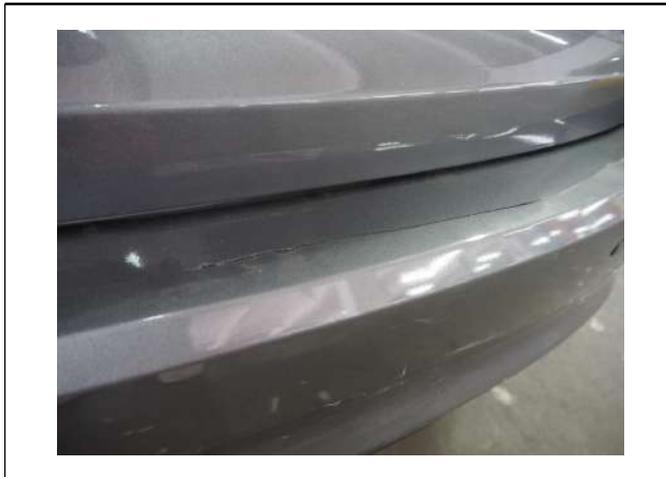
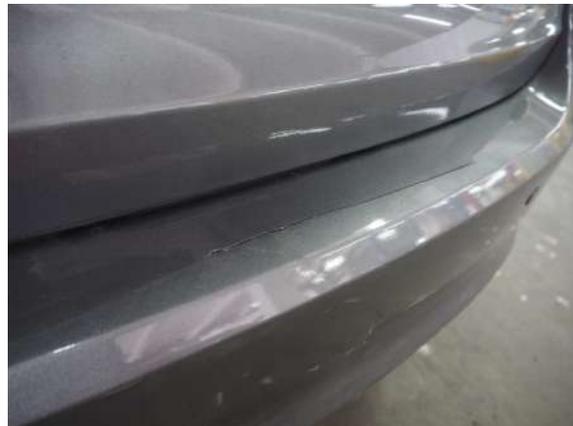
4. Description of Damages			
THE VEHICLE SUSTAINED DAMAGES AT THE REAR PORTION. DAMAGES SEE DETAILS.			
5. General Information			
Accident Date	04/03/2021	Inspection Date	05/03/2021
Survey held at	MG SOLUTION PTE LTD 23 KAKI BUKIT AVE 4 (SOUTH WING) #02-03B VICOM INSPECTION CENTRE, SINGAPORE 415933		
5a. Remarks			
A)THE INSPECTION WAS CONDUCTED ON A"WITHOUT PREJUDICE" BASIS. B)IN ACCORDANCE TO YOUR INSTRUCTIONS, WE HAVE NOT AUTHORISED REPAIRS.			
5b. Estimate Days of Repair			
ESTIMATED NORMAL PERIOD FOR REPAIR:		6 Working Days

Qty	Description of Parts	Condition	Estimate By Workshop (\$)	Our Adjusted (\$)
<u>REPLACEMENT OF PARTS</u>				
1	BOOTLID	DENTED	1,589.75	1,589.75
1	BOOTLID LOGO	NECESSARY	58.60	58.60
1	BOOTLID EMBLEM 'S'	NECESSARY	56.40	56.40
1	BOOTLID EMBLEM 'ELANTRA'	NECESSARY	86.90	86.90
2	BOOTLID HINGE @\$120.80	NOT NECESSARY	241.60	-
1	BOOTLID TOP LOCK	DAMAGED	198.60	118.00
1	BOOTLID LOWER CATCH	NOT NECESSARY	56.80	-
1	BOOTLID DETECTOR	CRACKED	180.50	85.00
1	BOOTLID WEATHERSTRIP	NOT NECESSARY	169.80	-
1	REAR BUMPER	DEFORMED	820.00	474.00
1	REAR BUMPER LOWER LID	DEFORMED	450.00	385.00
3	REAR BUMPER TOP BRACKET @\$33.50	NOT NECESSARY	100.50	-
2	REAR BUMPER BELOW BRACKET @\$33.50	NOT NECESSARY	67.00	-
2	REAR BUMPER REFLECTOR @\$68.60	O/S CUT	137.20	68.60
2	REAR BUMPER SIDE RETAINER @\$78.00	NECESSARY	156.00	68.00
1	REAR BUMPER REINFORCEMENT	BENT	565.60	339.00
2	REAR BUMPER REINFORCEMENT BRACKET @\$69.20	NOT NECESSARY	138.40	-

2	REAR NUMBER PLATE LAMP @\$89.60	NOT NECESSARY	179.20	-
2	TAILLAMP @\$468.20	CRACKED	936.40	936.40
2	TAILLAMP PANEL @\$188.90	NOT NECESSARY	377.80	-
1	REAR END PANEL	DENTED	576.30	576.30
1	REAR END PANEL TOP GARNISH	DEFORMED	124.00	124.00
	LESS 20% DISCOUNT		-1,453.47	-993.19
			5,813.88	3,972.76
<u>SPECIAL NETT ITEMS</u>				
1	REAR NUMBER PLATE (SN)	NOT NECESSARY	50.00	-
1	SET REAR BUMPER CLIP (SN)	NECESSARY	20.00	20.00
1	SET TAIL LAMP CLIP (SN)	NECESSARY	20.00	20.00
2	TAIL LAMP PANEL SEALANT @\$80.00 (SN)	NOT NECESSARY	160.00	-
1	SET REAR END PANEL TOP GARNISH CLIPS (SN)	NECESSARY	20.00	20.00

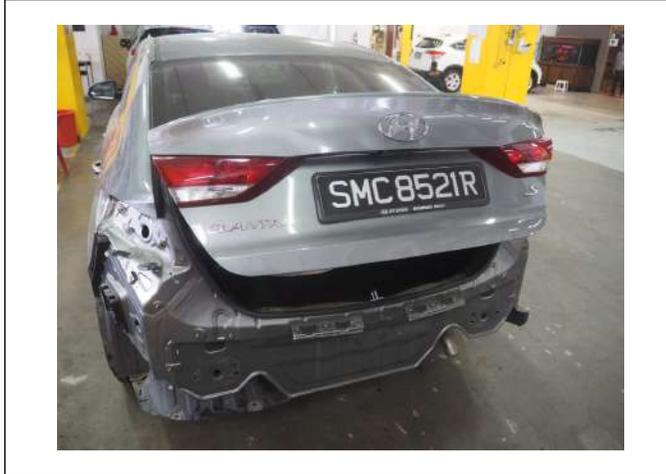
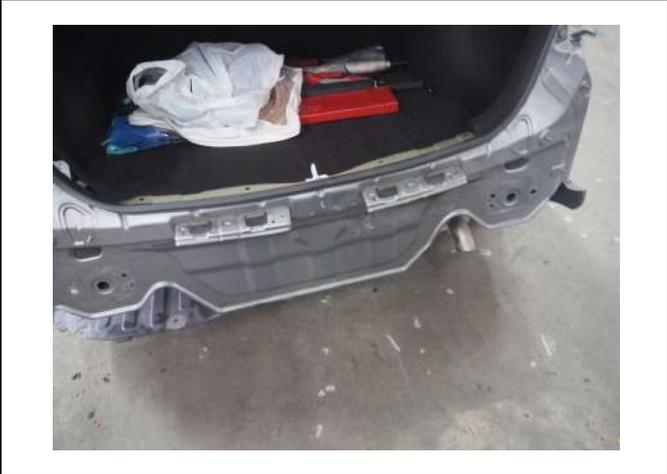
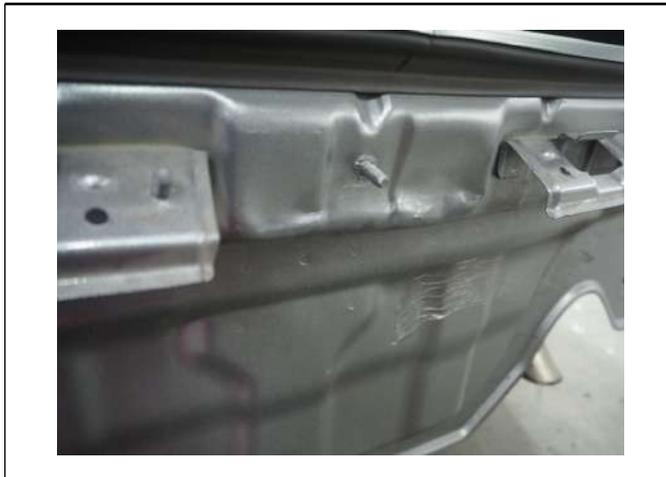
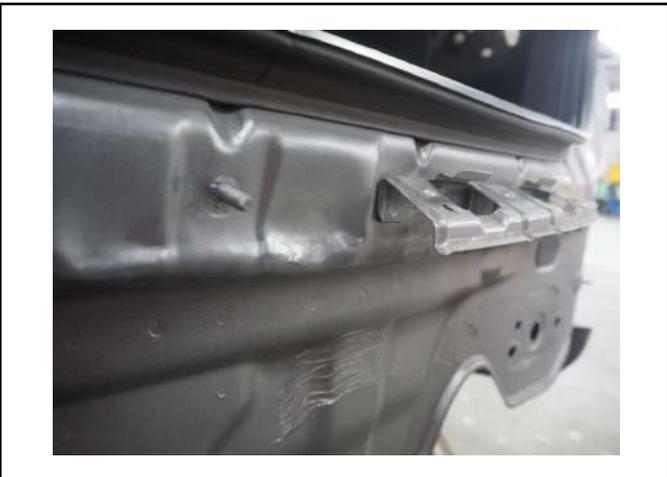
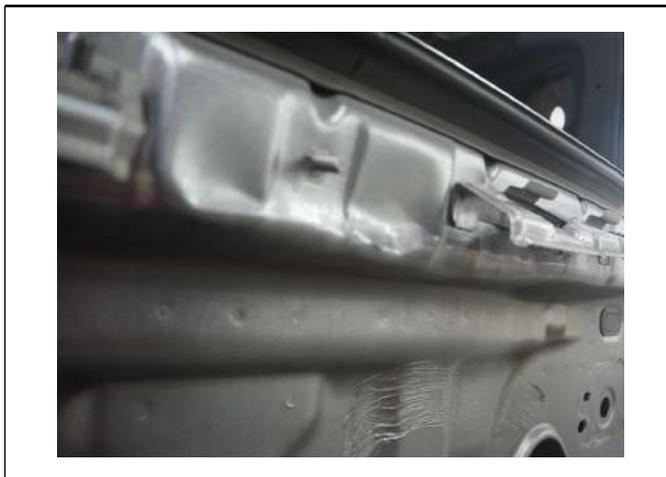
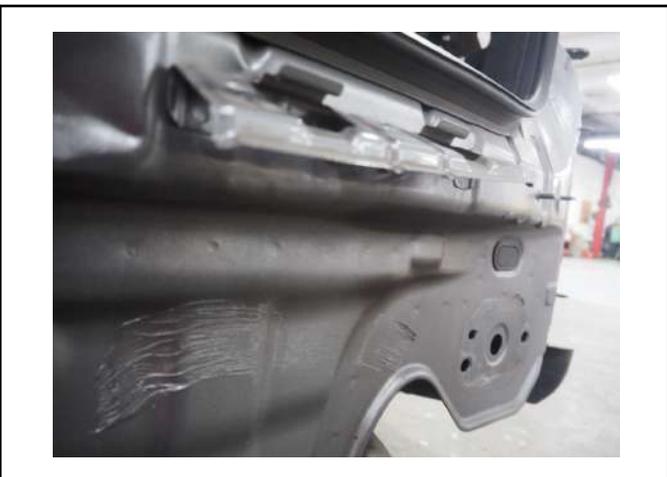
RE-INSPECTION

PHOTOGRAPHS FOR VEHICLE NO. SMC 8521R
