## LKK Auto Consultants Pte Ltd

### PROFESSIONAL SERVICE FEE

Vehicle No. SHD 4041P  
Insured Veh. YP 5887U  
Claim No. 20/21/21/VC05/024305  
Policy No. Z20VC05005600  
Accident Date 05/03/2021  
Inspection Date 09/03/2021

## ADJUSTMENT ON REPAIR COST FOR VEHICLE NO. SHD 4041P

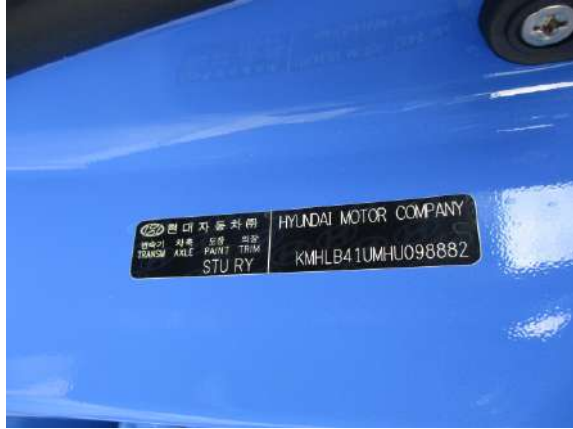
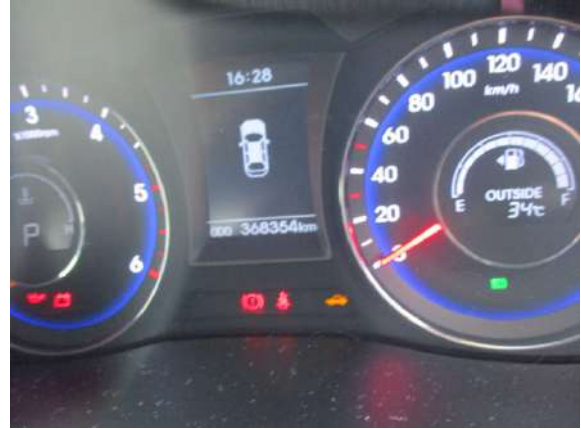
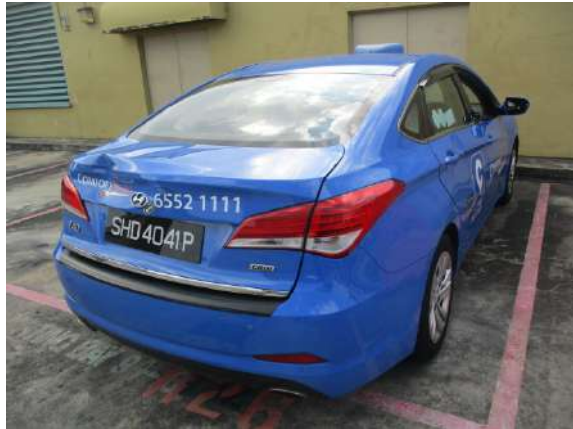
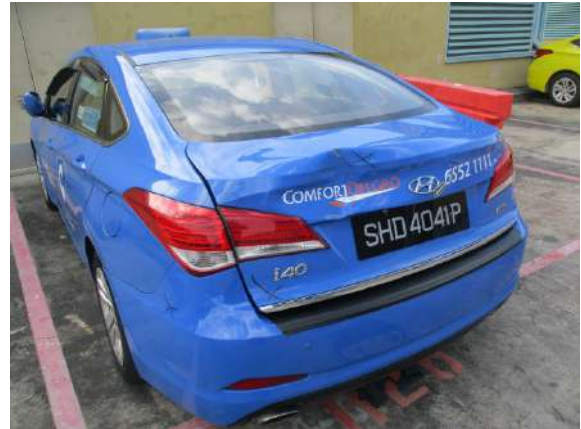
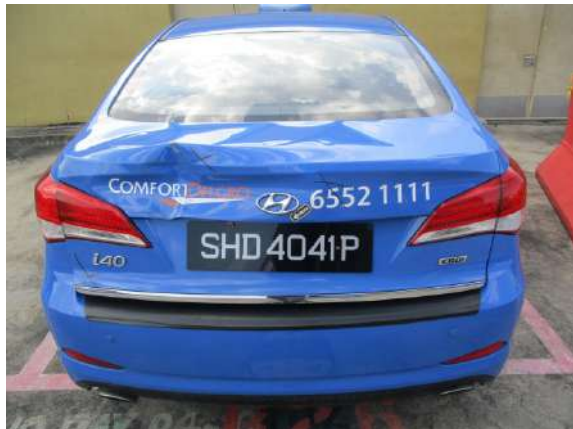
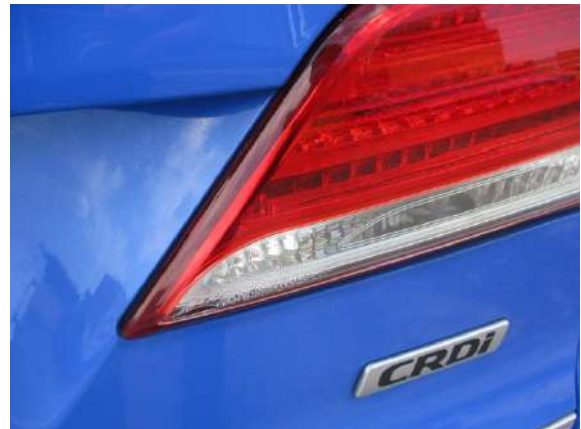
### INSPECTION

### PHOTOGRAPHS FOR VEHICLE NO. SHD 4041P

| Affiliated to Federation Internationale Des Experts En Automobile | | | | |
|---|---|---|---|--|
| THE VEHICLE SUSTAINED DAMAGES AT THE REAR PORTION.<br>DAMAGES SEE DETAILS. | | | | |

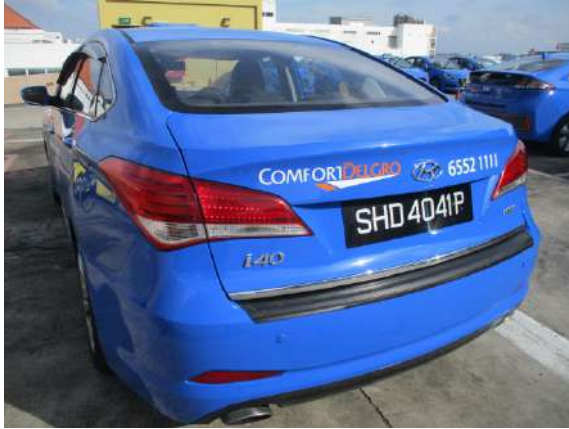
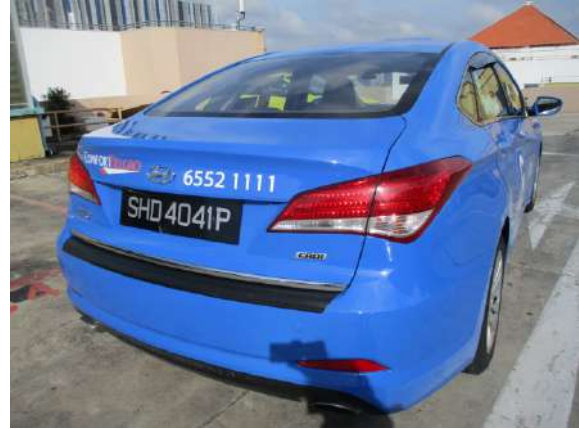
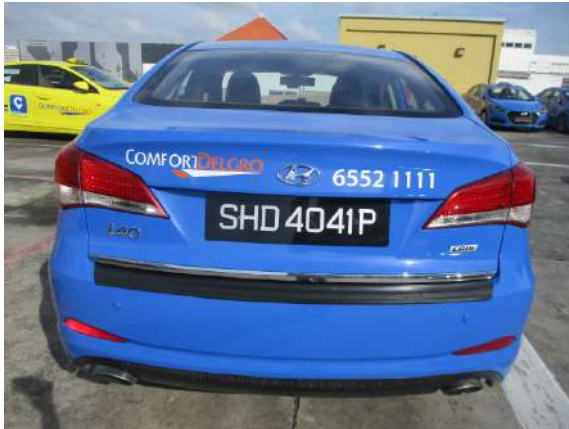
RE-INSPECTION

PHOTOGRAPHS FOR VEHICLE NO. SHD 4041P
