Affiliated to Federation Internationale Des Experts En Automobile								
AXA	NSURANCE PTE		Ref: CC4/ASM18005301/T1hb3q2					
		. 2.12						
	ENTON WAY #24		Date :	16-05-2019				
AXA TOWERSINGAPORE 068811								
	I:STACEY NG		Code :	ASM

1.	1. Policy Particulars :- THIRD PARTY CLAIM							
	Insured Veh.	SKV 6745Z	Veh. In	nspected	SFY 3880D			
	Policy No.	GA269131	Covera	age (\$)	0.00			
	Claim No.	S8M00BDM	Exces	s (\$)	0.00			
	Assign From		Assigr	n Date	21/03/2018

#### ADJUSTMENT ON REPAIR COST FOR VEHICLE NO. SFY 3880D

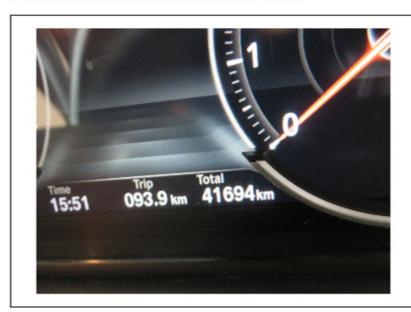
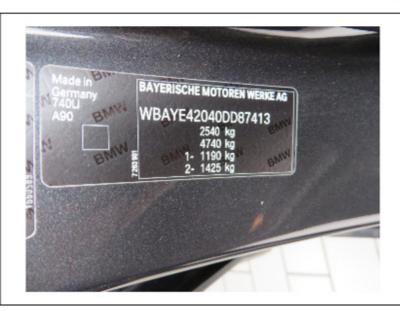
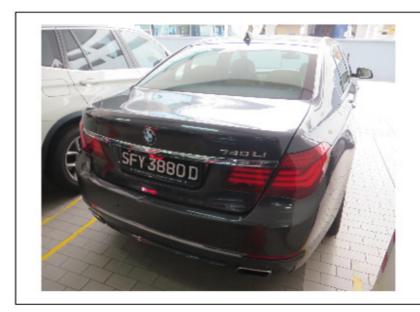
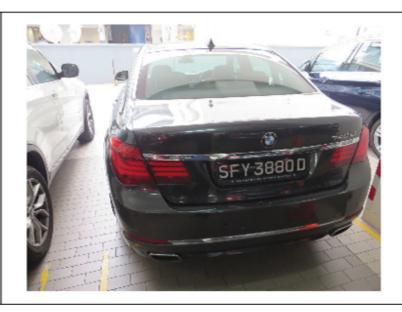
#### PHOTOGRAPHS FOR VEHICLE NO. SFY 3880D

4.		Description	n of Da	amages				
	THE VEHICLE SU	STAINED DAMAGES AT THE REA	AR POR	TION.				
	DAMAGES SEE D	ETAILS.						
5.		General	Inform	ation				
	Accident Date	20/03/2018	Inspec	tion Date	21/03/2018			
	Survey held at PERFORMANCE MOTORS LTD							
		303 ALEXANDRA ROAD SINGAPORE 159941						
5a.			marks					
	A)THE INSPECTION WAS CONDUCTED ON A"WITHOUT PREJUDICE" BASIS. B)IN ACCORDANCE TO YOUR INSTRUCTIONS, WE HAVE NOT AUTHORISED REPAIRS.							
5b.	b. Estimate Days of Repair							
	ESTIMATED NORMAL PERIOD FOR REPAIR: 5 Working Days
