Vehicle No. SHC 6392T  
Insured Veh. SMT 5798P  
Claim No. SNM21D201635  
Policy No. DMPCSNW00109112000  
Accident Date 20/03/2021  
Inspection Date 23/03/2021

## ADJUSTMENT ON REPAIR COST FOR VEHICLE NO. SHC 6392T

### PHOTOGRAPHS FOR VEHICLE NO. SHC 6392T

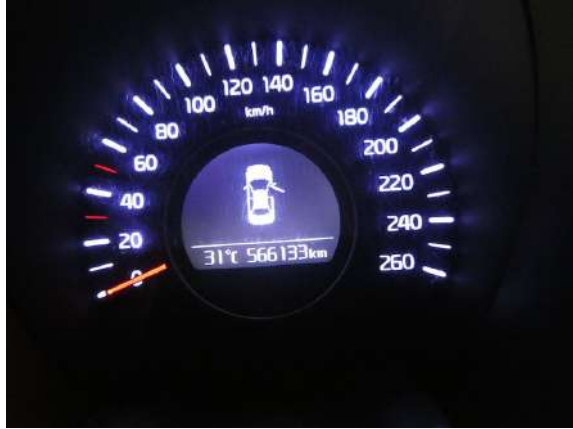
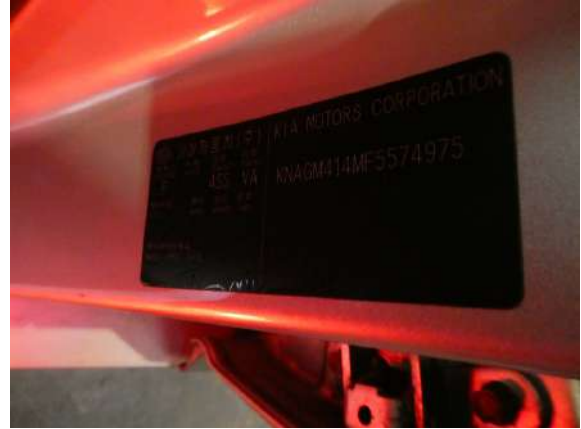
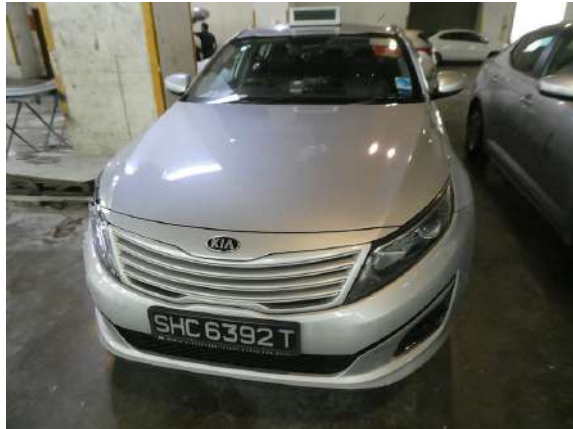
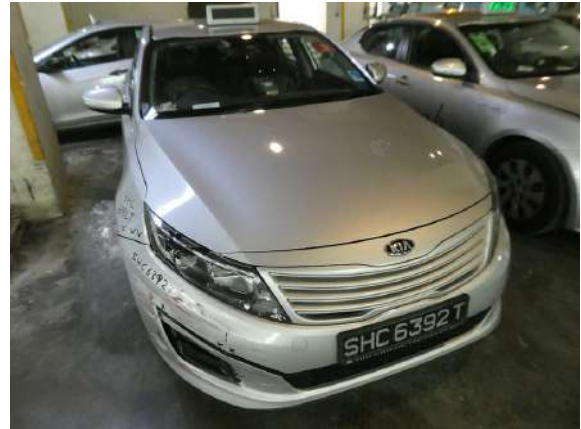
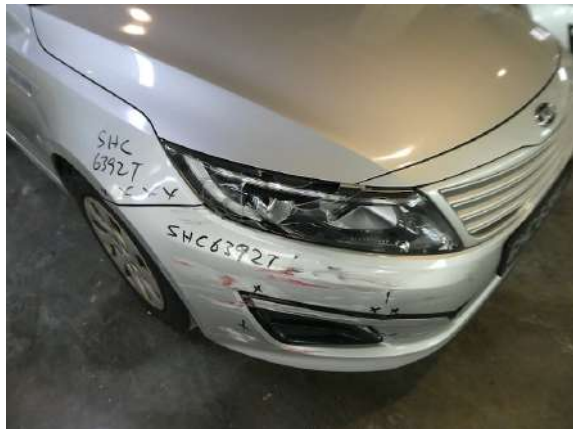
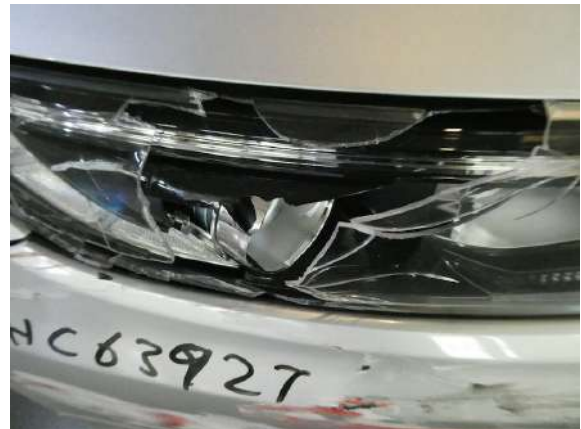
### INSPECTION

| Affiliated to Federation Internationale Des Experts En Automobile | | | | |
|---|---|---|---|---|
| | THE VEHICLE SUSTAINED DAMAGES AT THE FRONT O/S PORTION.<br><br>DAMAGES SEE DETAILS. | | | |

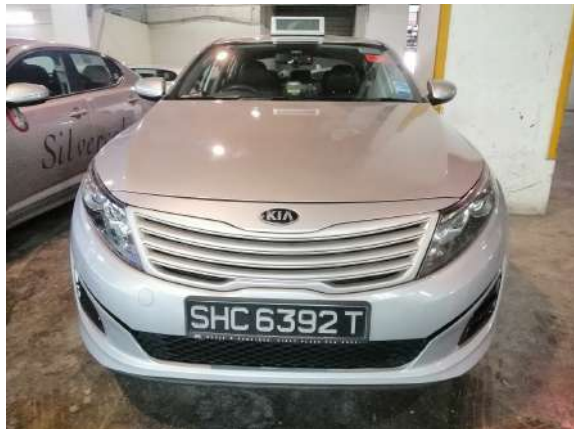
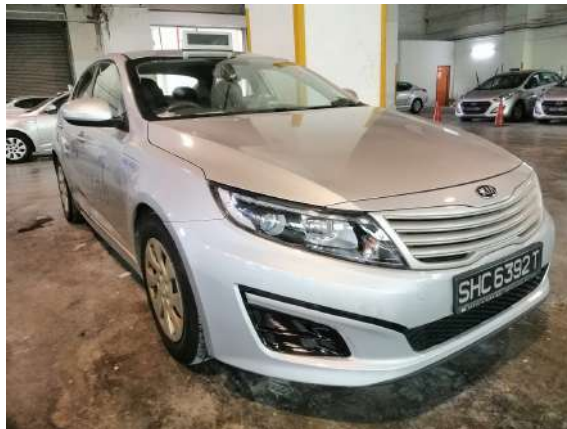
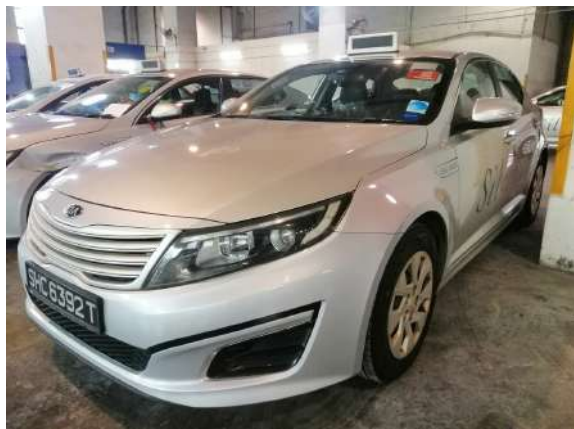
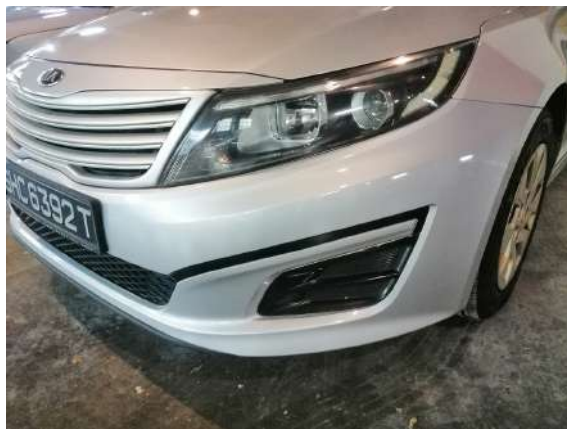
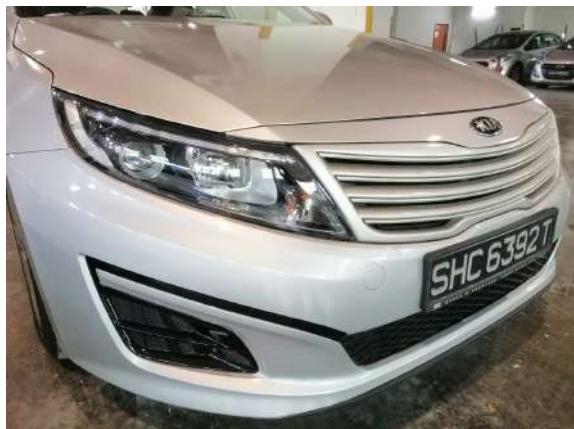
**RE-INSPECTION**

**PHOTOGRAPHS FOR VEHICLE NO. SHC 6392T**
