# CL APPRAISER PTE LTD

## VEHICLE INSPECTION REPORT

Date : 17 November 2015  
Our ref : 899/10/1501/TP

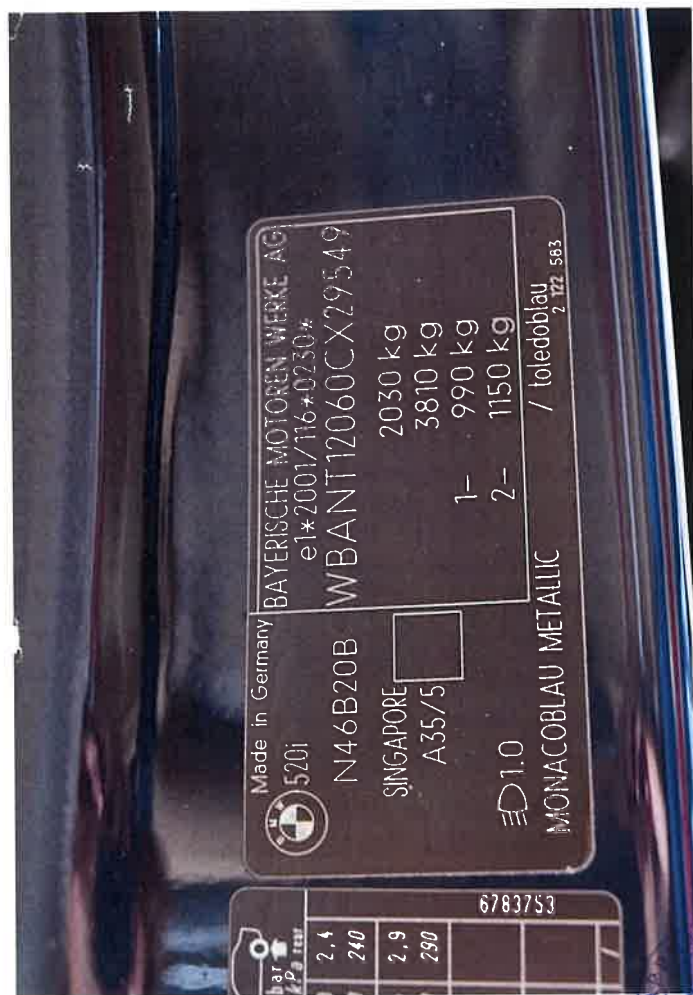
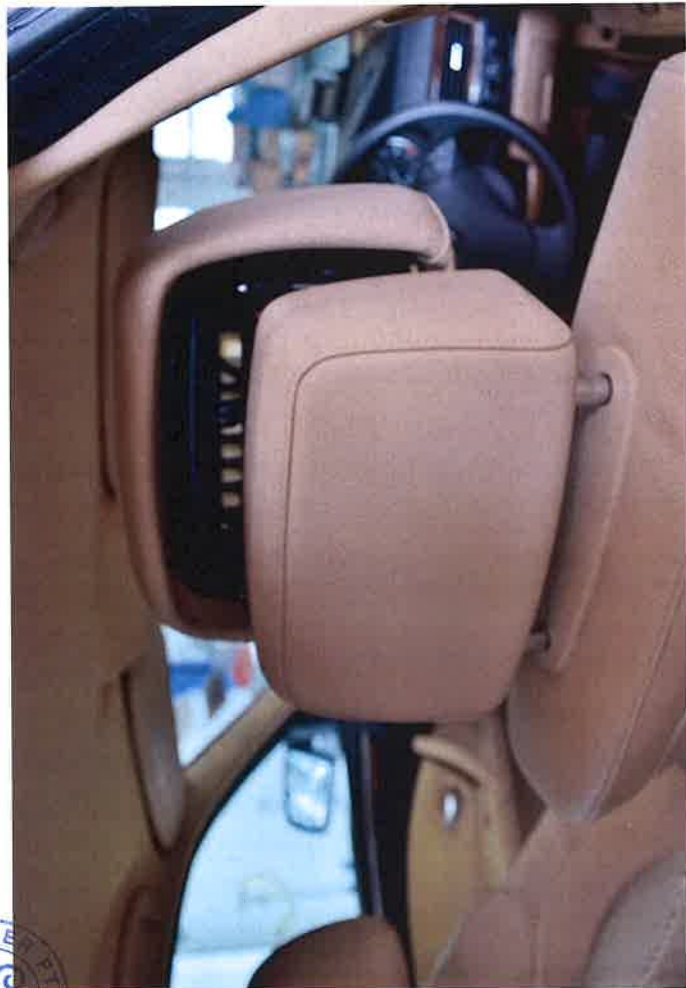
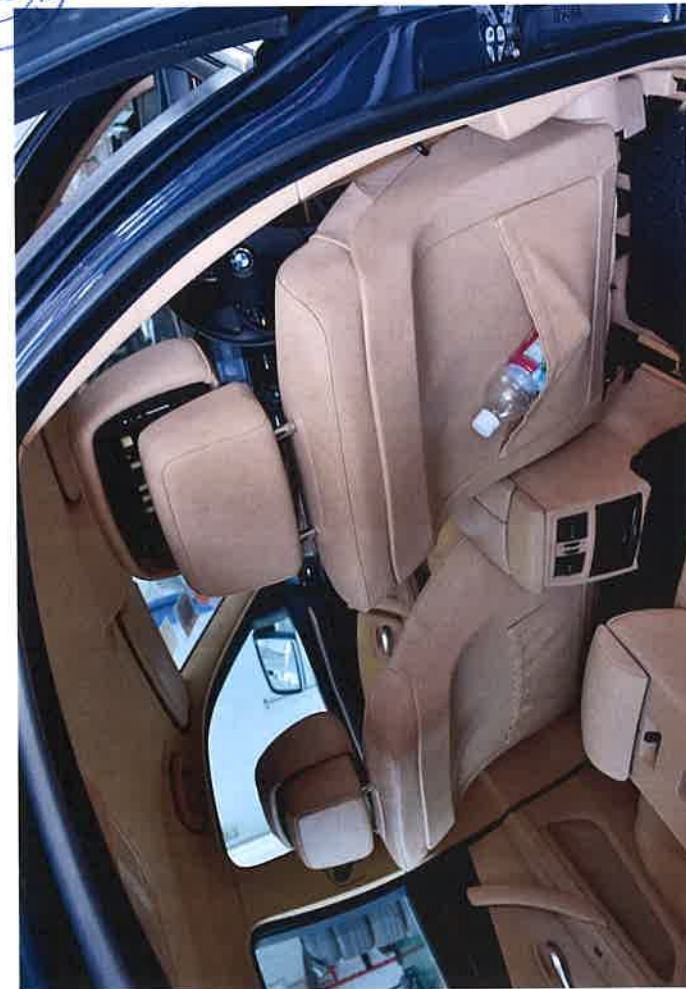
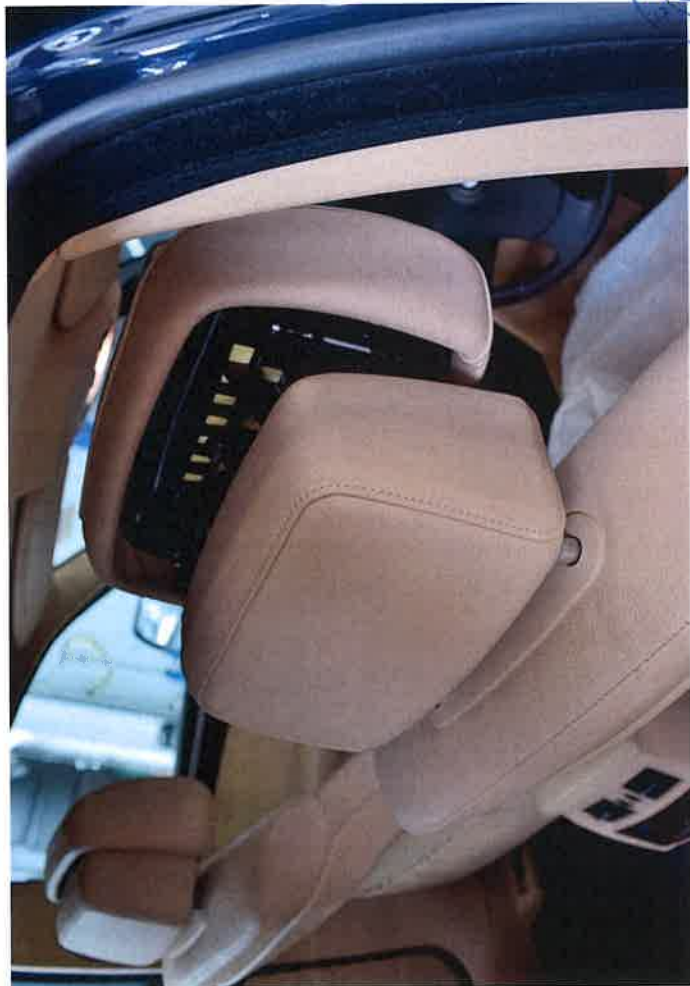
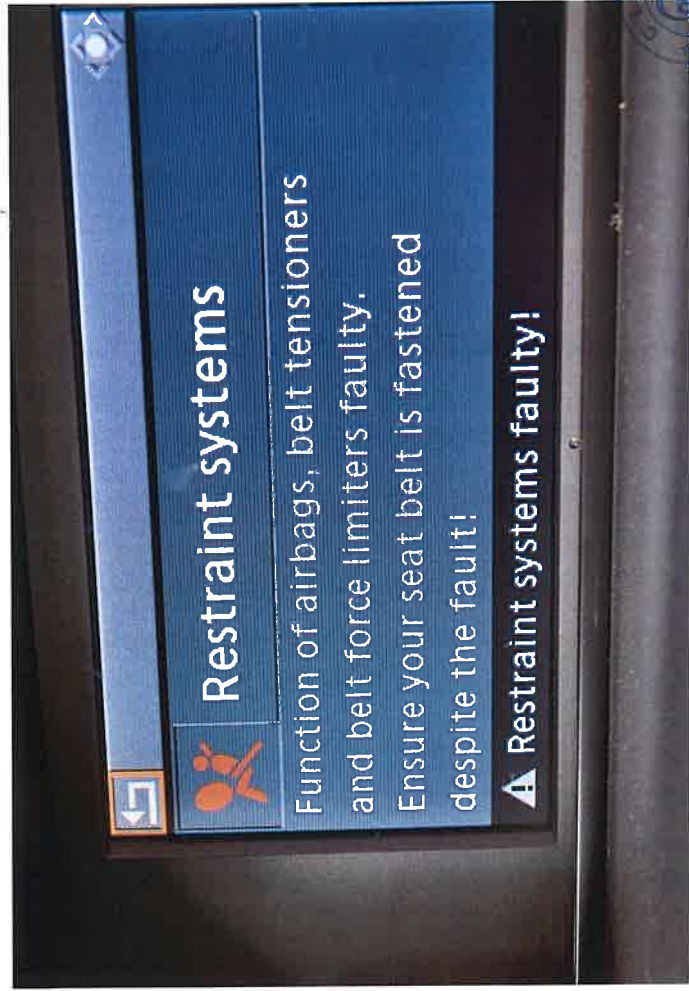
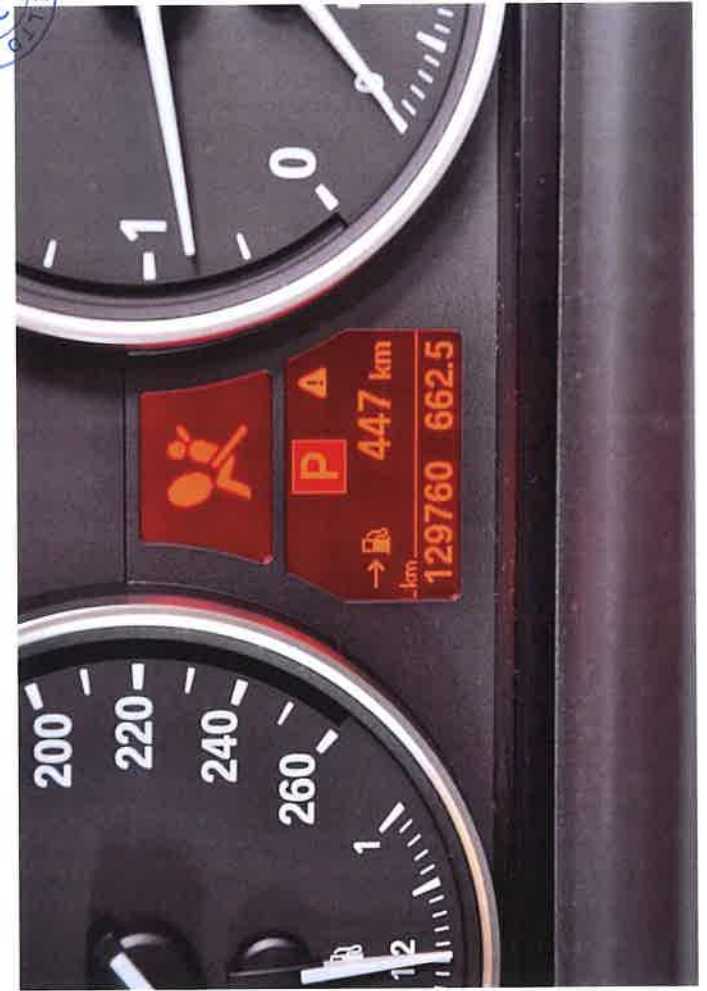
The impact damages sustained on the vehicle at the time of inspection is on the rear portion.  
(Details refer to the photographs attached)
