VEHICLE DAMAGE INSPECTION REPORT

Our Ref: 226/TP/2016

Reg No:	SKT1456B	Make &	Toyota
Reg date:	25/5/2015	Model	Estima Aeras Premium 2.4
Colour:	Silver	Engine No:	2AZJ137879
Type:	Motor Car	Chassis No:	ACR500188296
Type of Claims:	Third Party	Odometer No:	22665km
		Engine Cap:	2362cc

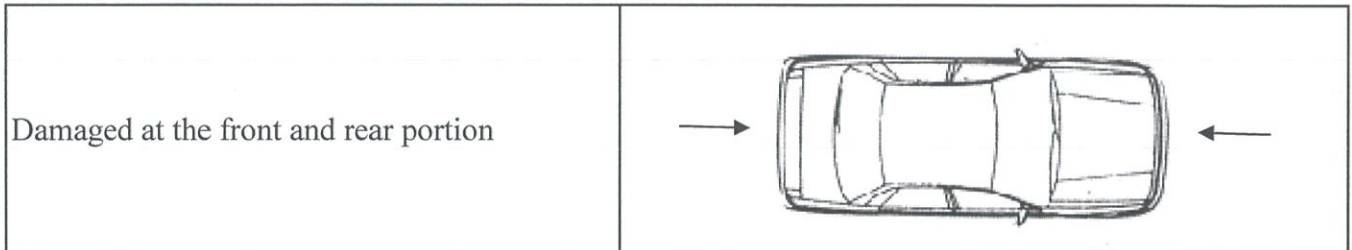
POINT OF IMPACT

Our visual inspection of the vehicle revealed that the damages noted are at the front and rear portion.

The Insured's vehicle collided onto the Third Party's vehicle along PIE Expressway towards Tuas.
