Vehicle No. SLN 9785T  
Insured Veh. XD 7126U  
Claim No. D21000981MFVS/2  
Policy No. D-21096931MFVS  
Accident Date 26/03/2021  
Inspection Date 31/03/2021

### ADJUSTMENT ON REPAIR COST FOR VEHICLE NO. SLN 9785T

PHOTOGRAPHS FOR VEHICLE NO. SLN 9785T

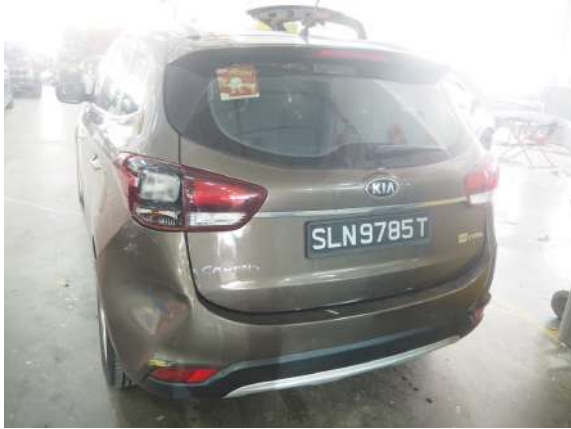
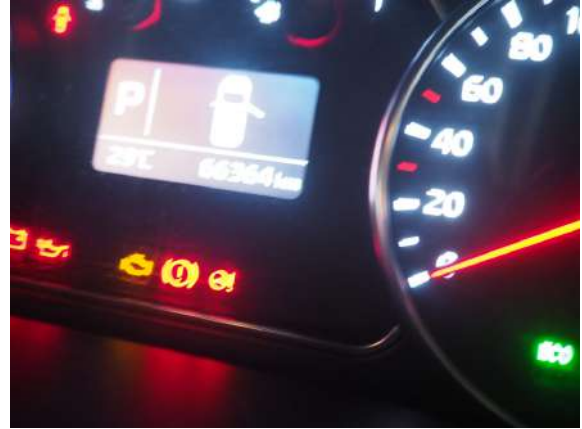
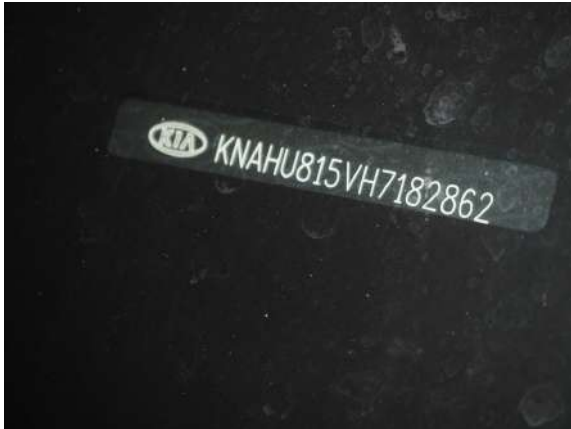
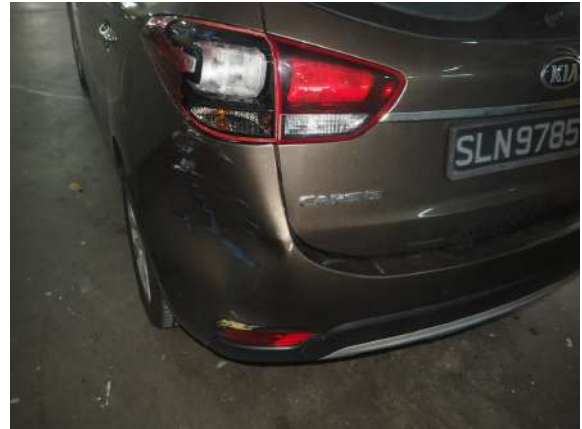
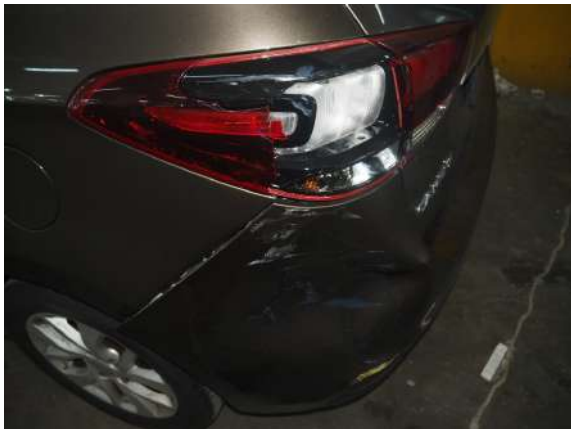
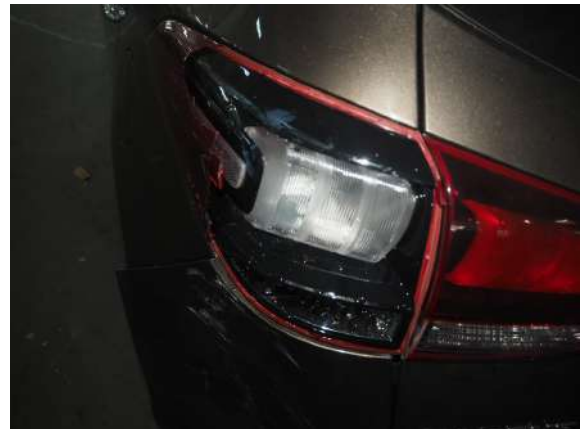
INSPECTION

| Affiliated to Federation Internationale Des Experts En Automobile | | | | |
|---|---|---|---|---|
| | THE VEHICLE SUSTAINED DAMAGES AT THE REAR N/S PORTION.<br><br>DAMAGES SEE DETAILS. | | | |

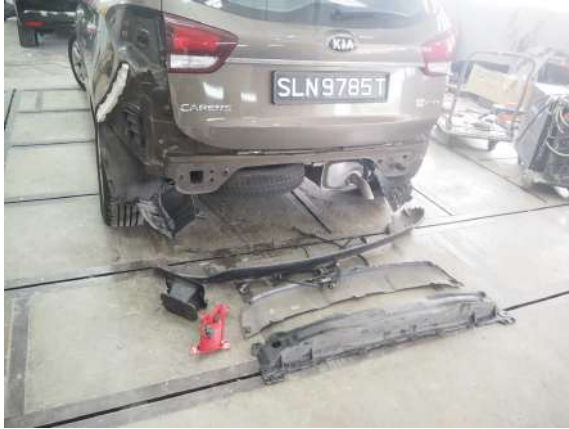
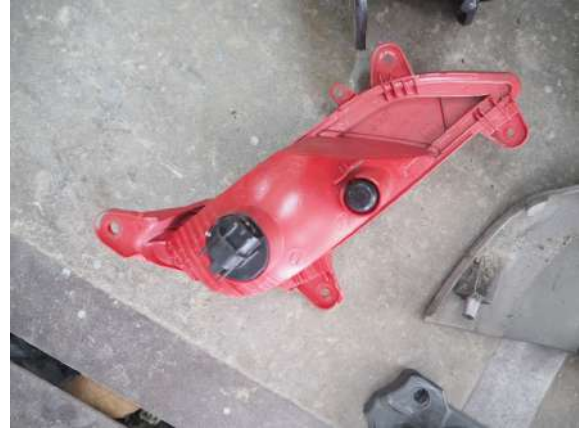
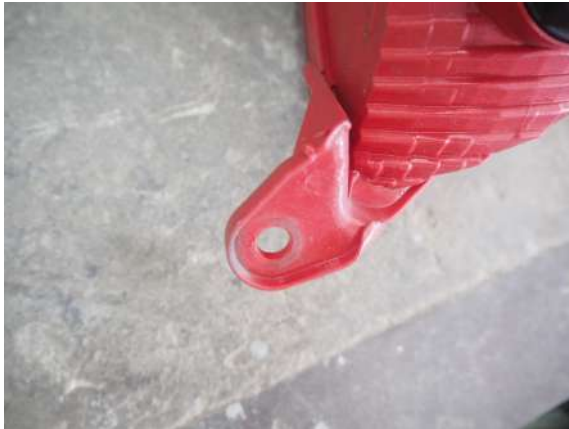
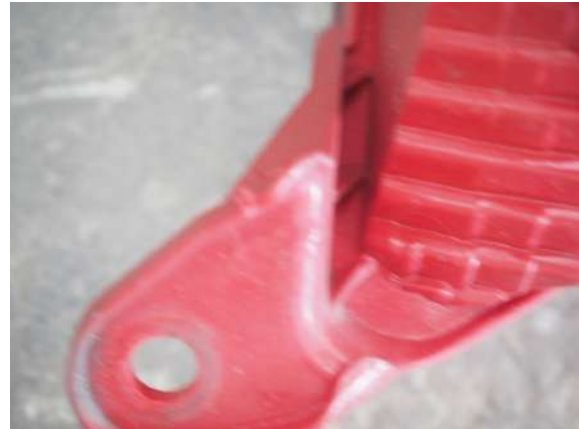
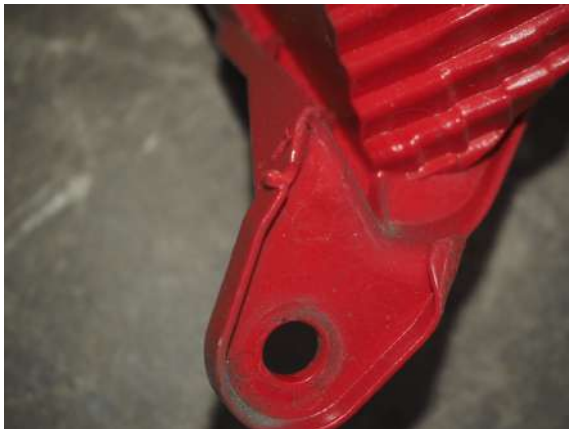
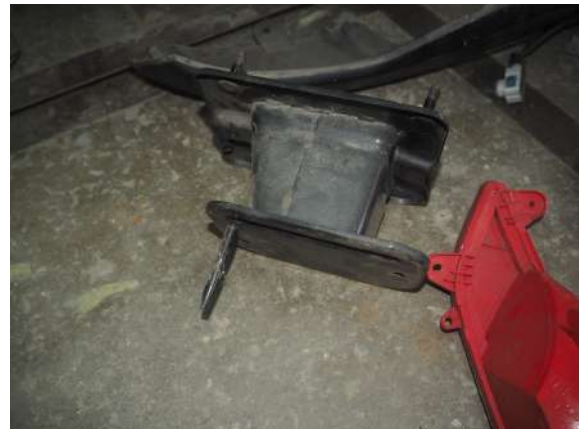
**RE-INSPECTION**

**PHOTOGRAPHS FOR VEHICLE NO. SLN 9785T**
