## LKK Auto Consultants Pte Ltd

### TAX INVOICE

Vehicle No. SJS 6204X  
Insured Veh. GQ 8913R  
Claim No. SNM21D201775/C02  
Policy No. DMCVSNW00040482000  
Accident Date 28/03/2021  
Inspection Date 29/03/2021

## ADJUSTMENT ON REPAIR COST FOR VEHICLE NO. SJS 6204X

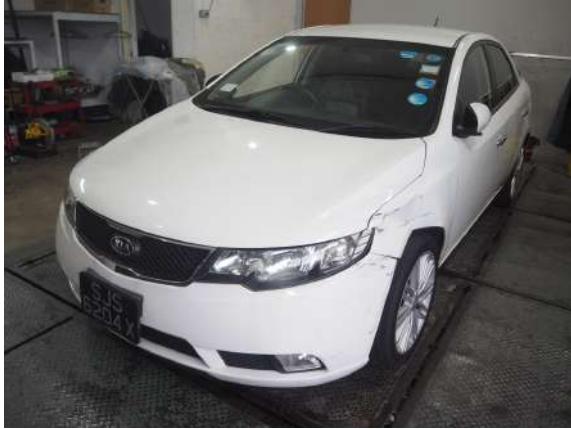
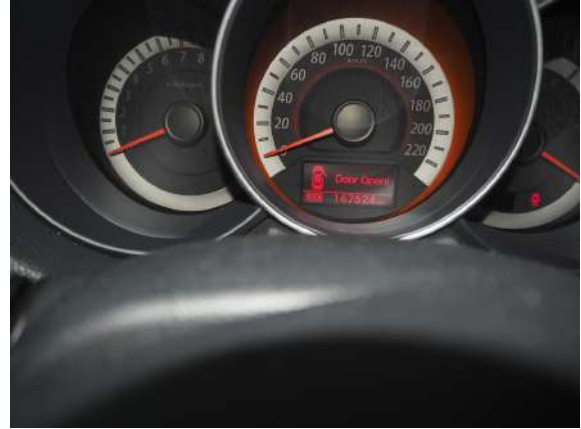
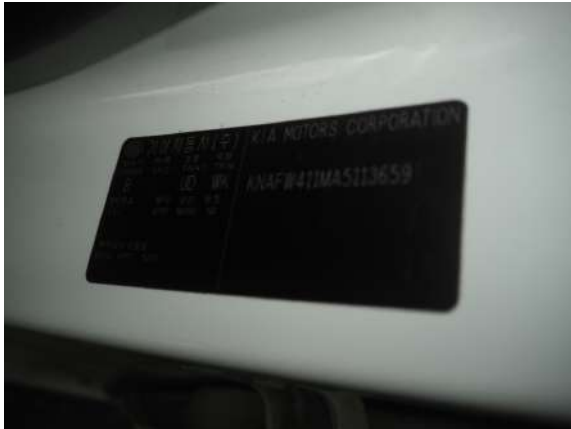
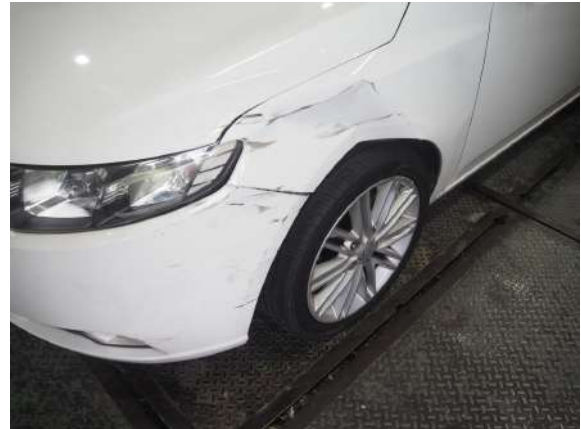
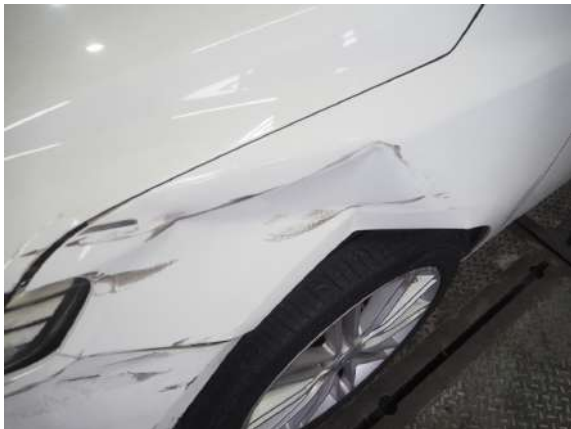
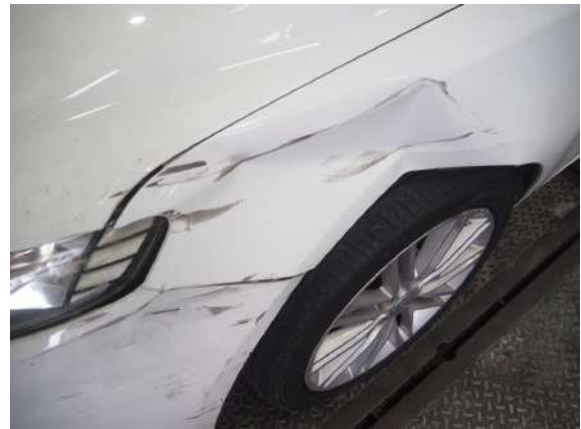
### PHOTOGRAPHS FOR VEHICLE NO. SJS 6204X

### INSPECTION

| Affiliated to Federation Internationale Des Experts En Automobile | | | | |
|---|---|---|---|--|
| THE VEHICLE SUSTAINED DAMAGES AT THE FRONT N/S PORTION.<br><br>DAMAGES SEE DETAILS. | | | | |

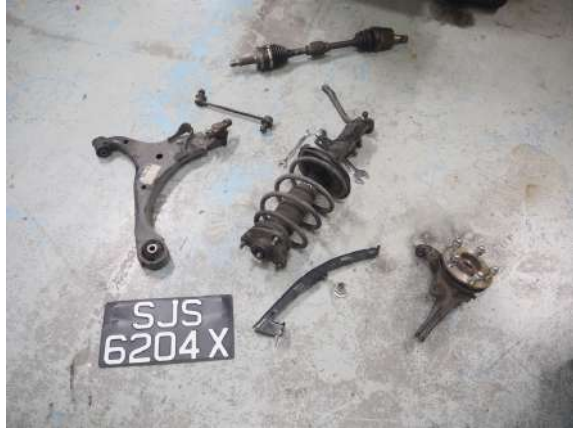
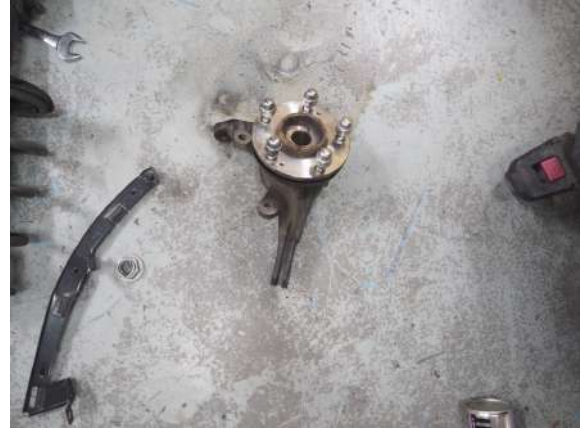
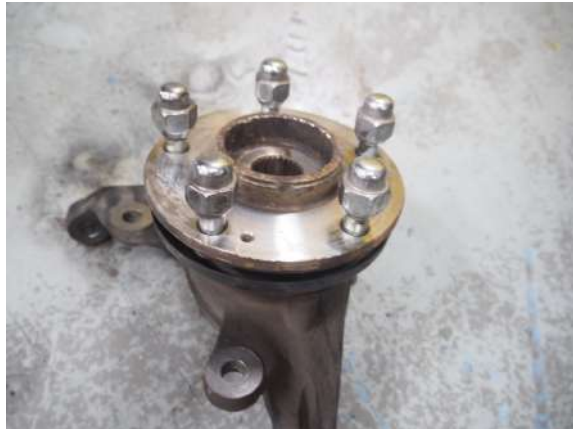
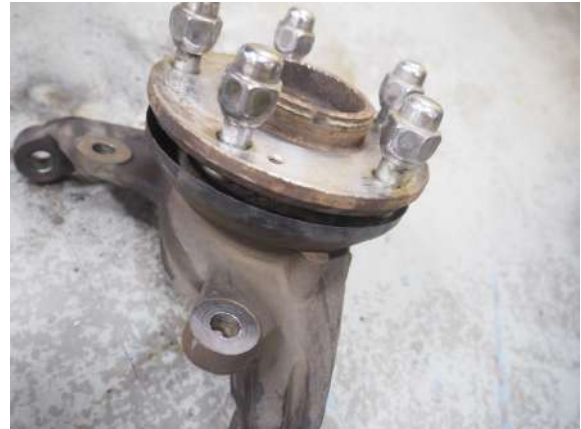
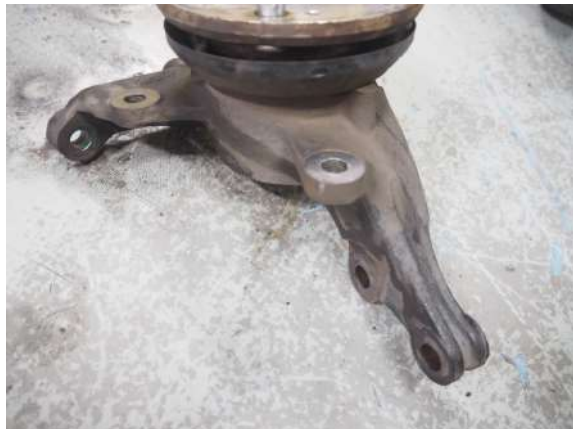
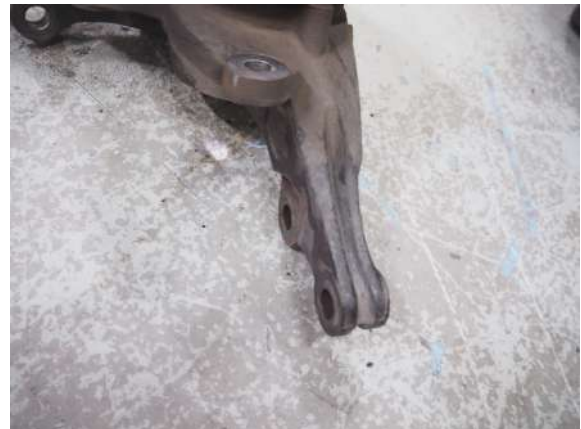
PHOTOGRAPHS FOR VEHICLE NO. SJS 6204X

RE-INSPECTION
