Vehicle No.	GBH 6737C
Insured Veh.	YP 9912D
Claim No.	SNM21D201958/LKKDS
Policy No.	DMCVSNW00122122000
Accident Date	05/04/2021
Inspection Date	08/04/2021

## ADJUSTMENT ON REPAIR COST FOR VEHICLE NO. GBH 6737C

## PHOTOGRAPHS FOR VEHICLE NO. GBH 6737C

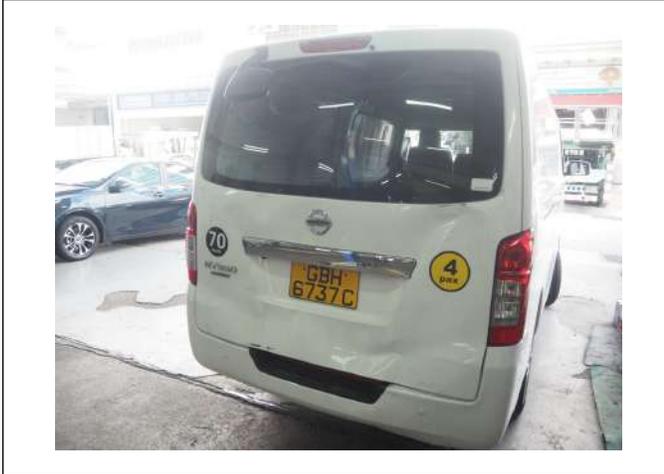
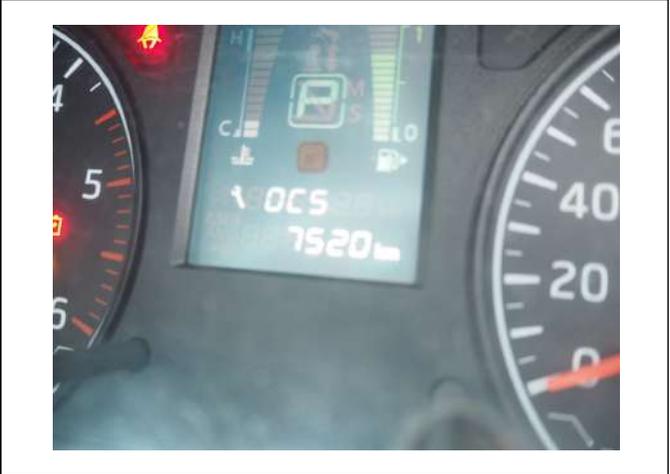
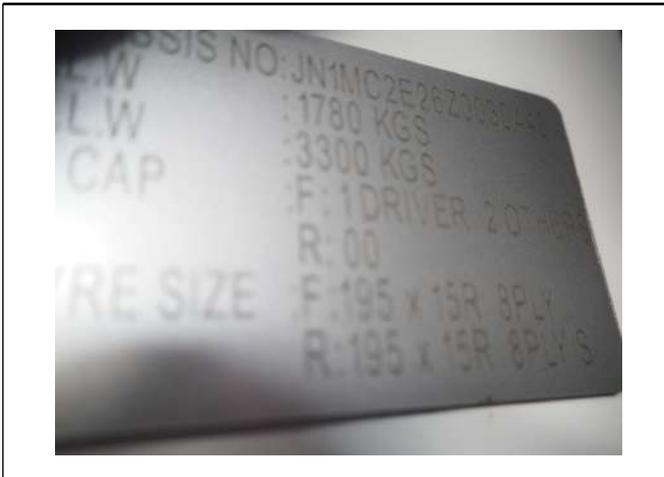
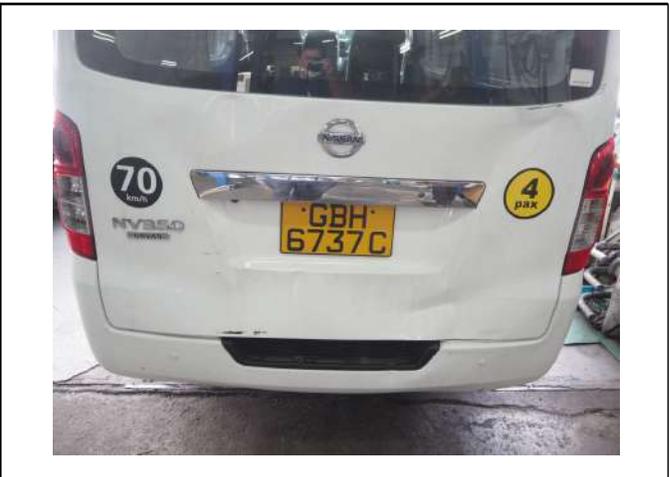
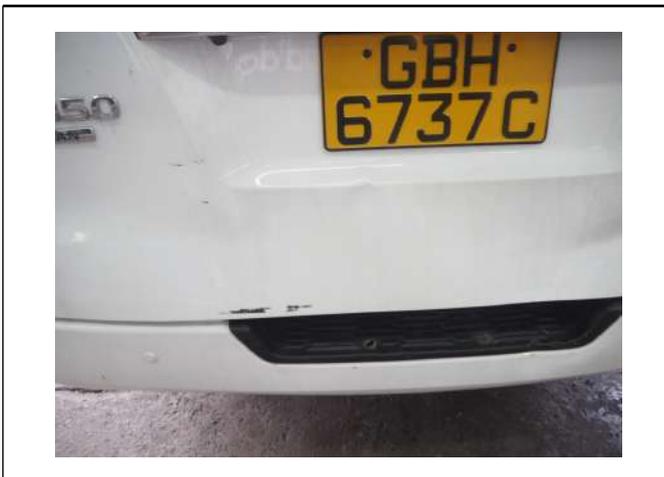
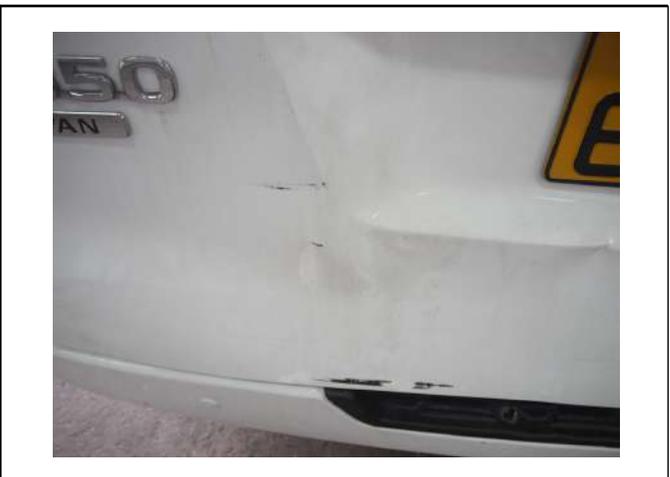
## INSPECTION

4. Description of Damages			
THE VEHICLE SUSTAINED DAMAGES AT THE REAR PORTION. DAMAGES SEE DETAILS.			
5. General Information			
Accident Date	05/04/2021	Inspection Date	08/04/2021
Survey held at	KT MOTORWERK 3012 BEDOK INDUSTRIAL PARK E, #01-2020, BEDOK INDUSTRIAL PARK E, SINGAPORE 489978		
5a. Remarks			
A)THE INSPECTION WAS CONDUCTED ON A"WITHOUT PREJUDICE" BASIS. B)IN ACCORDANCE TO YOUR INSTRUCTIONS, WE HAVE NOT AUTHORISED REPAIRS.			
5b. Estimate Days of Repair			
ESTIMATED NORMAL PERIOD FOR REPAIR:		6 Working Days

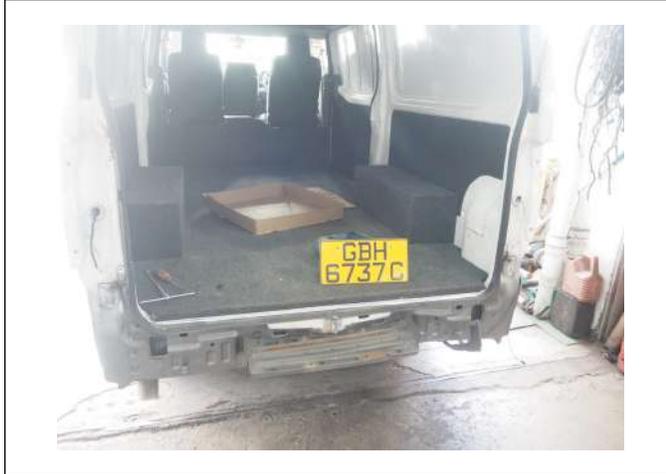
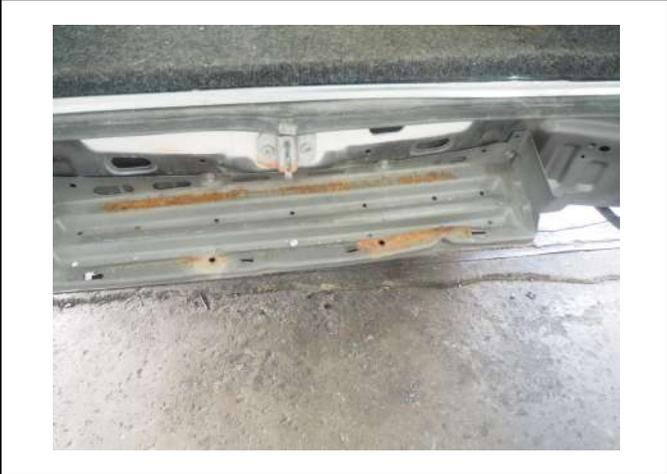
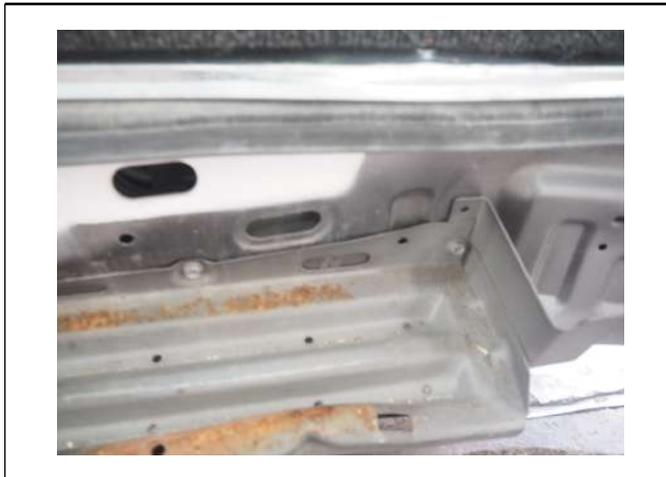
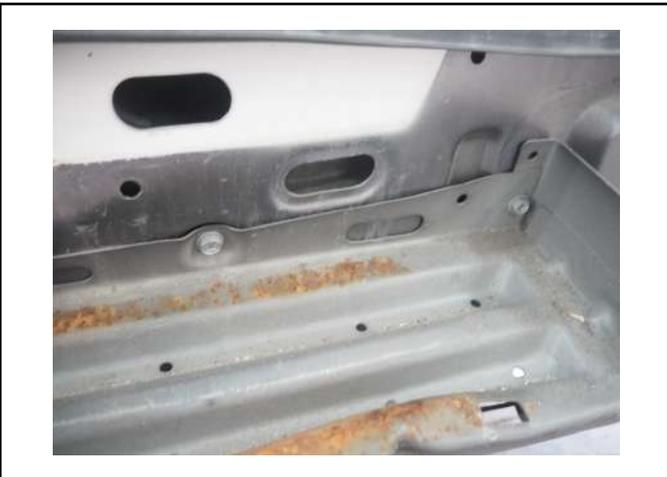
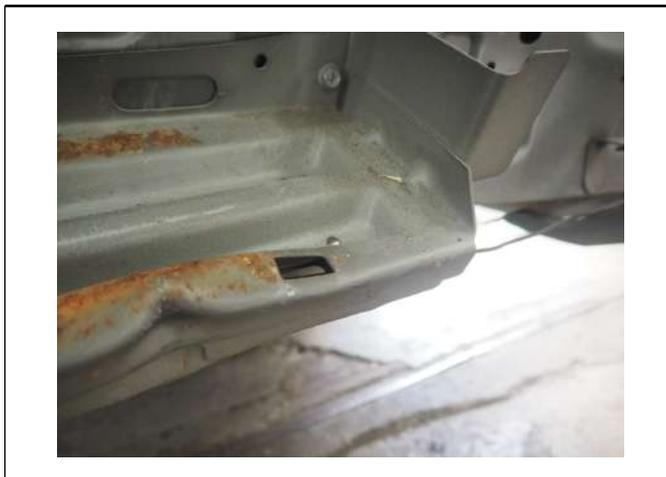
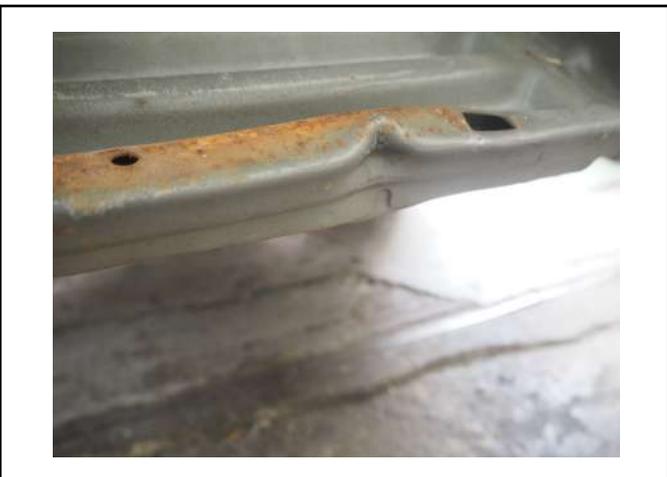
## PHOTOGRAPHS FOR VEHICLE NO. GBH 6737C

## RE-INSPECTION
