Vehicle No. SJP 7717S  
Insured Veh. SLD 444P  
Claim No. SNM21D201908/LKKDS  
Policy No. DMPCSNW00041162001  
Accident Date 02/04/2021  
Inspection Date 06/04/2021

### ADJUSTMENT ON REPAIR COST FOR VEHICLE NO. SJP 7717S

### PHOTOGRAPHS FOR VEHICLE NO. SJP 7717S

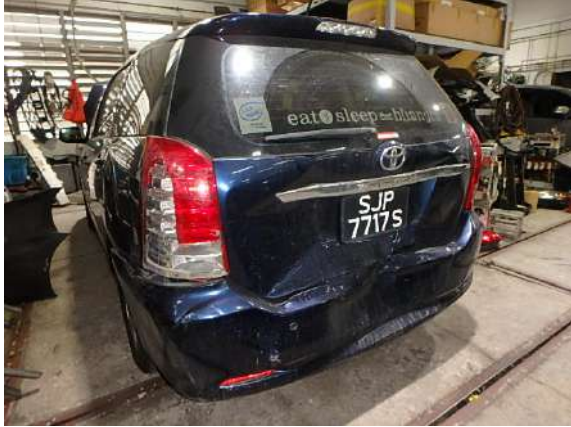
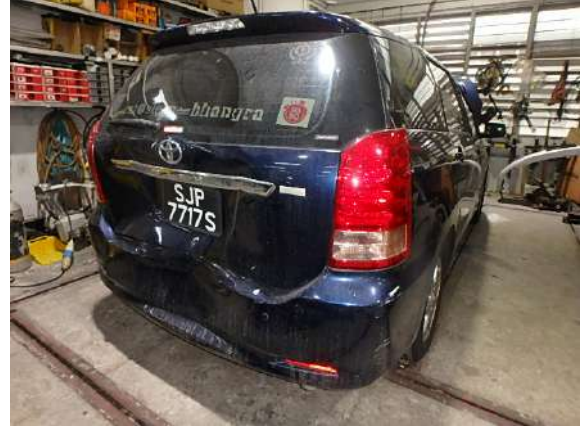
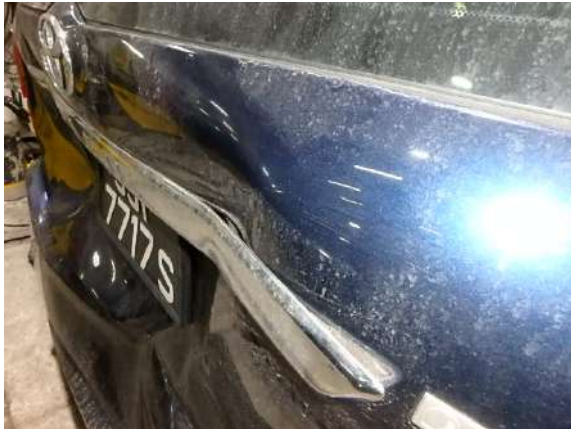
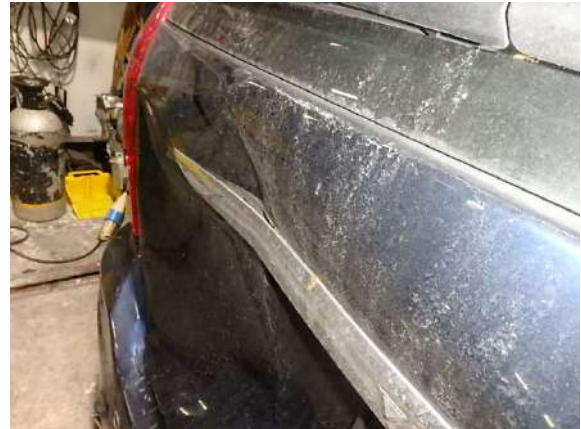
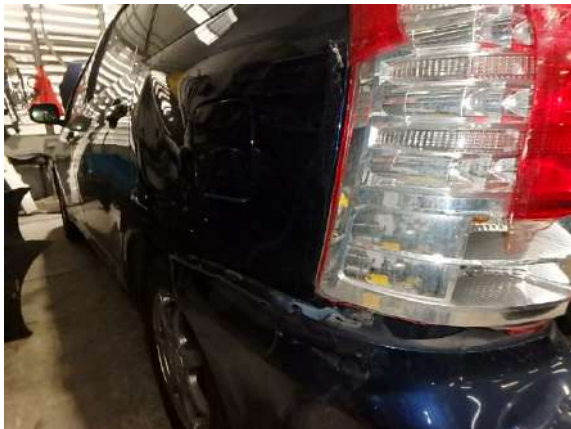
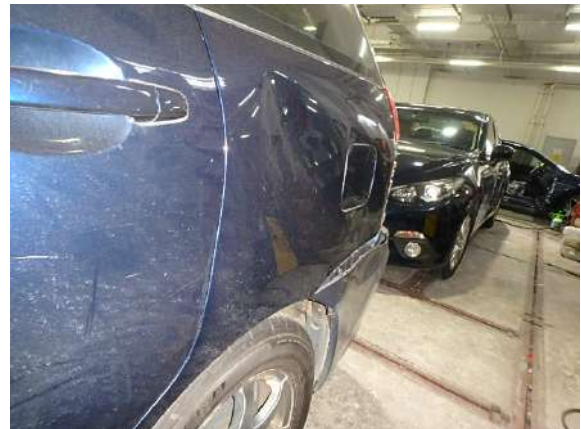
### INSPECTION

| Affiliated to Federation Internationale Des Experts En Automobile | | | | |
|---|---|---|---|--|
| THE VEHICLE SUSTAINED DAMAGES AT THE REAR & FRONT PORTION.<br><br>DAMAGES SEE DETAILS. | | | | |

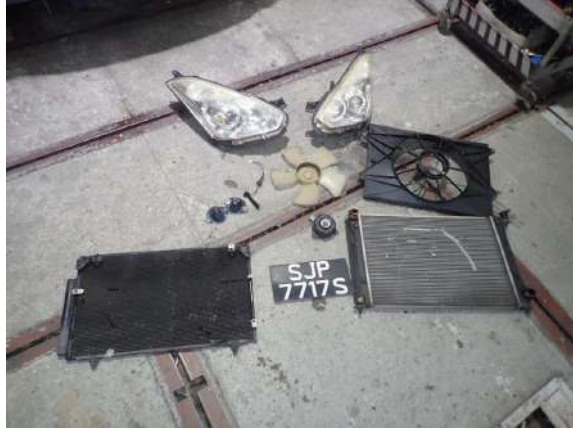
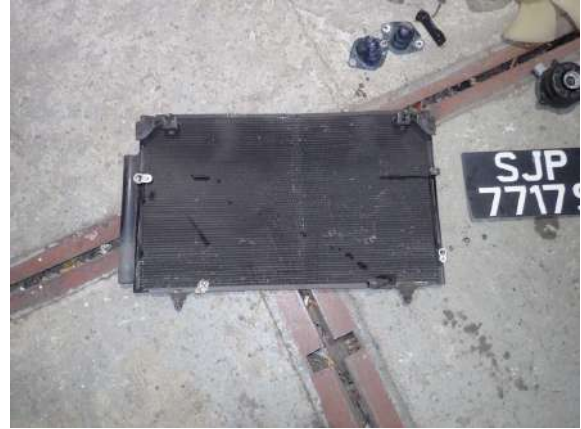
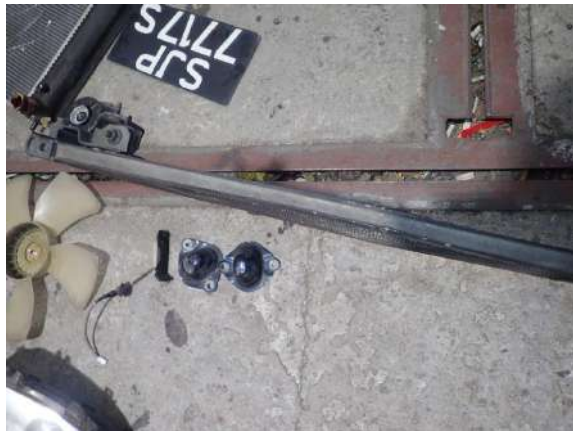
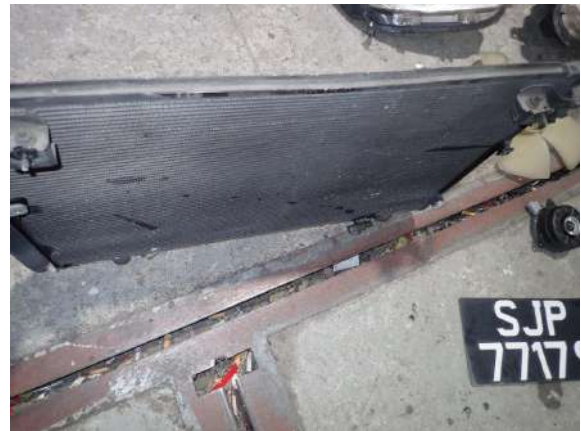
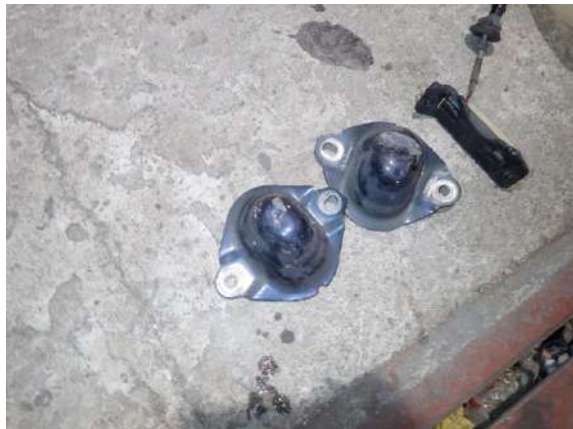
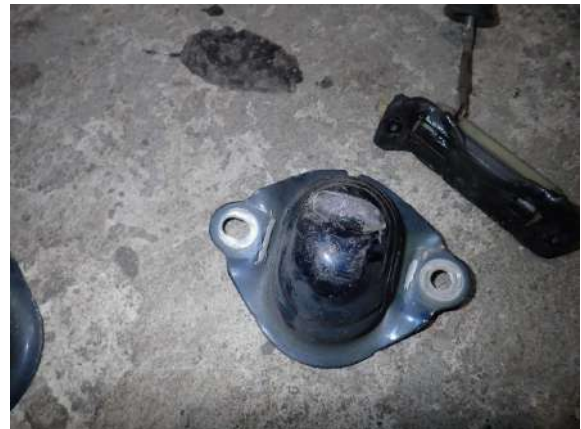
RE-INSPECTION

PHOTOGRAPHS FOR VEHICLE NO. SJP 7717S
