## LKK Auto Consultants Pte Ltd

### PROFESSIONAL SERVICE FEE

Vehicle No. SMF 4133M  
Insured Veh. SLB 4117T  
Claim No. SNM21D202075/C02  
Policy No. DMPCSNW00135952001  
Accident Date 10/04/2021  
Inspection Date 13/04/2021

## ADJUSTMENT ON REPAIR COST FOR VEHICLE NO. SMF 4133M

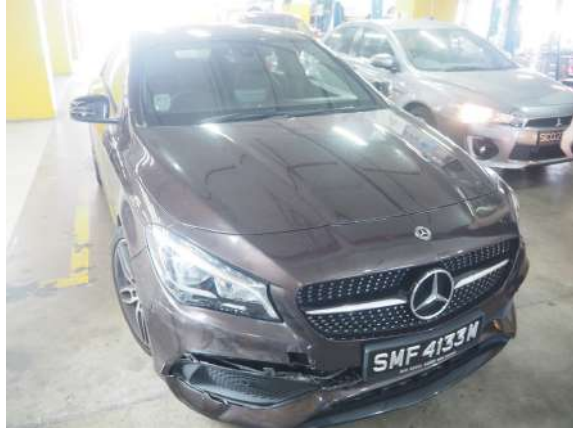
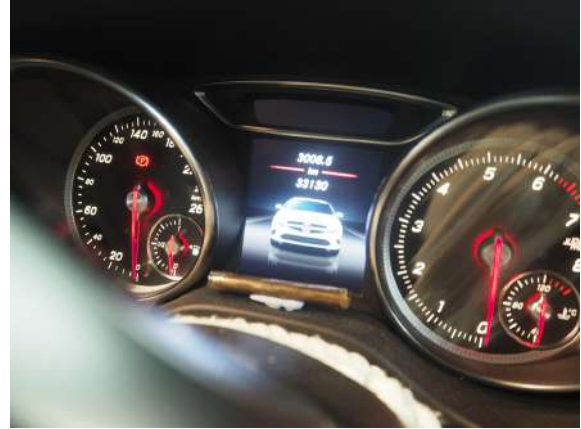
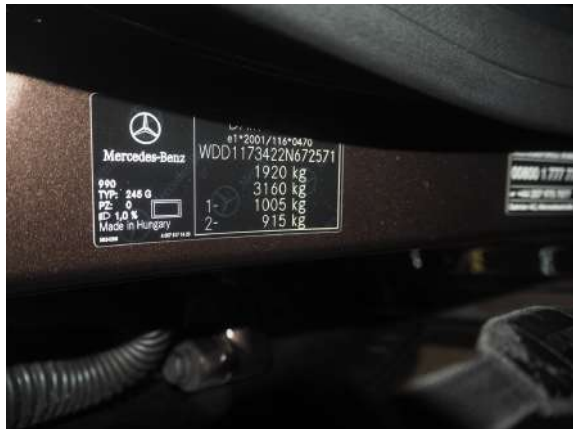
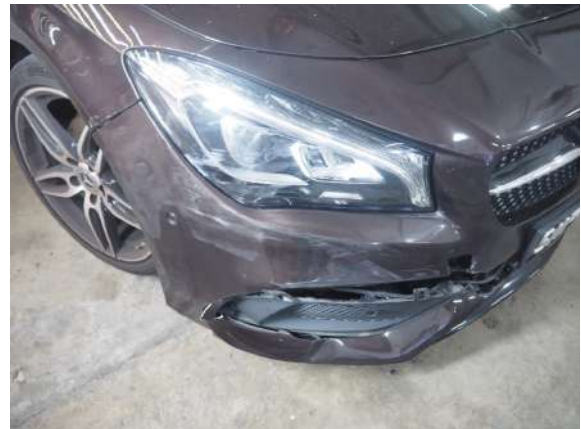
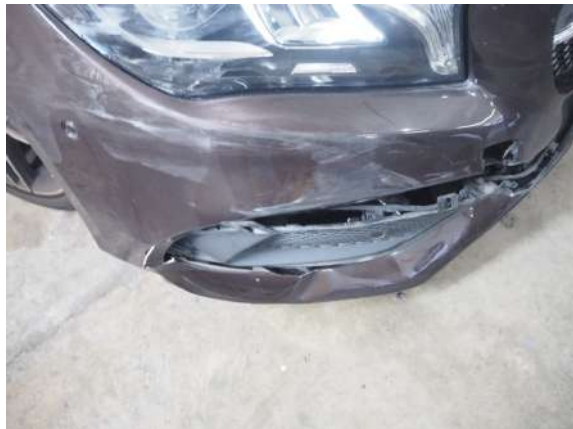
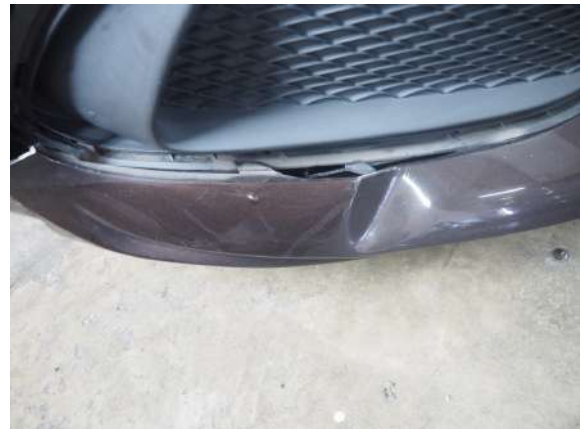
### INSPECTION

### PHOTOGRAPHS FOR VEHICLE NO. SMF 4133M

| Affiliated to Federation Internationale Des Experts En Automobile | | | | |
|---|---|---|---|--|
| THE VEHICLE SUSTAINED DAMAGES AT THE FRONT O/S PORTION.<br>DAMAGES SEE DETAILS. | | | | |

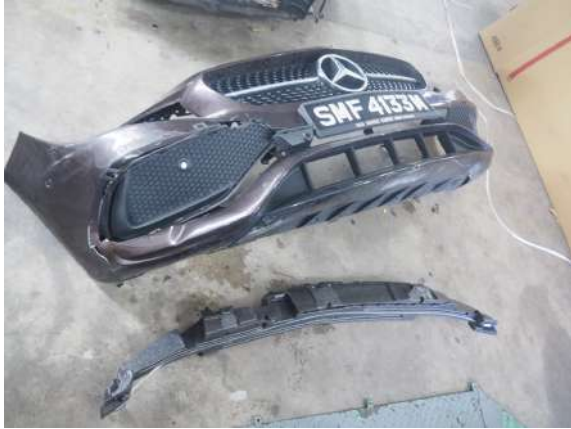
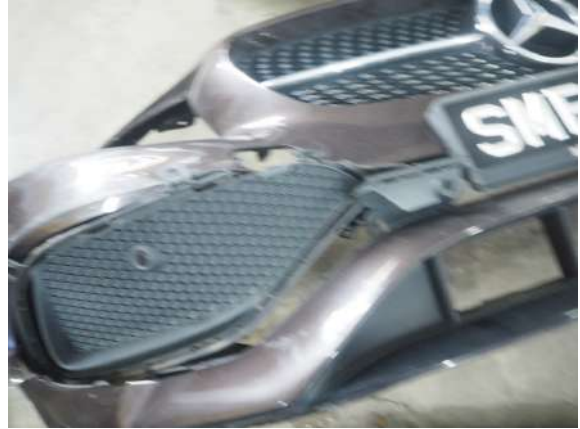
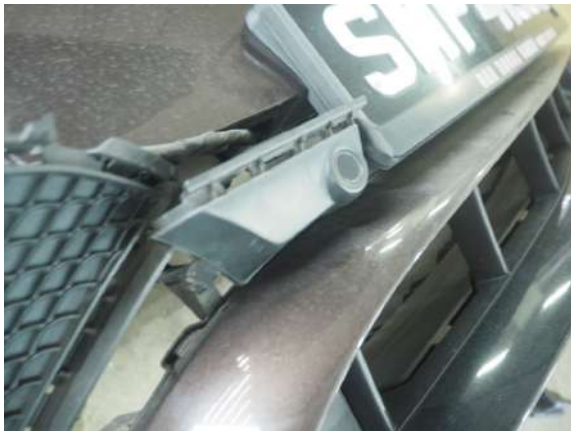
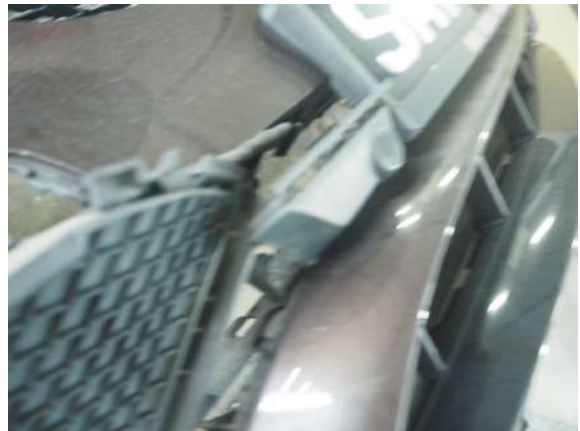
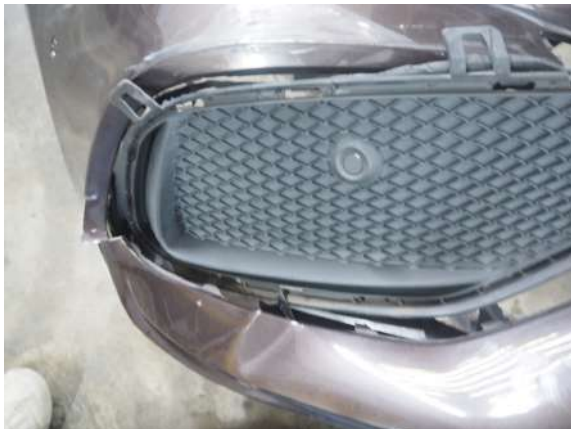
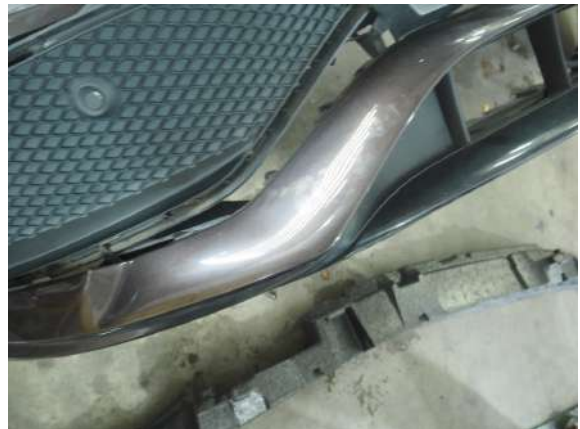
RE-INSPECTION

PHOTOGRAPHS FOR VEHICLE NO. SMF 4133M
