# LKK Auto Consultants Pte Ltd

## ADJUSTMENT ON REPAIR COST FOR VEHICLE NO. SMQ 2877E

### PHOTOGRAPHS FOR VEHICLE NO. SMQ 2877E

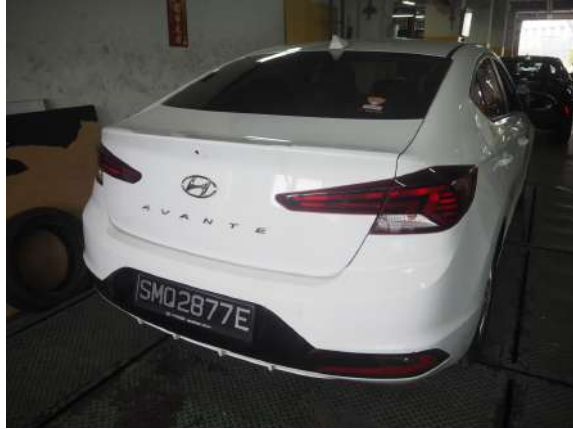
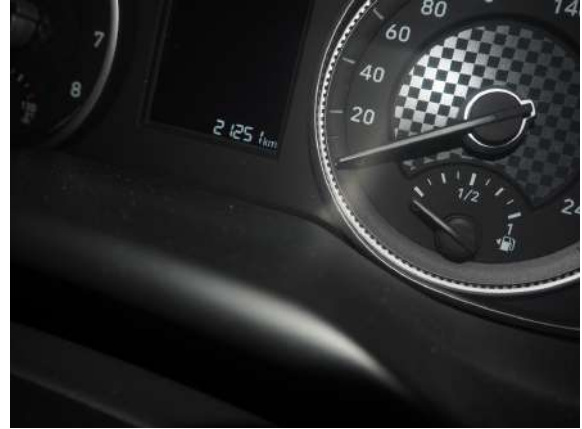
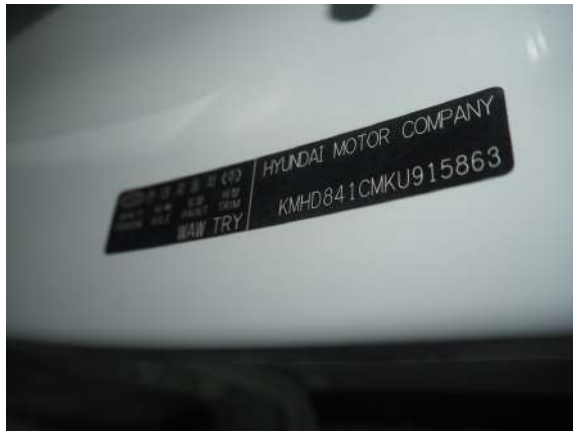
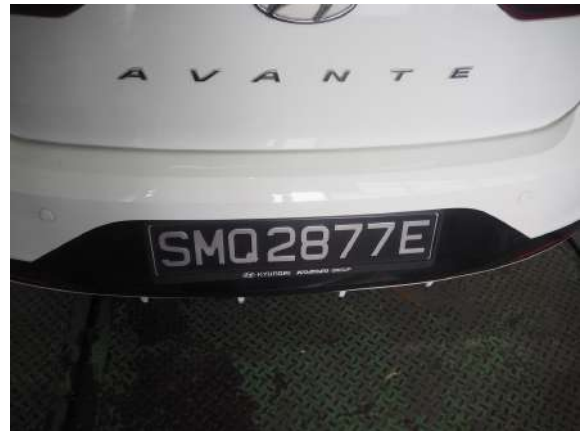
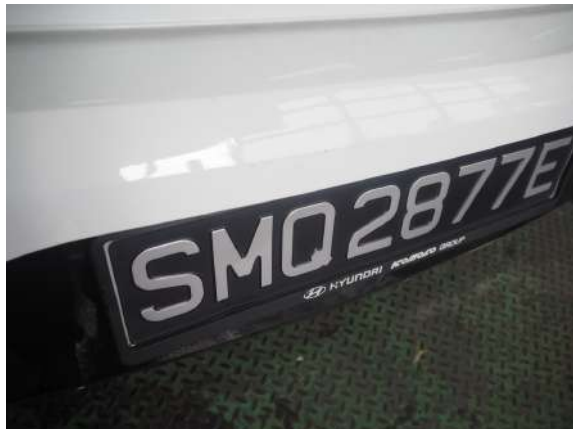
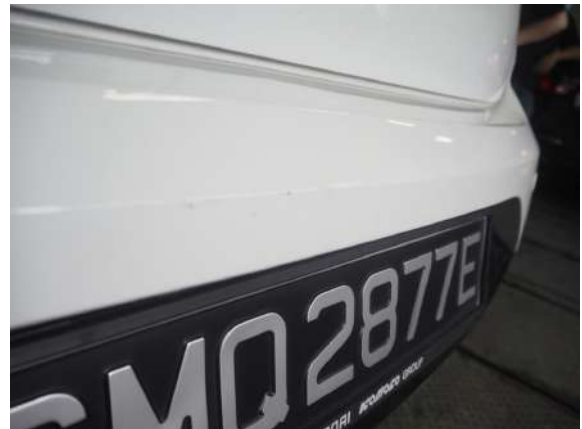
### INSPECTION

| Affiliated to Federation Internationale Des Experts En Automobile | | | | |
|---|---|---|---|--|
| THE VEHICLE SUSTAINED DAMAGES AT THE REAR PORTION.<br><br>DAMAGES SEE DETAILS. | | | | |

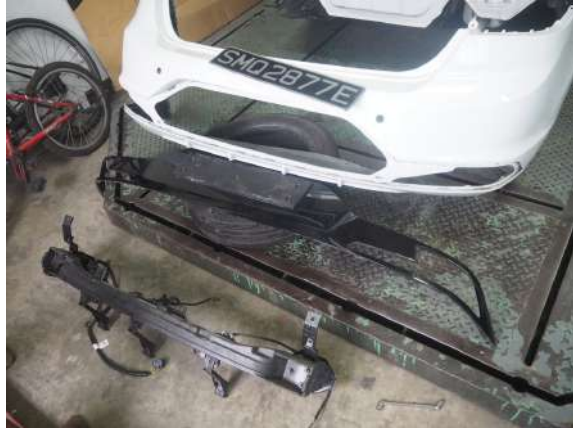
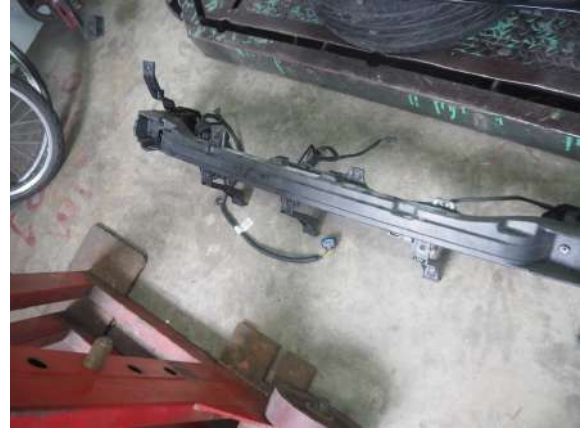
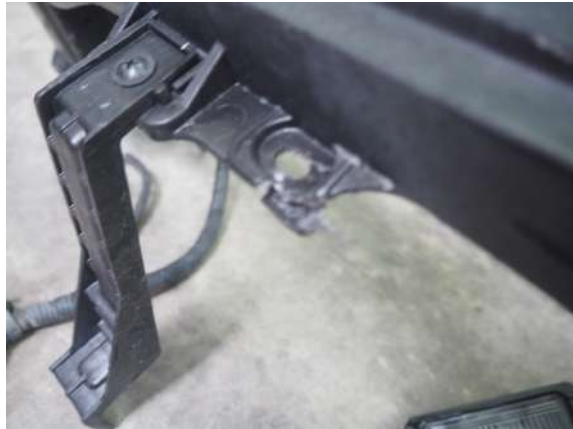
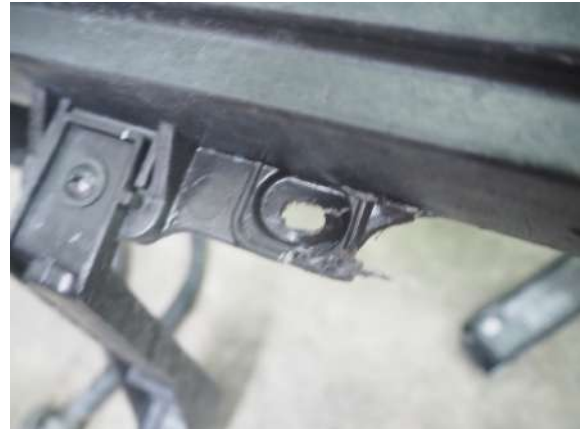
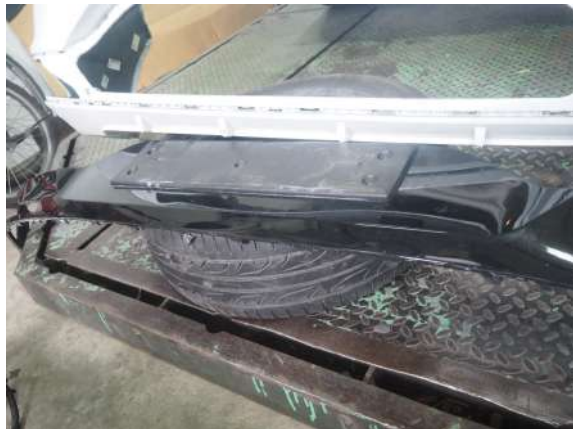
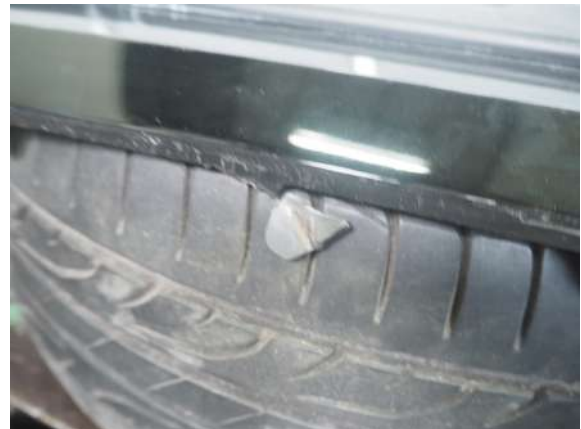
RE-INSPECTION

PHOTOGRAPHS FOR VEHICLE NO. SMQ 2877E
