### PROFESSIONAL SERVICE FEE

Vehicle No. SLT 9281Z  
Insured Veh. SJK 2957A  
Claim No. 21/21/21/024502  
Policy No. Z21VP05028812  
Accident Date 27/04/2021  
Inspection Date 28/04/2021

### ADJUSTMENT ON REPAIR COST FOR VEHICLE NO. SLT 9281Z

### PHOTOGRAPHS FOR VEHICLE NO. SLT 9281Z

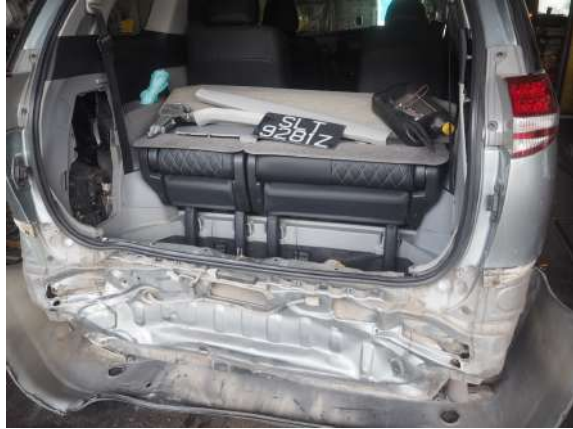
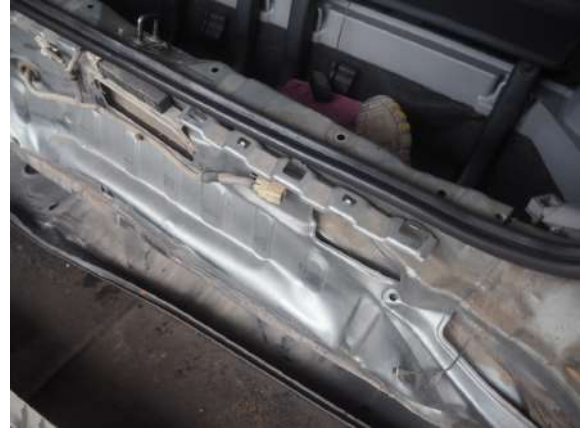
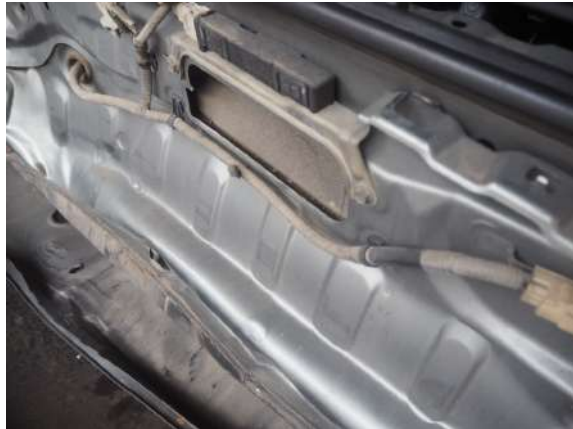
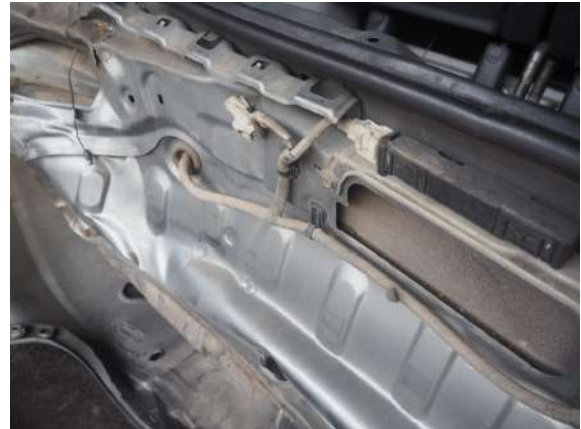
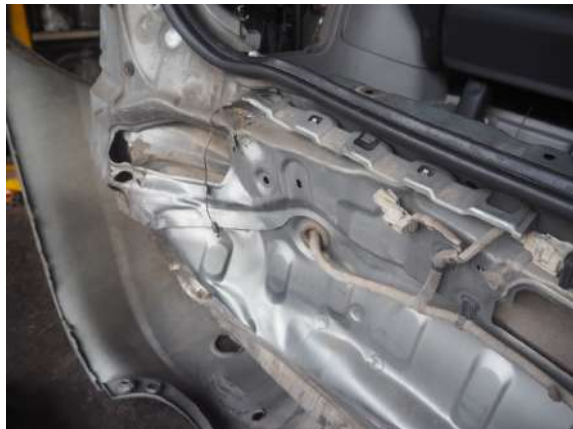
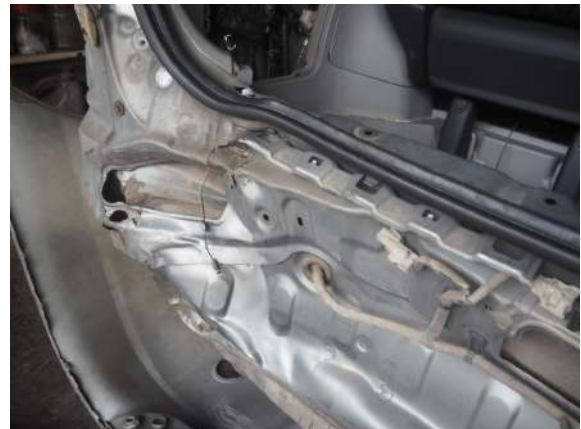
**PHOTOGRAPHS FOR VEHICLE NO. SLT 9281Z**

**RE-INSPECTION**

| Affiliated to Federation Internationale Des Experts En Automobile | | | | |
|---|---|---|---|--|
| THE VEHICLE SUSTAINED DAMAGES AT THE REAR PORTION.<br><br>DAMAGES SEE DETAILS. | | | | |
