Vehicle No. SMR 8847Y  
Insured Veh. SMH 4565P  
Claim No. SNM21D202582/C02  
Policy No. DMPCSNW00017862100  
Accident Date 02/05/2021  
Inspection Date 04/05/2021

## ADJUSTMENT ON REPAIR COST FOR VEHICLE NO. SMR 8847Y

### PHOTOGRAPHS FOR VEHICLE NO. SMR 8847Y

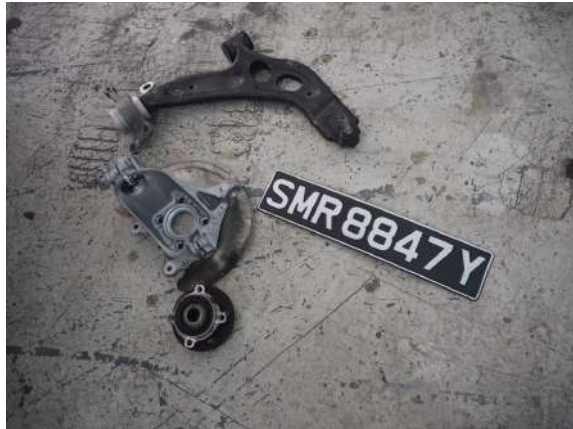
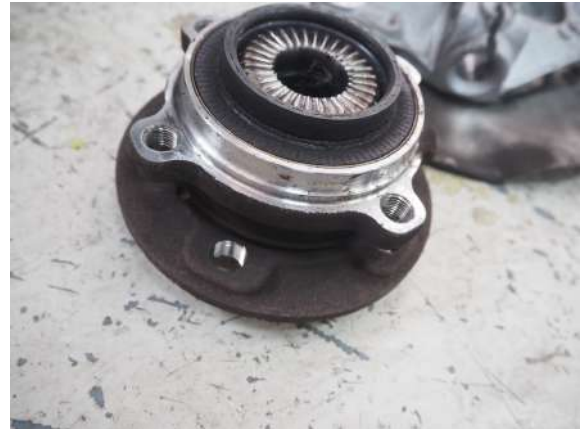
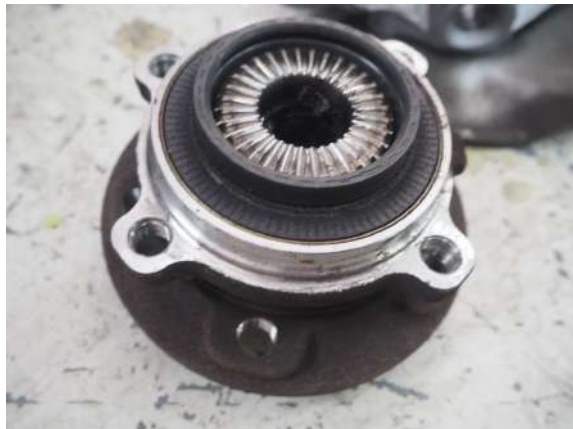
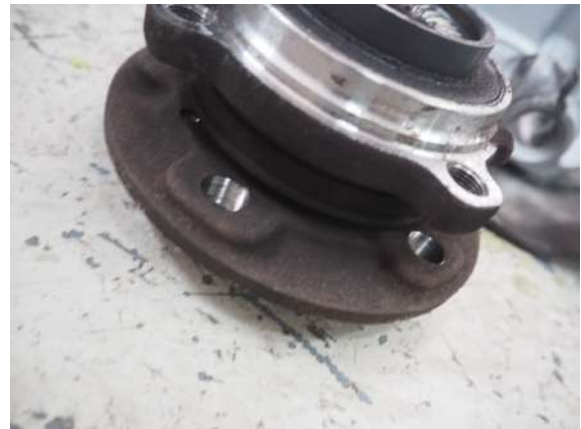
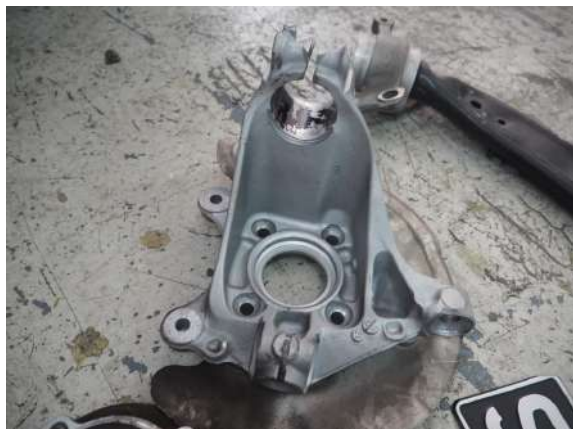
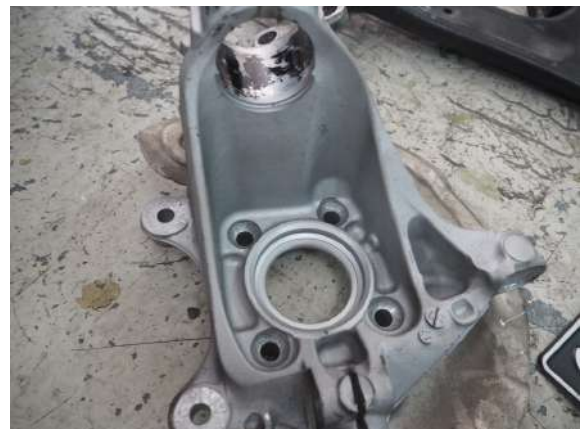
PHOTOGRAPHS FOR VEHICLE NO. SMR 8847Y

RE-INSPECTION

| Affiliated to Federation Internationale Des Experts En Automobile | | | | |
|---|---|---|---|--|
| THE VEHICLE SUSTAINED DAMAGES AT THE O/S BODY AND UNDERCARRIAGE.<br>DAMAGES SEE DETAILS. | | | | |
