## LKK Auto Consultants Pte Ltd

#### 1. Policy Particulars :- THIRD PARTY CLAIM

#### 2. Vehicle Particulars & Condition

### PHOTOGRAPHS FOR VEHICLE NO. YP 3526A

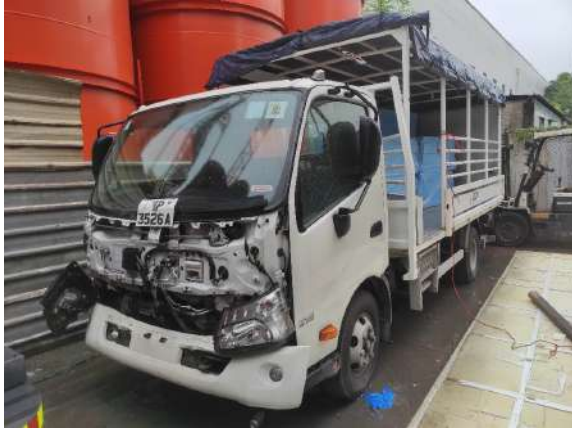
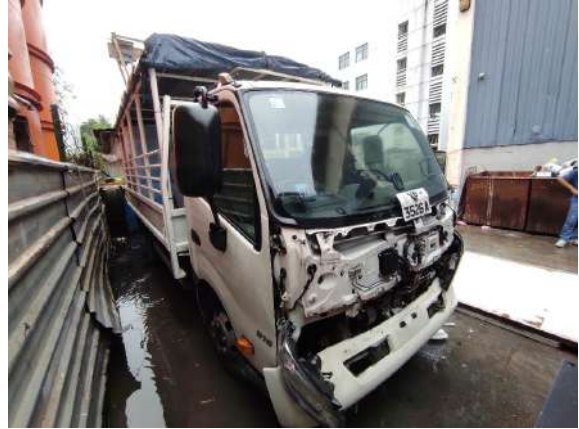
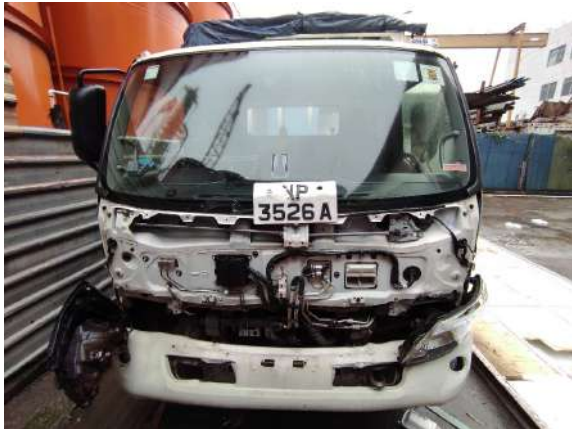
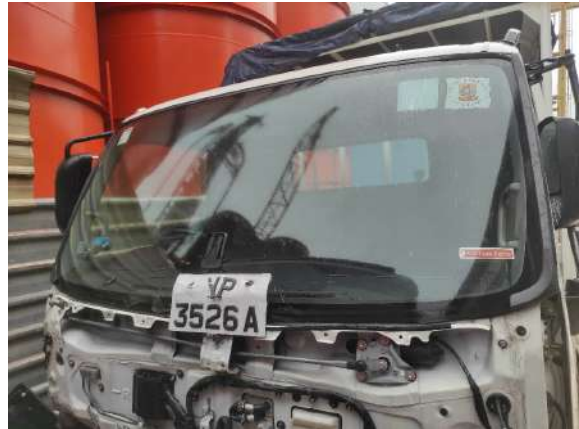
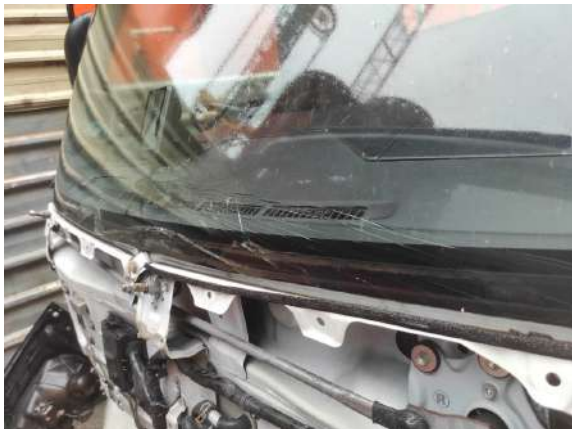
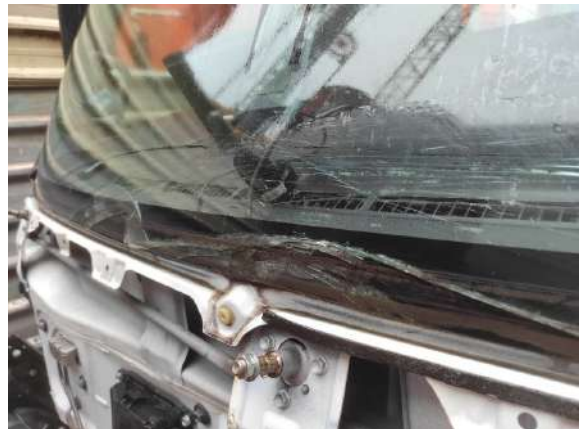
THE VEHICLE SUSTAINED DAMAGES AT THE FRONT PORTION.  
DAMAGES SEE DETAILS.

### INSPECTION
