### TAX INVOICE

### PROFESSIONAL SERVICE FEE

Vehicle No. SHC 6641A  
Insured Veh. XE 6155L  
Claim No. SNM21D202694/C02  
Policy No. DMCVSNW00011752100  
Accident Date 07/05/2021  
Inspection Date 07/05/2021

## ADJUSTMENT ON REPAIR COST FOR VEHICLE NO. SHC 6641A

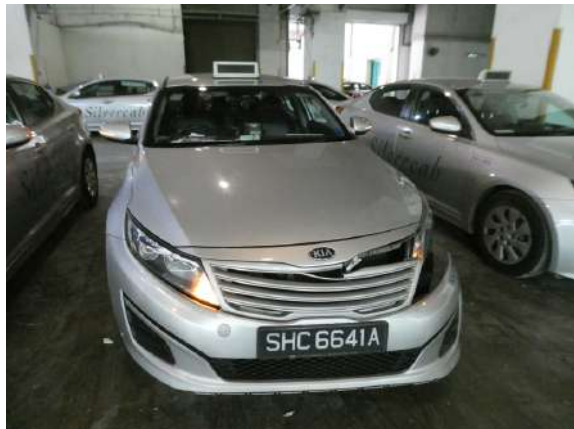
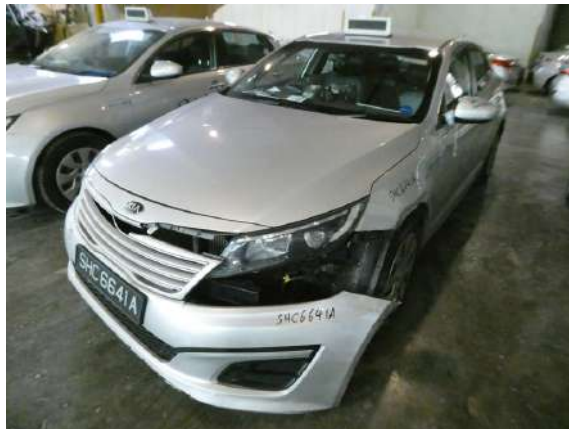
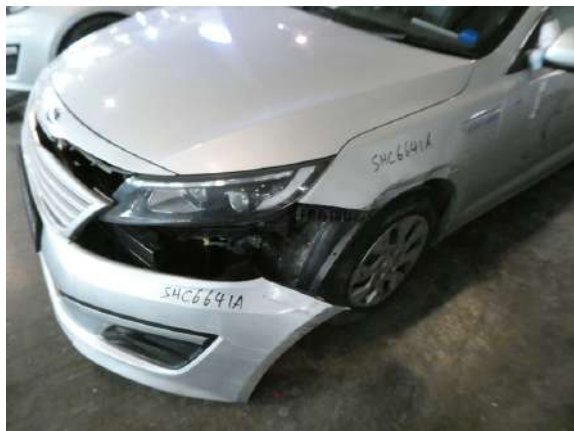
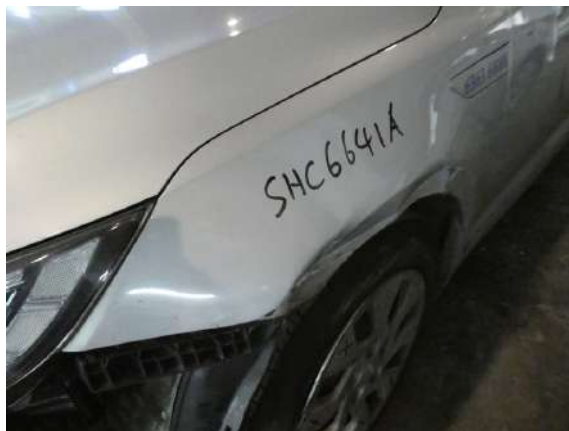
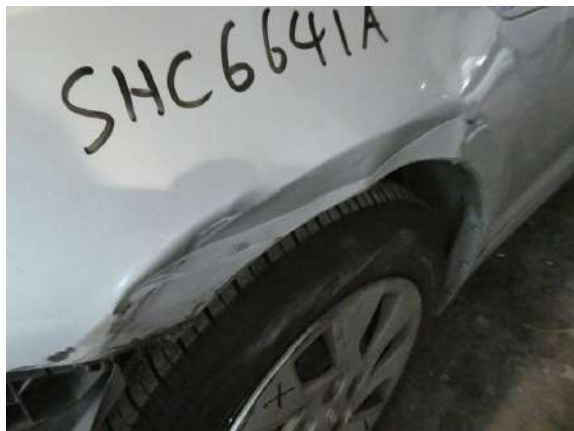
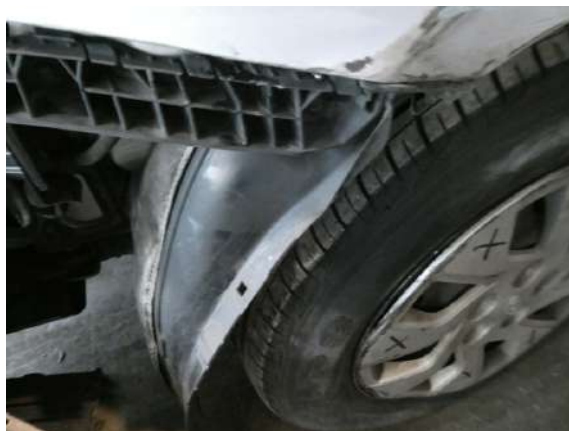
### PHOTOGRAPHS FOR VEHICLE NO. SHC 6641A

| Affiliated to Federation Internationale Des Experts En Automobile | | | | |
|---|---|---|---|---|
| | THE VEHICLE SUSTAINED DAMAGES AT THE FRONT N/S PORTION.<br><br>DAMAGES SEE DETAILS. | | | |

### INSPECTION
