# LKK Auto Consultants Pte Ltd

## ADJUSTMENT ON REPAIR COST FOR VEHICLE NO. SHB 9999D

### PHOTOGRAPHS FOR VEHICLE NO. SHB 9999D

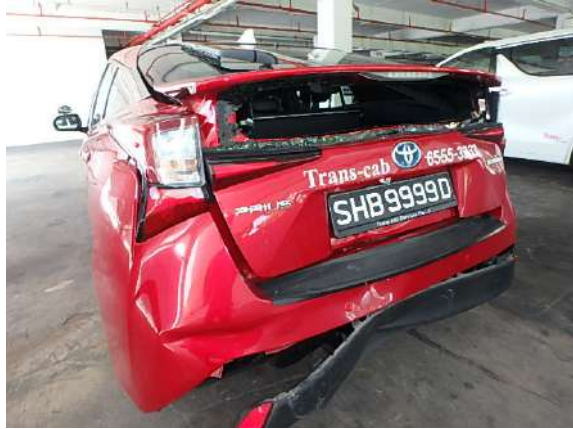
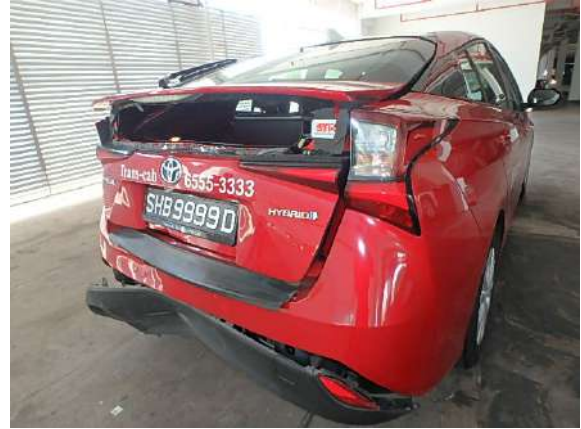
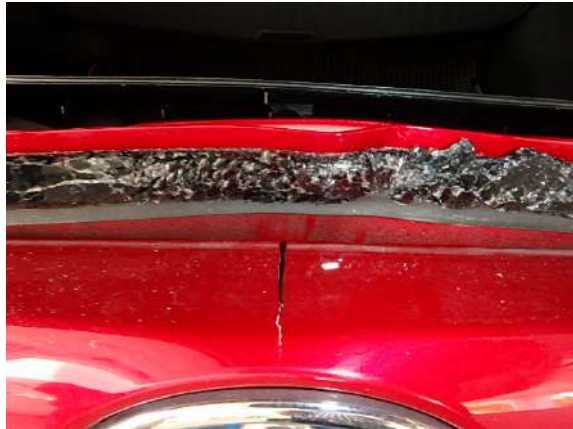
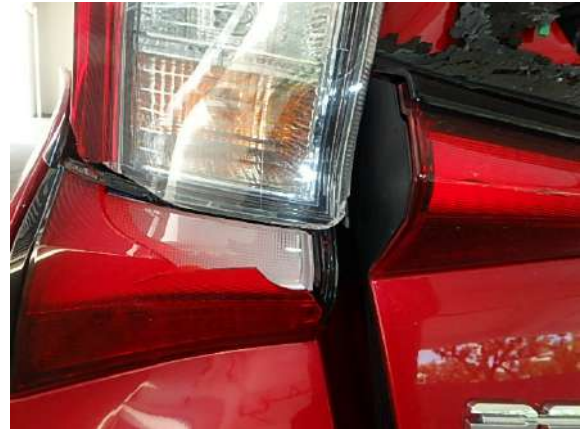
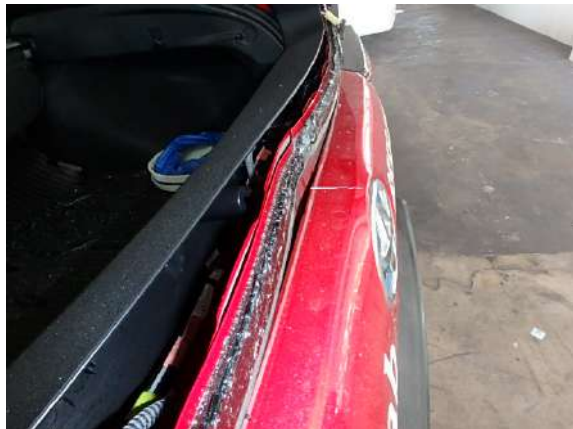
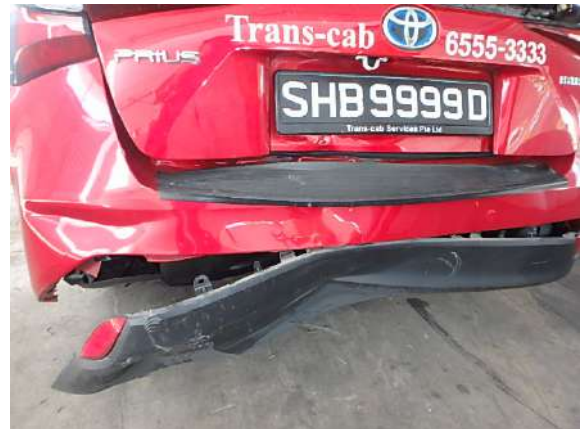
### INSPECTION

| Affiliated to Federation Internationale Des Experts En Automobile | | | | |
|---|---|---|---|--|
| THE VEHICLE SUSTAINED DAMAGES AT THE REAR PORTION.<br>DAMAGES SEE DETAILS. | | | | |
