Vehicle No. SLX 8853J  
Insured Veh. XD 6555X  
Claim No. 20/21/21/VC00/024546  
Policy No. Z/20/VC00/107172-001  
Accident Date 07/05/2021  
Inspection Date 18/05/2021

## LKK Auto Consultants Pte Ltd

## ADJUSTMENT ON REPAIR COST FOR VEHICLE NO. SLX 8853J

### PHOTOGRAPHS FOR VEHICLE NO. SLX 8853J

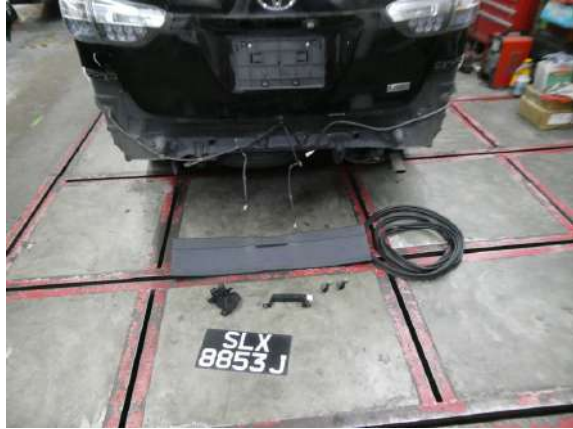
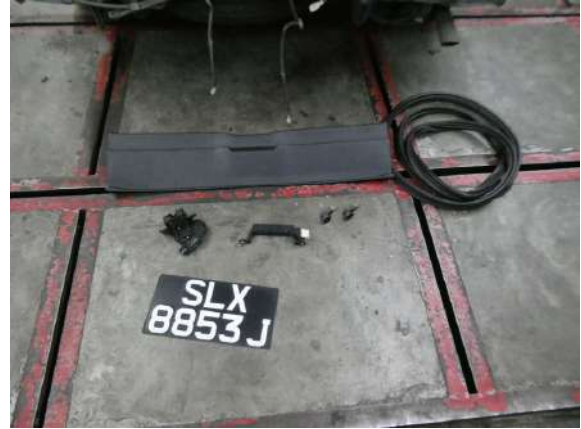
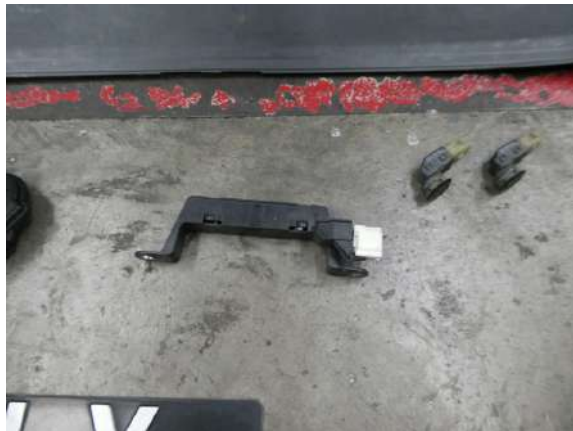
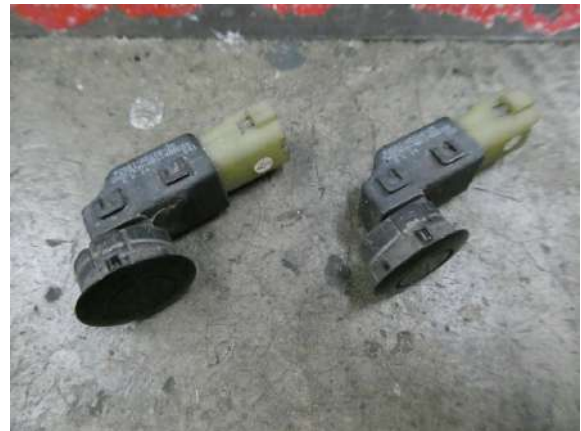
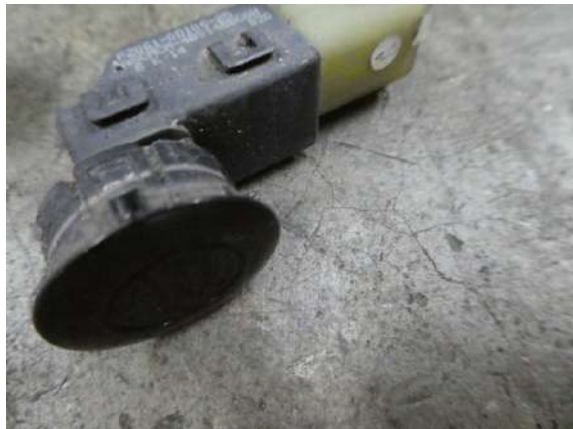
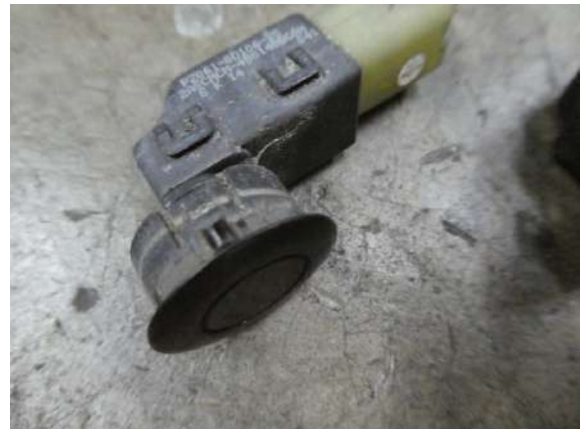
PHOTOGRAPHS FOR VEHICLE NO. SLX 8853J

RE-INSPECTION

| Affiliated to Federation Internationale Des Experts En Automobile | | | | |
|---|---|---|---|--|
| THE VEHICLE SUSTAINED DAMAGES AT THE REAR PORTION.<br>DAMAGES SEE DETAILS. | | | | |
