Vehicle No. SGN 7890U  
Insured Veh. GBJ 913P  
Claim No. D21001519MFCV  
Policy No. D-21097015MFCV  
Accident Date 13/05/2021  
Inspection Date 31/05/2021

## ADJUSTMENT ON REPAIR COST FOR VEHICLE NO. SGN 7890U

PHOTOGRAPHS FOR VEHICLE NO. SGN 7890U

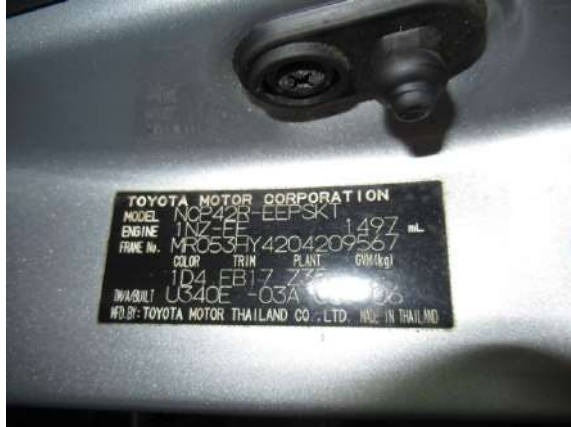
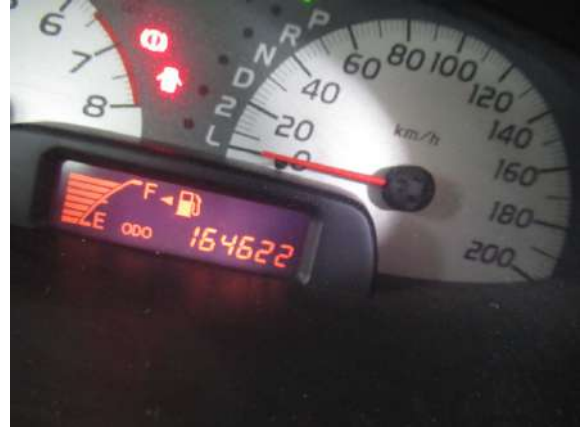
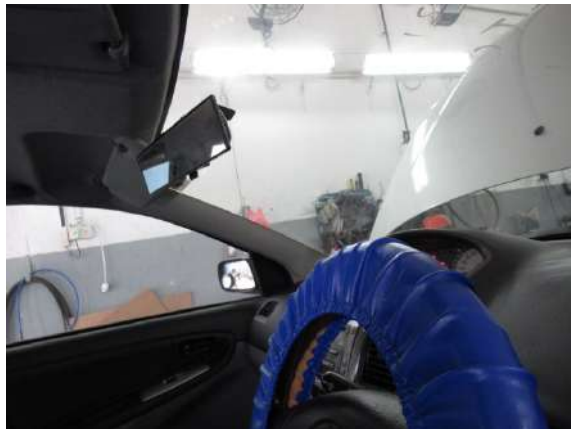
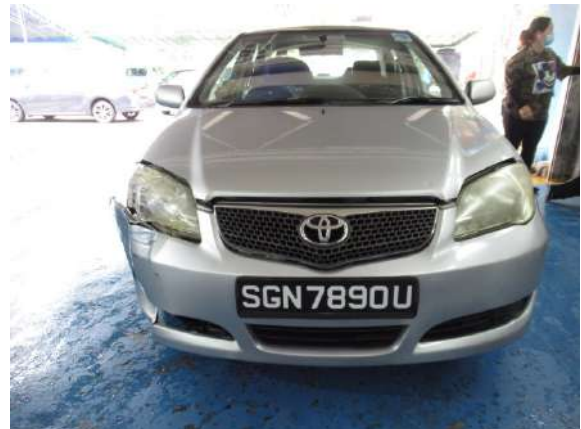
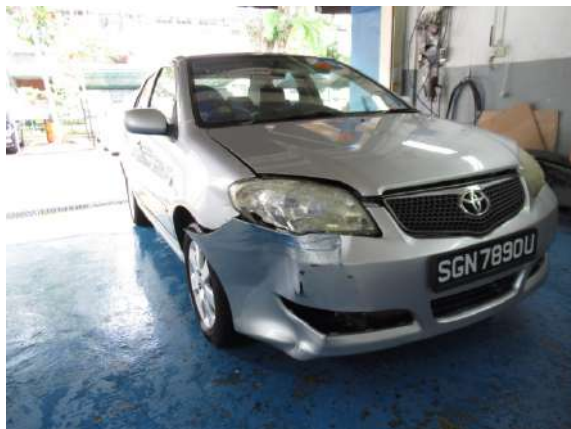
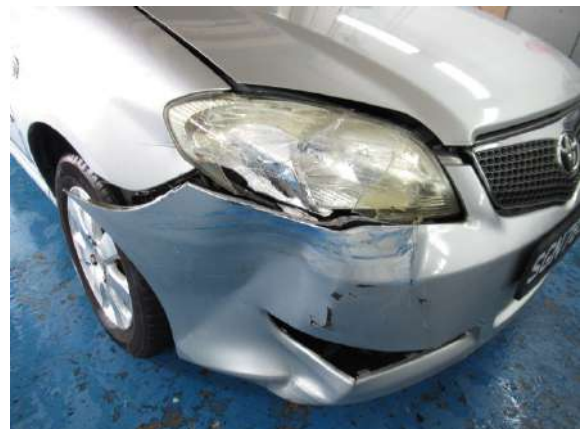
| Affiliated to Federation Internationale Des Experts En Automobile | | | | |
|---|---|---|---|---|
| | THE VEHICLE SUSTAINED DAMAGES AT THE O/S FRONT PORTION.<br><br>DAMAGES SEE DETAILS. | | | |

INSPECTION

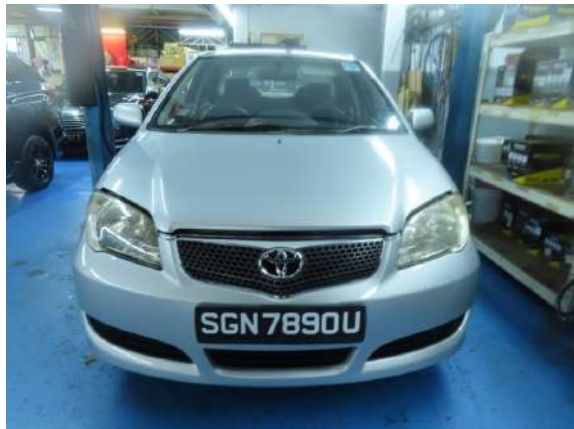
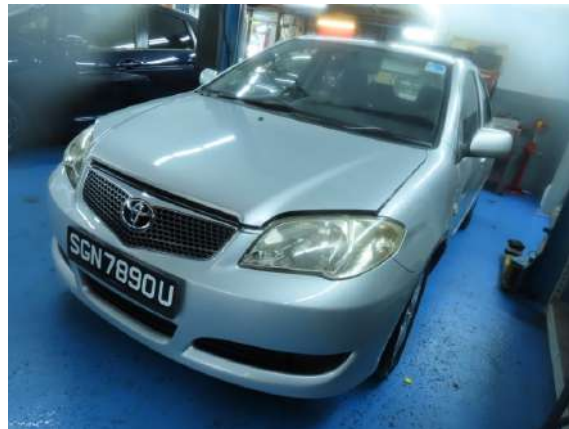
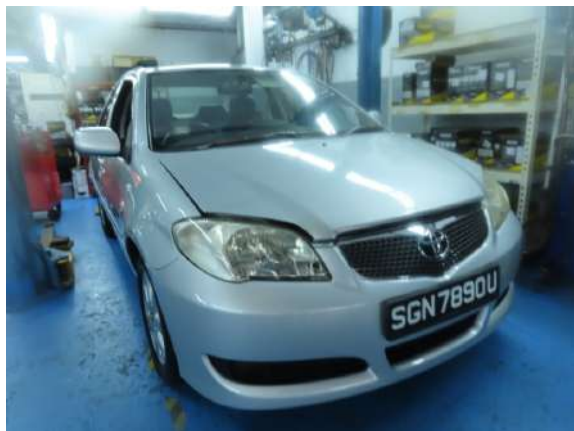
**PHOTOGRAPHS FOR VEHICLE NO. SGN 7890U**

**RE-INSPECTION**
