**VEHICLE INSPECTION REPORT**

| Report No. TP/0016/21 | Date of Report | : 29 July 21 |

| Model | : GKB45CLBHNH Prime Mover | Radio / Cassette / CD | : Yes |

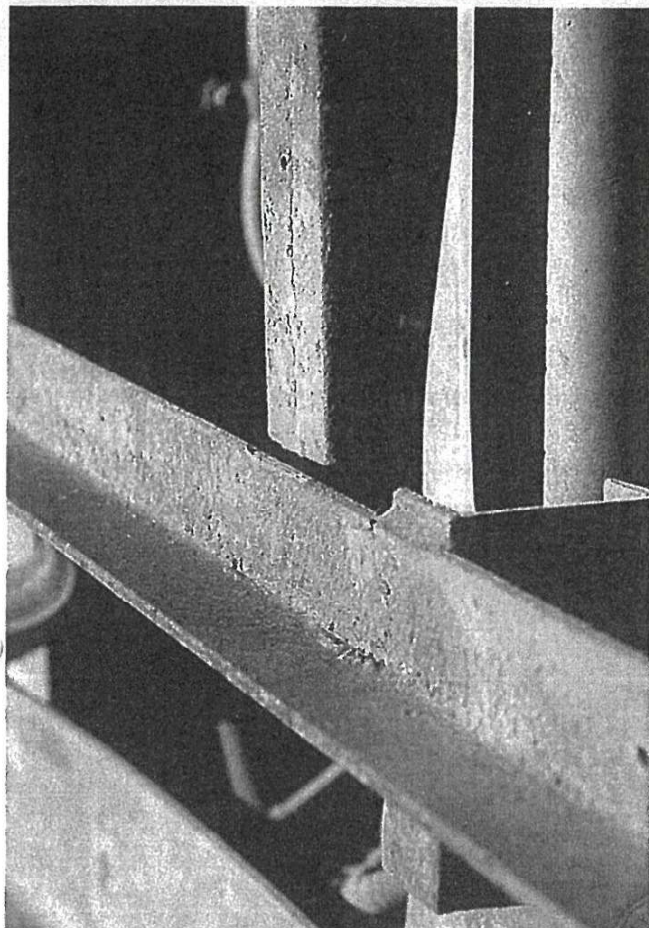
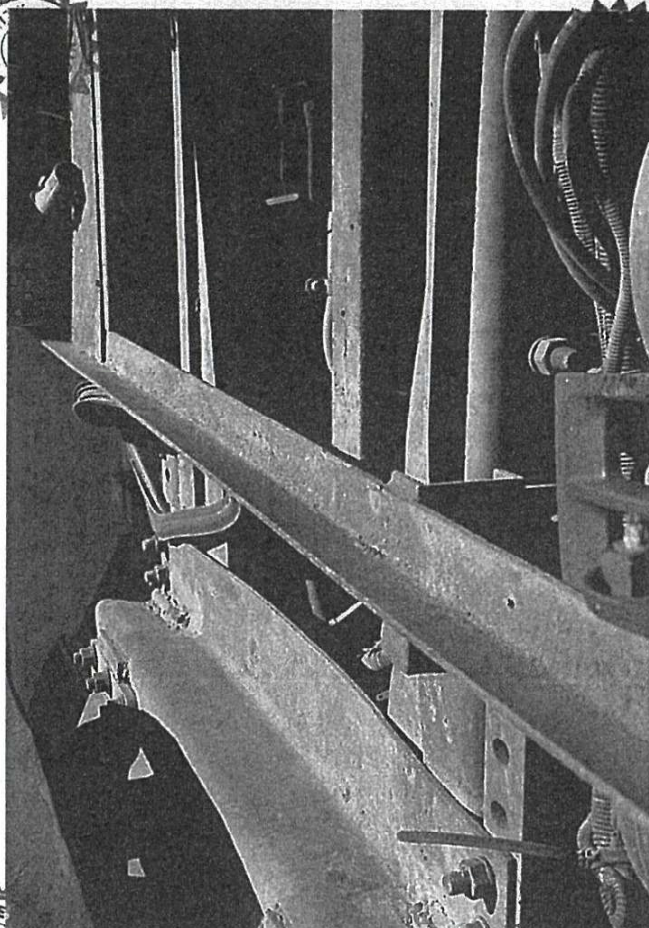
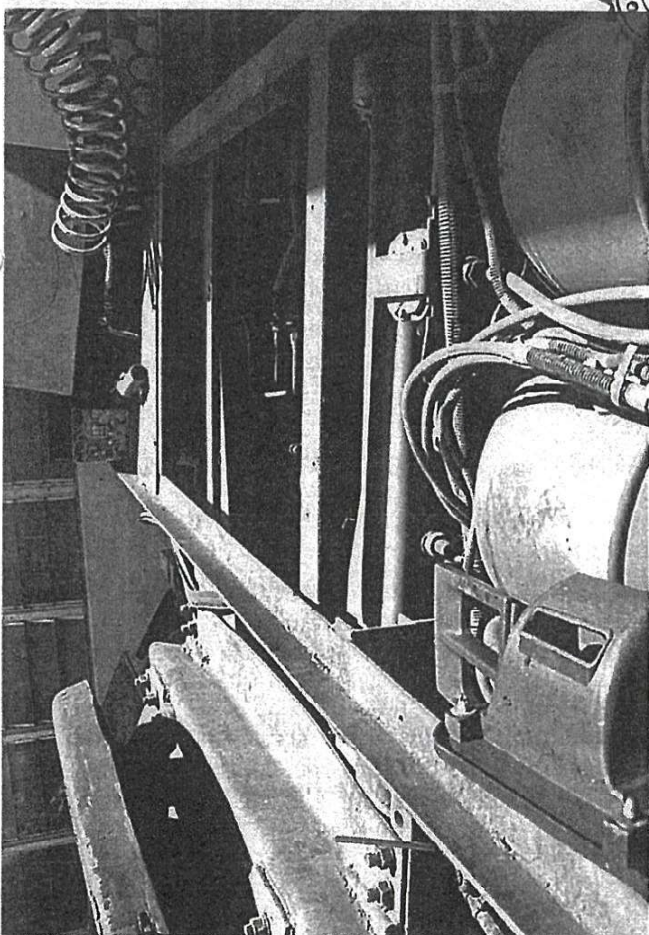
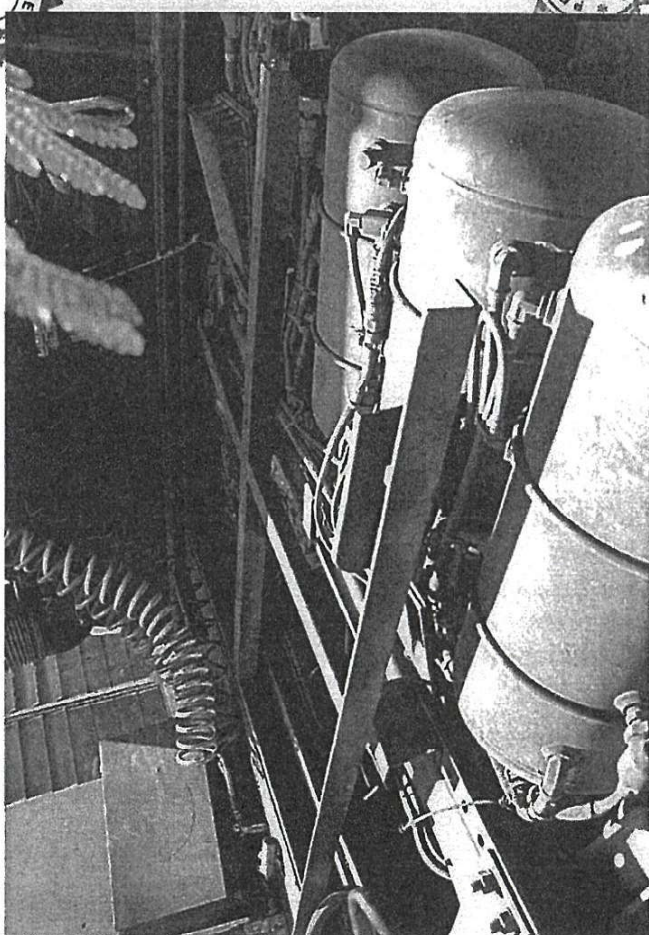
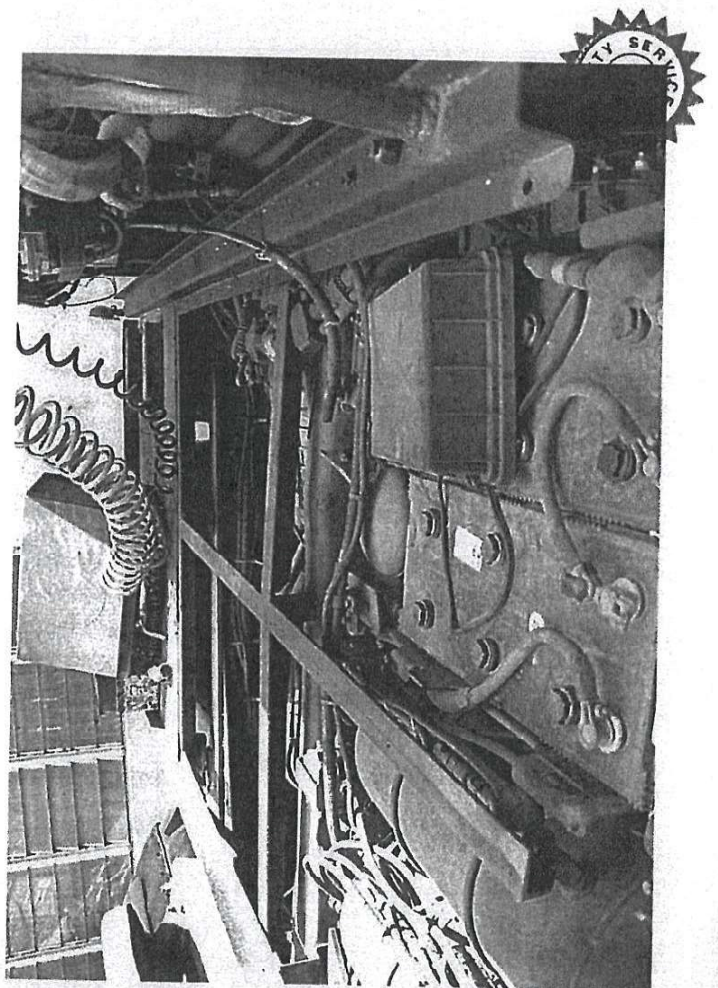
Encl. Photographs of the damaged vehicle taken by us during inspection.

Other parts were also found damaged. (see schedule for details)
