Vehicle No. SHC 3572K  
Insured Veh. YQ 8480J  
Claim No. SNM21D202822/C02  
Policy No. DMCVSNW00122002002  
Accident Date 06/05/2021  
Inspection Date 17/05/2021

## ADJUSTMENT ON REPAIR COST FOR VEHICLE NO. SHC 3572K

PHOTOGRAPHS FOR VEHICLE NO. SHC 3572K

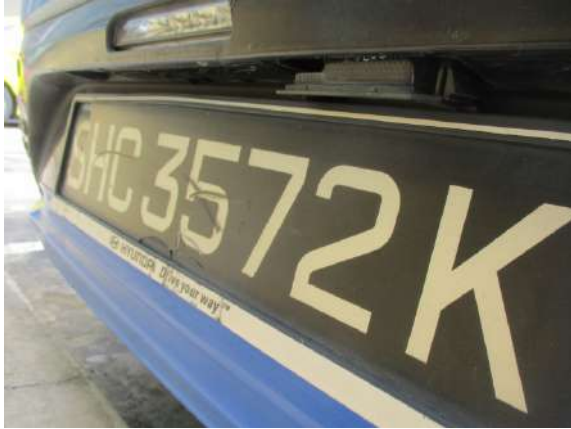
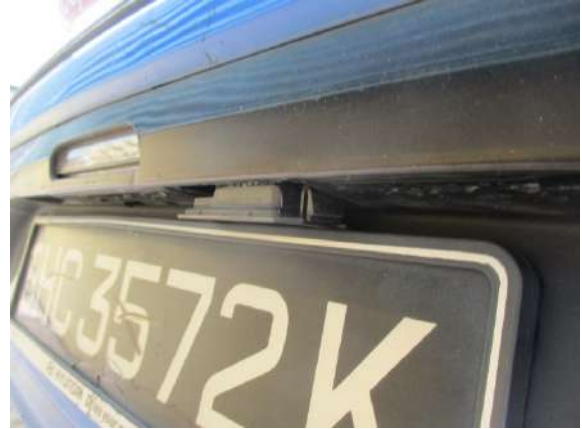
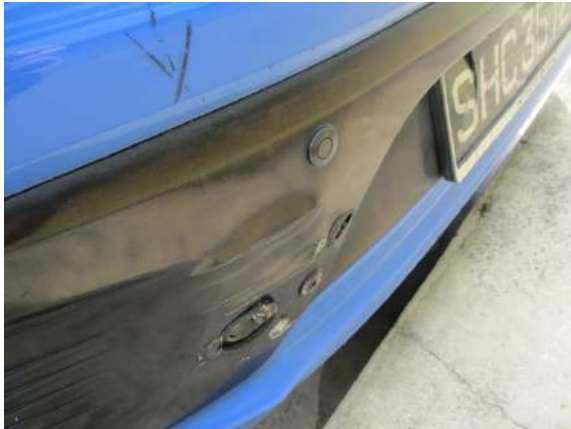
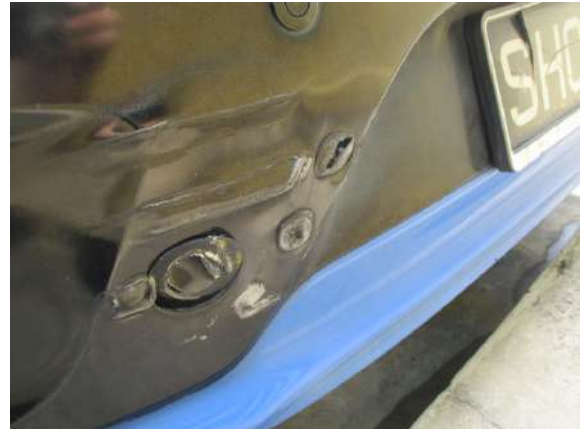
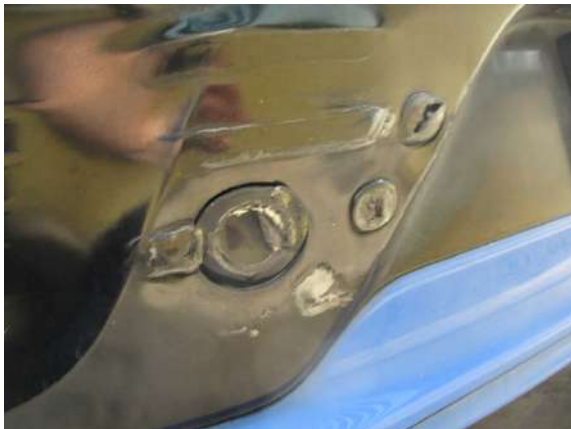
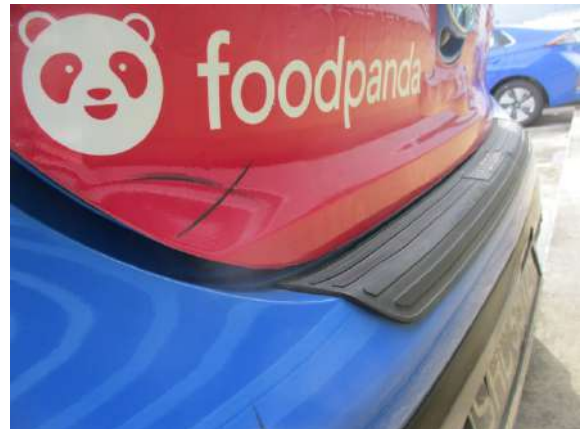
| Affiliated to Federation Internationale Des Experts En Automobile | | | | |
|---|---|---|---|--|
| THE VEHICLE SUSTAINED DAMAGES AT THE FRONT AND REAR PORTION.<br><br>DAMAGES SEE DETAILS. | | | | |

INSPECTION

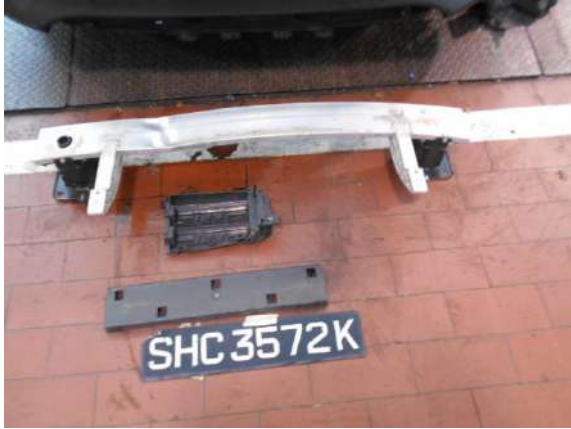
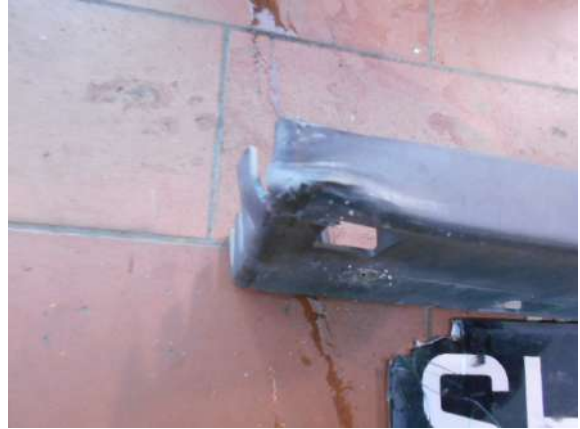
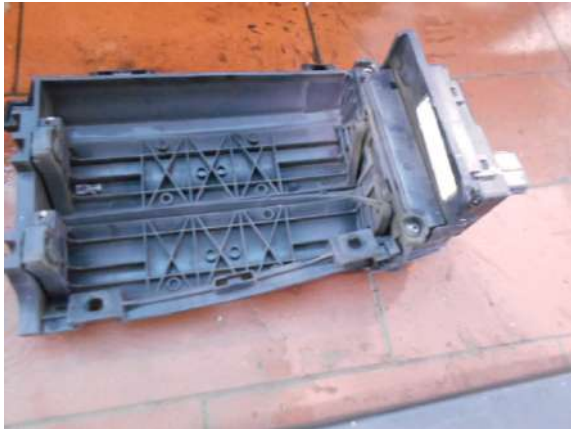
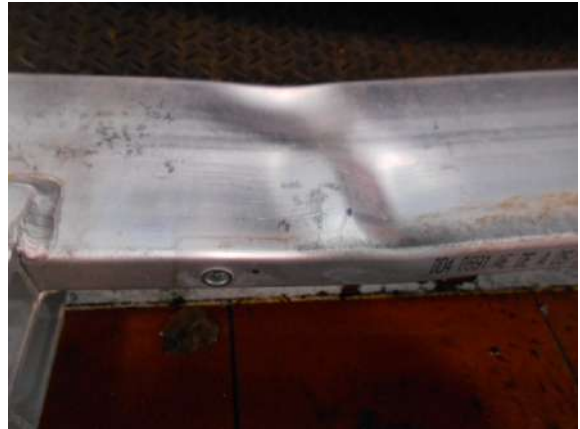
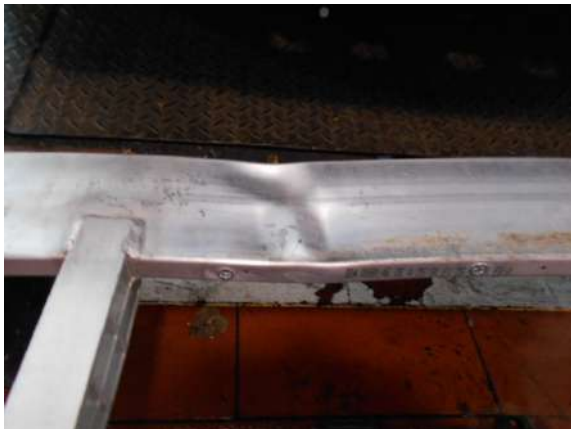
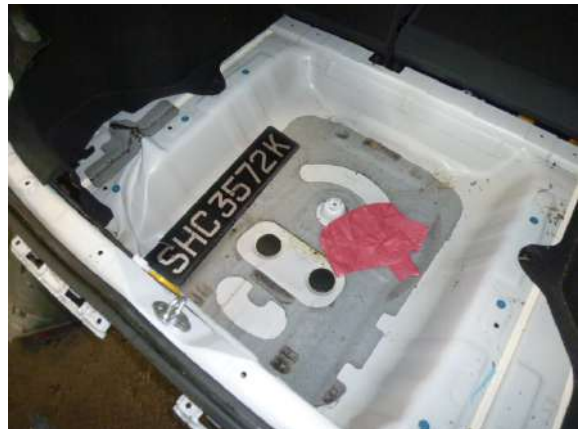
PHOTOGRAPHS FOR VEHICLE NO. SHC 3572K

RE-INSPECTION
