## LKK Auto Consultants Pte Ltd

### PROFESSIONAL SERVICE FEE

Vehicle No. SDZ 1132L  
Insured Veh. GBD 8712G  
Claim No. SNM21D202902/C02  
Policy No. DMCVSNW00093862000  
Accident Date 18/05/2021  
Inspection Date 21/05/2021

## ADJUSTMENT ON REPAIR COST FOR VEHICLE NO. SDZ 1132L

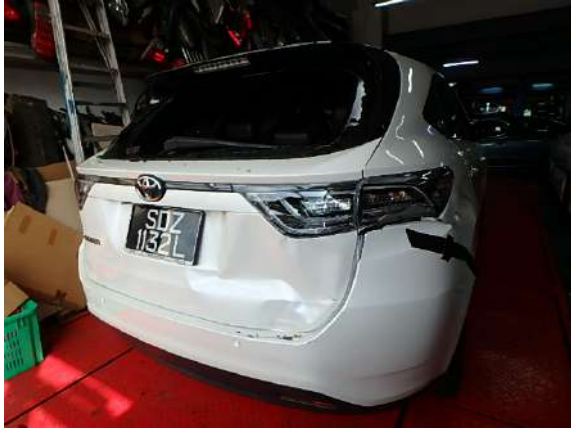
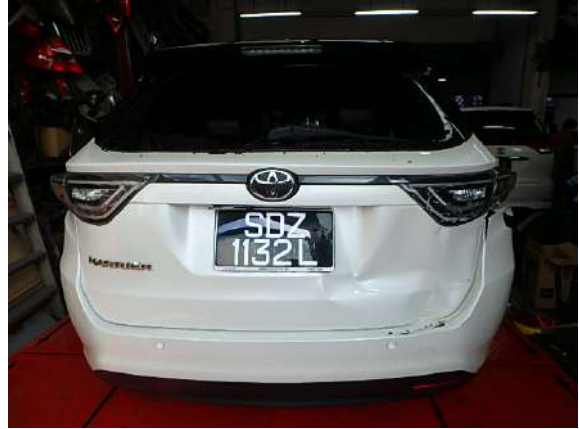
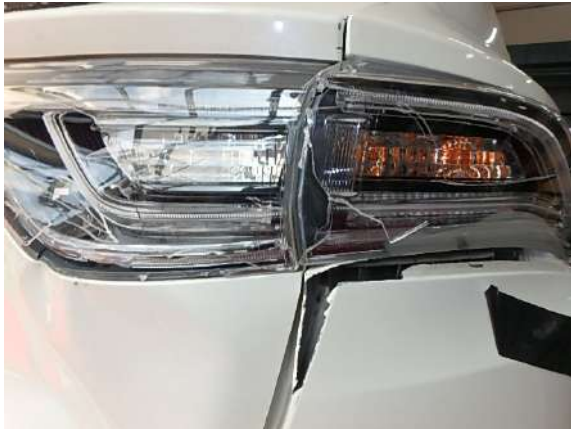
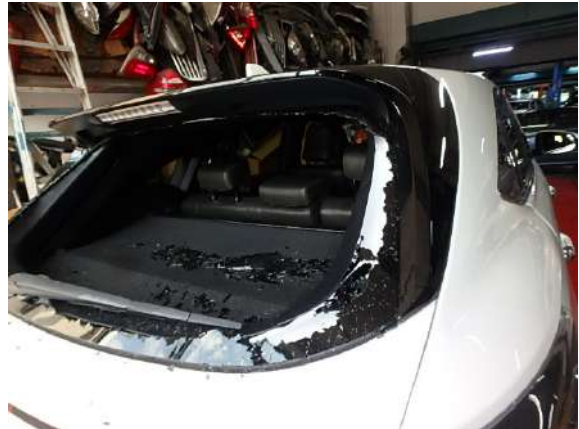
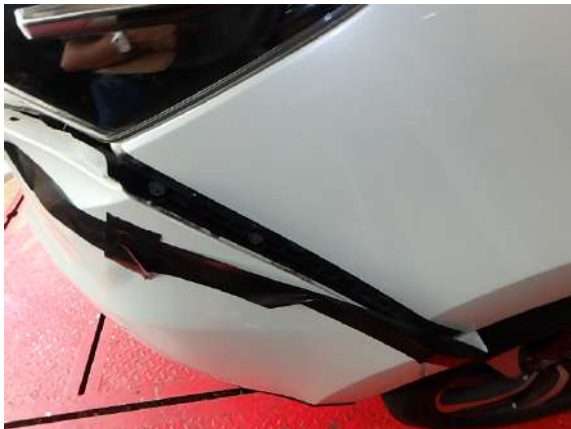
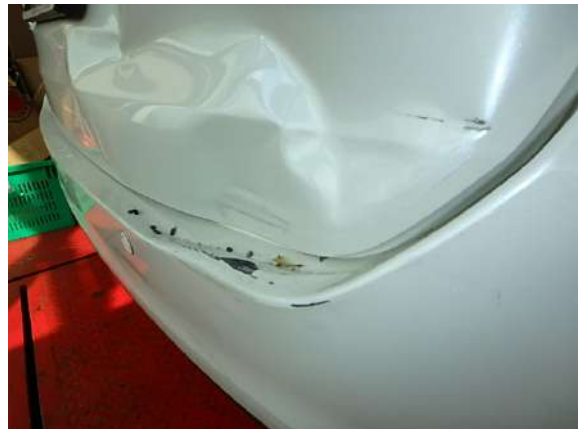
INSPECTION

| Affiliated to Federation Internationale Des Experts En Automobile | | | | |
|---|---|---|---|---|
| | THE VEHICLE SUSTAINED DAMAGES AT THE REAR O/S PORTION.<br><br>DAMAGES SEE DETAILS. | | | |

PHOTOGRAPHS FOR VEHICLE NO. SDZ 1132L

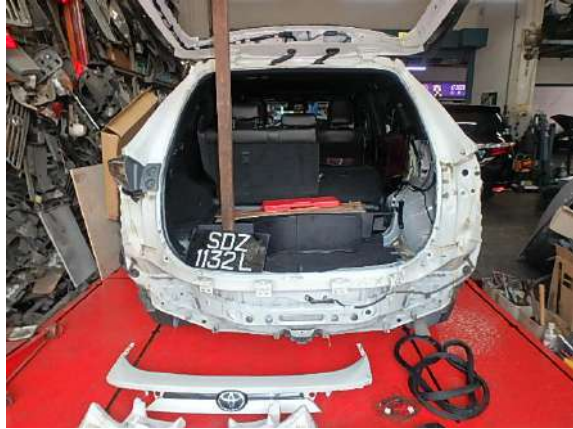
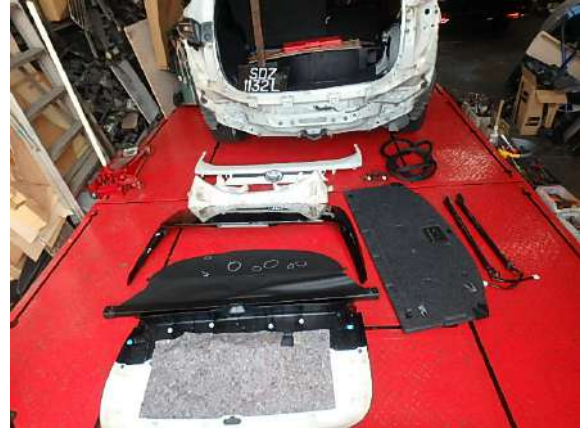
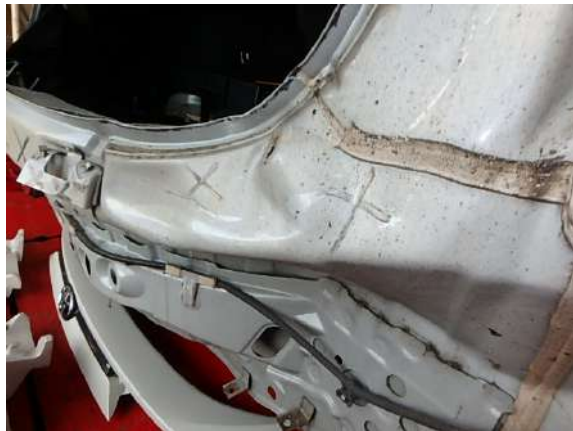
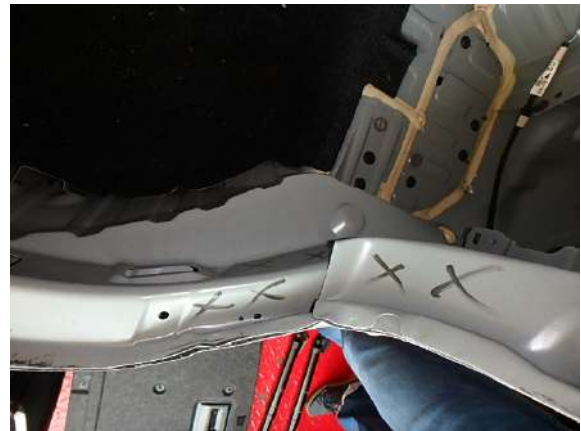
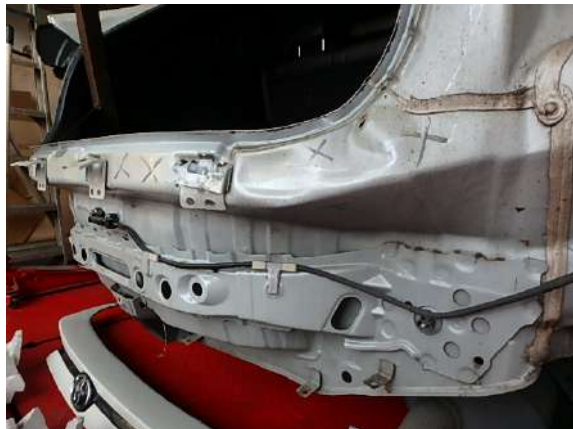
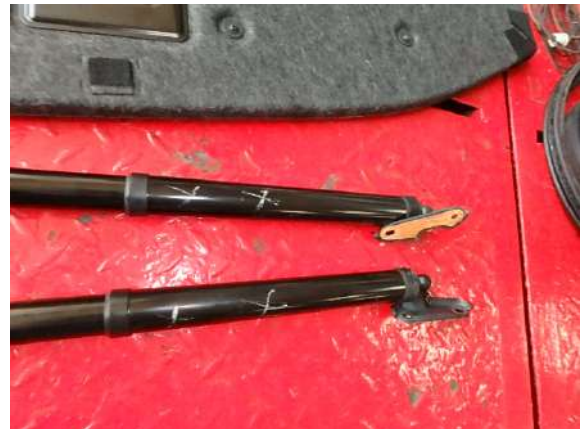
### RE-INSPECTION

### PHOTOGRAPHS FOR VEHICLE NO. SDZ 1132L

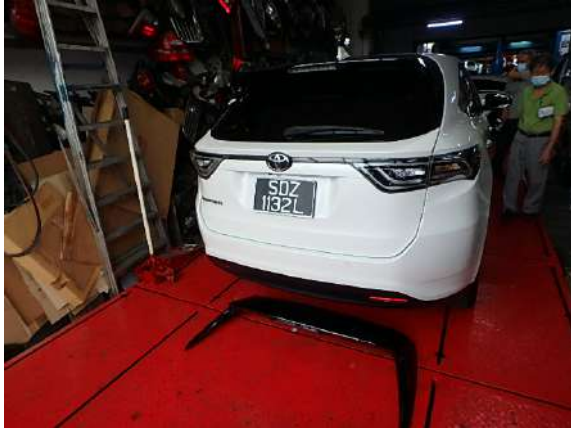
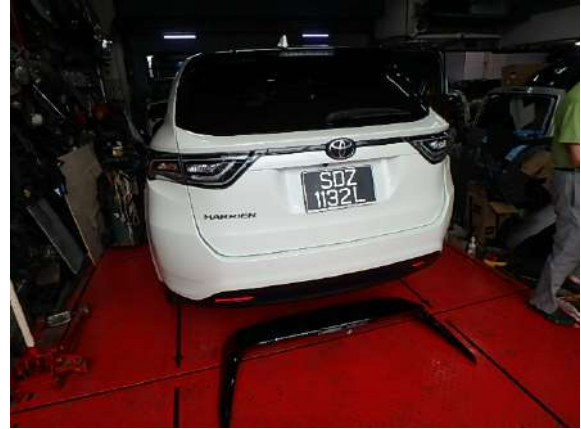
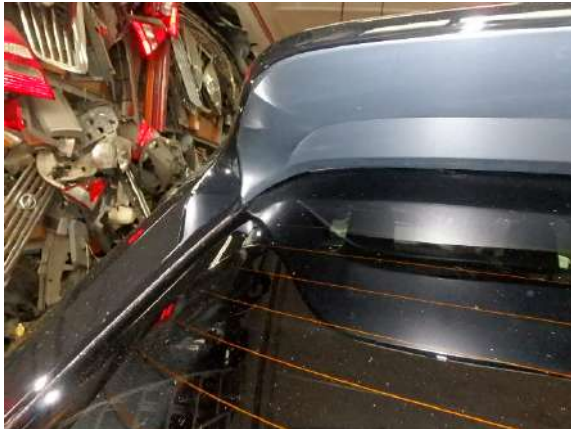
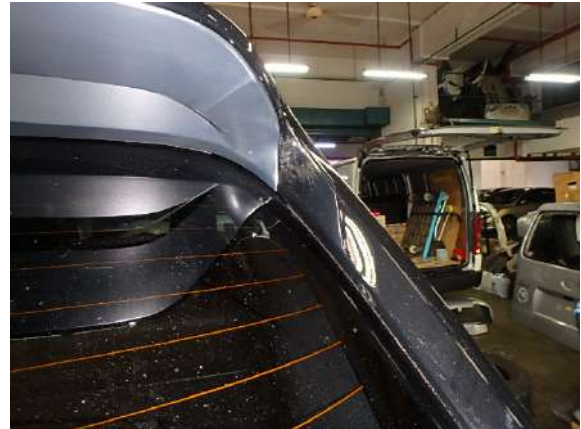
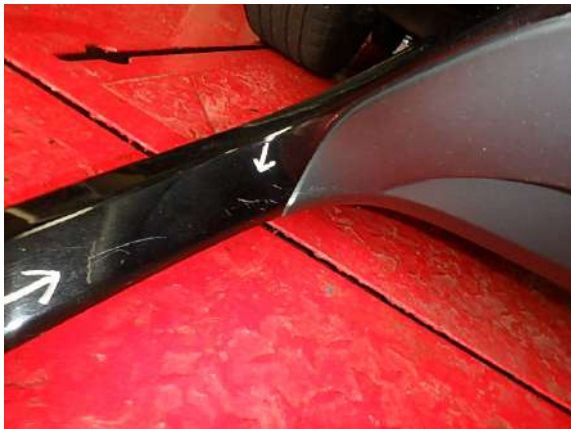
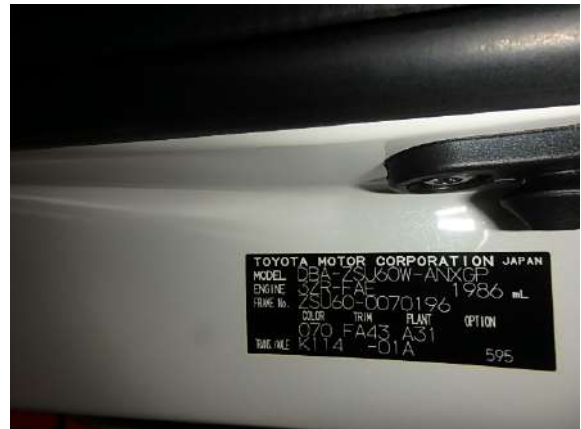
### RE-INSPECTION

### PHOTOGRAPHS FOR VEHICLE NO. SDZ 1132L

TOYOTA MOTOR CORPORATION JAPAN  
MODEL DBA-ZSU60W-ANXCF  
ENGINE 3A-FX 1986 mL  
FRAME No. ZSU60-0070196  
COLOR TRIM PLANT OPTION  
070 FA43 A31  
TIME MILE KIT4 -01A 595
