## LKK Auto Consultants Pte Ltd

### ADJUSTMENT ON REPAIR COST FOR VEHICLE NO. SJK 9996R

### PHOTOGRAPHS FOR VEHICLE NO. SJK 9996R

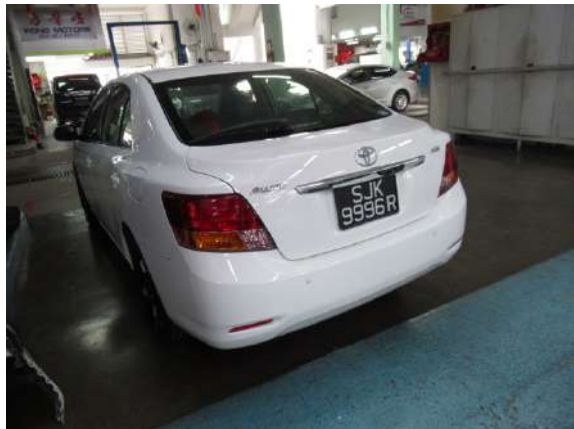
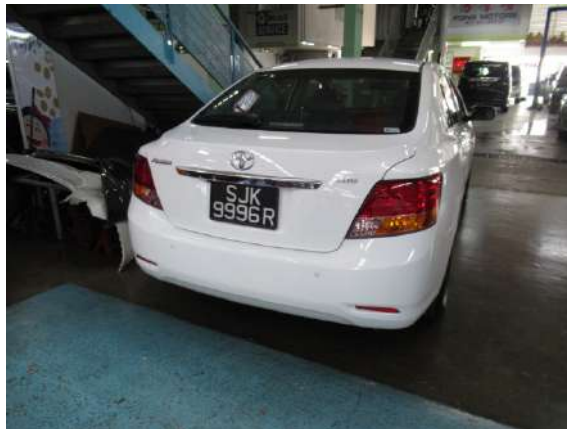
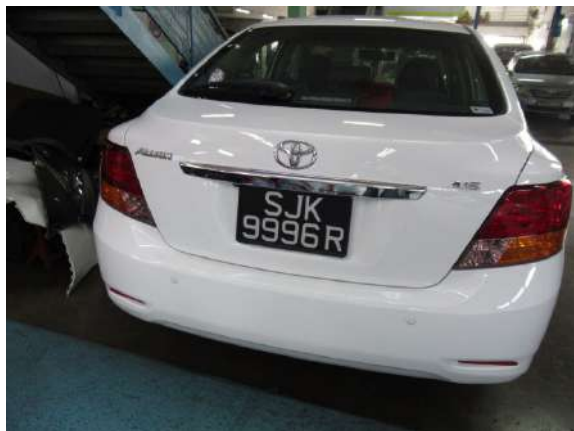
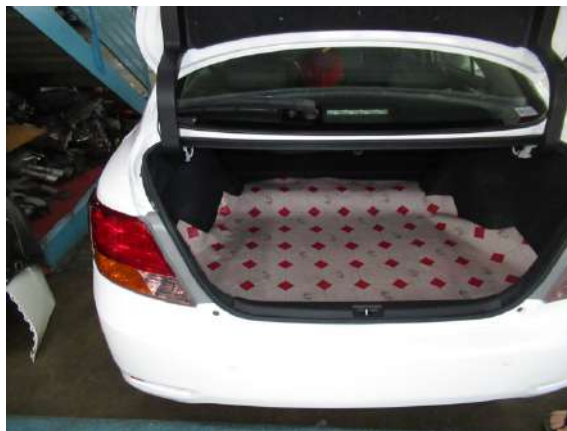
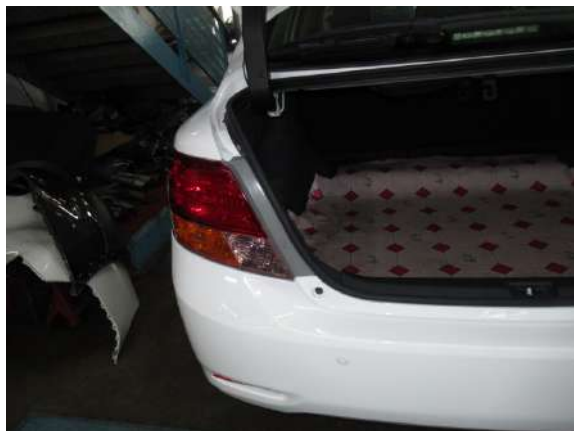
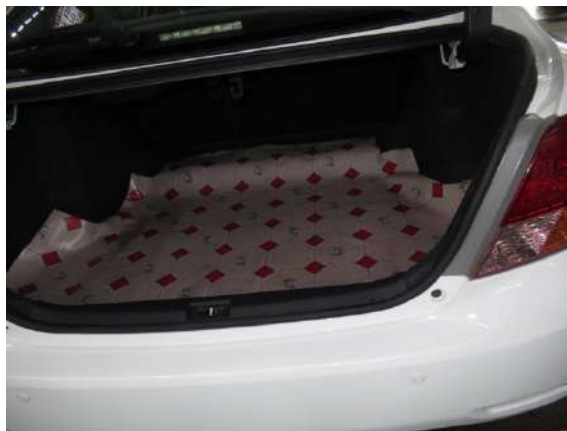
**PHOTOGRAPHS FOR VEHICLE NO. SJK 9996R**

**RE-INSPECTION**

| Affiliated to Federation Internationale Des Experts En Automobile | | | | |
|---|---|---|---|--|
| THE VEHICLE SUSTAINED DAMAGES AT THE REAR PORTION.<br>DAMAGES SEE DETAILS. | | | | |
