## ADJUSTMENT ON REPAIR COST FOR VEHICLE NO. XB 4072X

### PHOTOGRAPHS FOR VEHICLE NO. XB 4072X

### INSPECTION

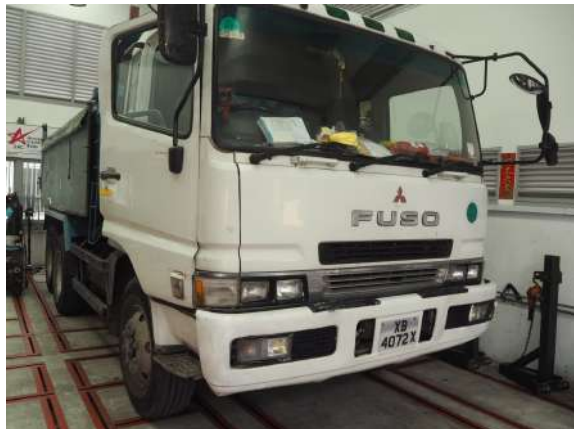
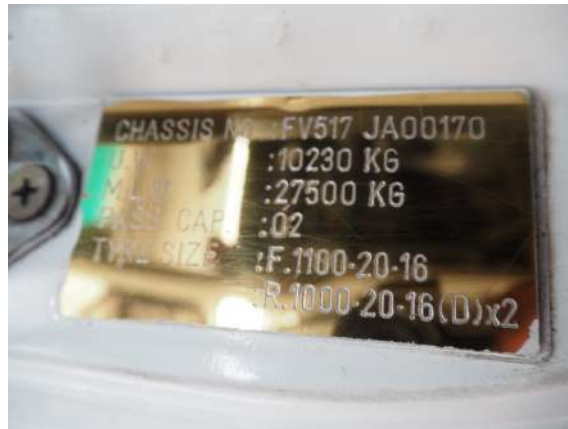
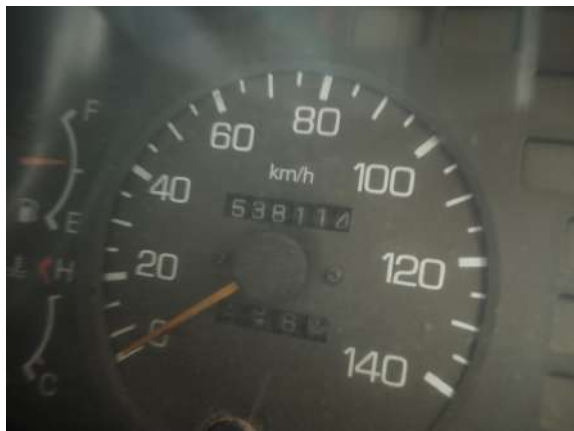
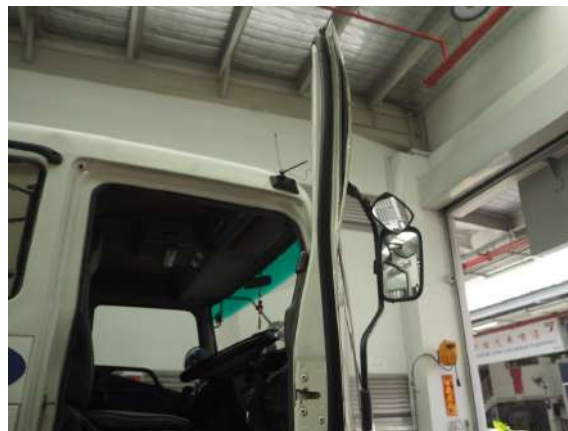
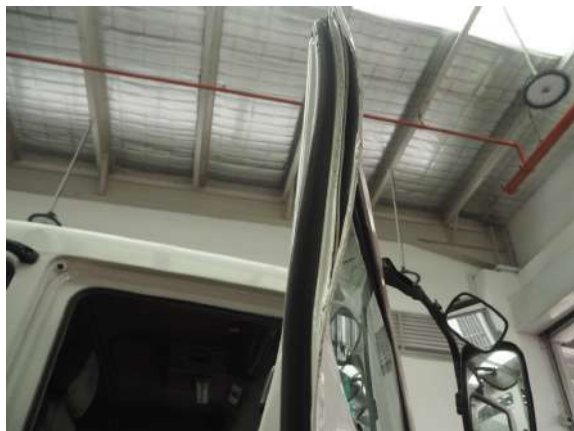
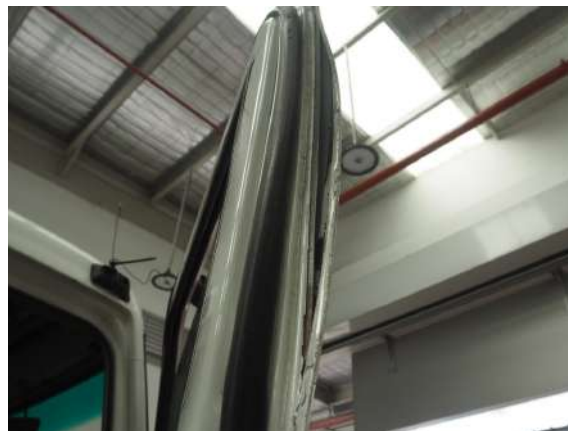
| Affiliated to Federation Internationale Des Experts En Automobile | | | | |
|---|---|---|---|--|
| THE VEHICLE SUSTAINED DAMAGES AT THE O/S BODY.<br>DAMAGES SEE DETAILS. | | | | |
