Vehicle No. GBA 8004H  
Insured Veh. GBC 1224A  
Claim No. 20/21/21/VC05/024642  
Policy No. Z20VC05005655  
Accident Date 10/06/2021  
Inspection Date 11/06/2021

# LKK Auto Consultants Pte Ltd

### ADJUSTMENT ON REPAIR COST FOR VEHICLE NO. GBA 8004H

### PHOTOGRAPHS FOR VEHICLE NO. GBA 8004H

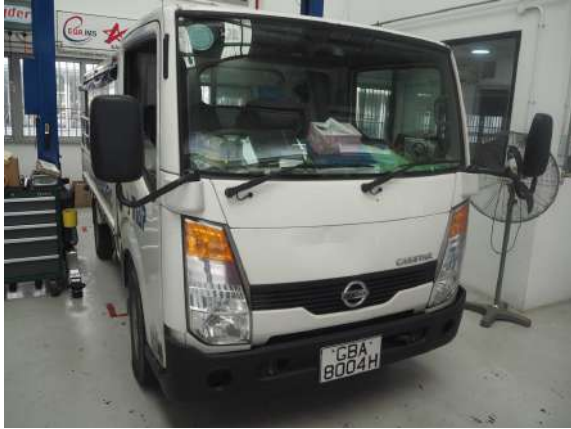
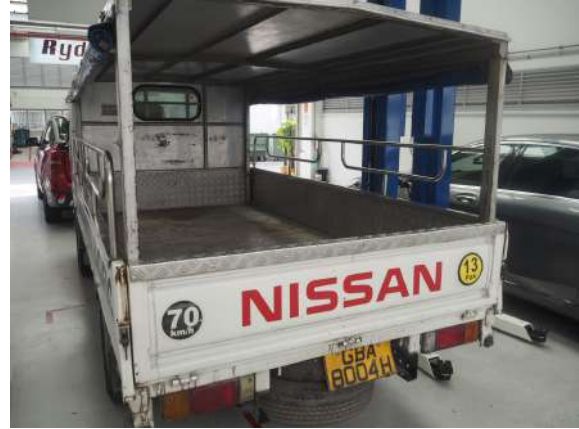
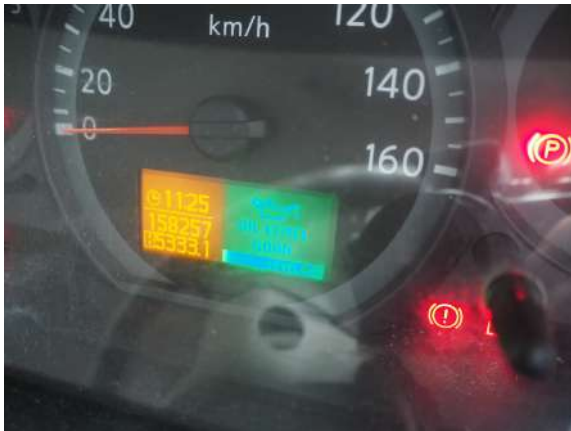
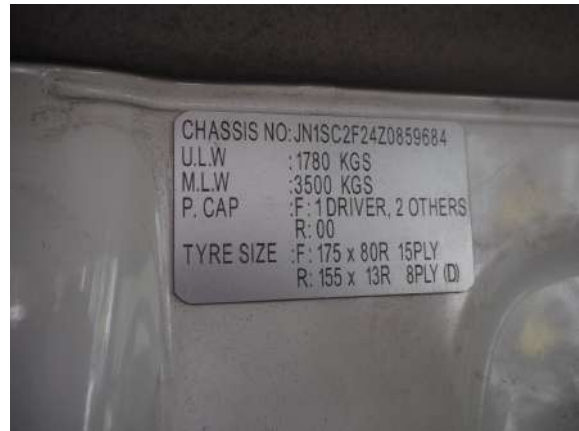
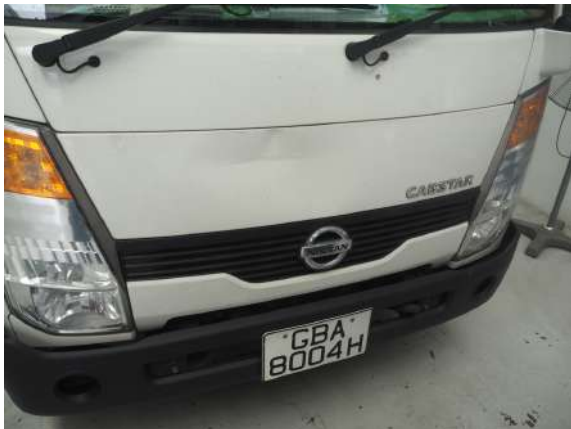
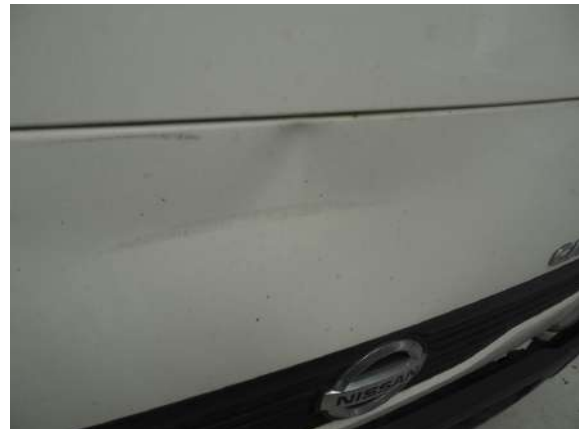
### INSPECTION

| Affiliated to Federation Internationale Des Experts En Automobile | | | | |
|---|---|---|---|--|
| THE VEHICLE SUSTAINED DAMAGES AT THE FRONT & REAR PORTION.<br>DAMAGES SEE DETAILS. | | | | |
