Vehicle No. SKM 5766S  
Insured Veh. YP 3293X  
Claim No. 20/21/21/VC05/024640  
Policy No. Z20VC05005703  
Accident Date 09/06/2021  
Inspection Date 17/06/2021

## ADJUSTMENT ON REPAIR COST FOR VEHICLE NO. SKM 5766S

### PHOTOGRAPHS FOR VEHICLE NO. SKM 5766S

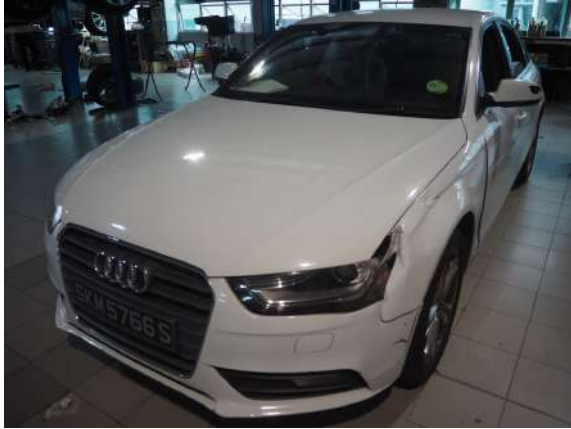
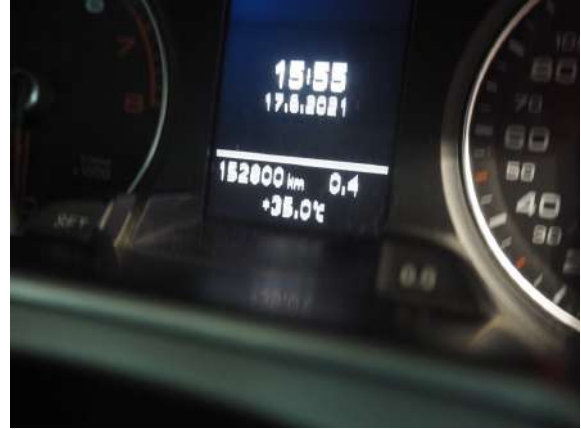
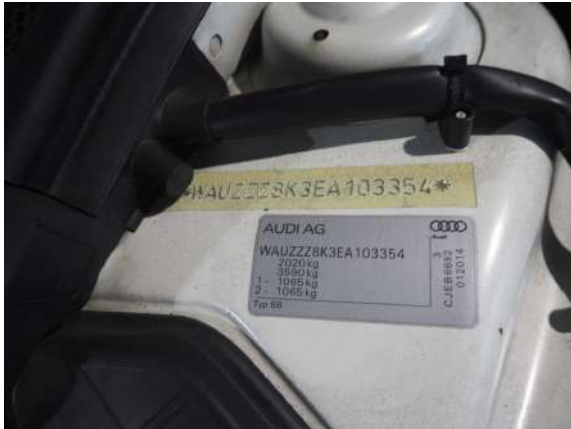
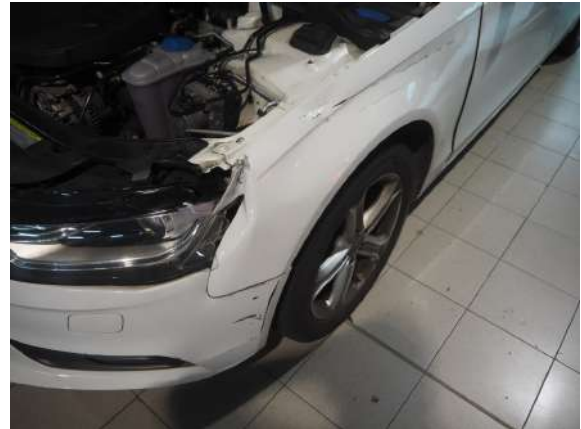
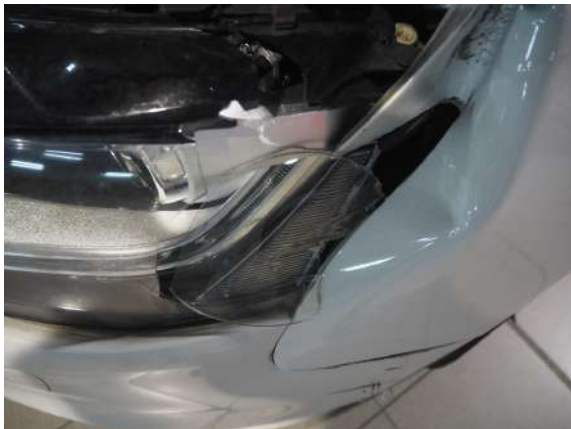
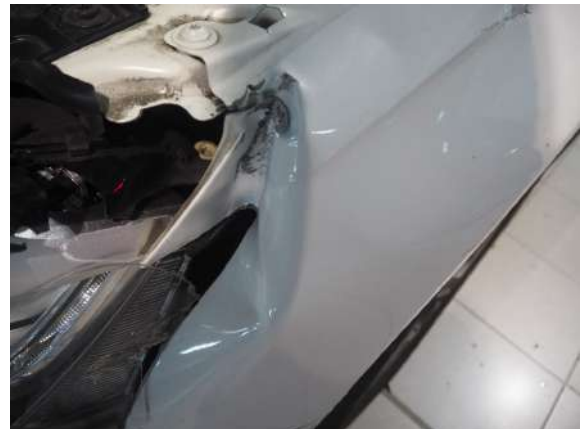
### INSPECTION

| Affiliated to Federation Internationale Des Experts En Automobile | | | | |
|---|---|---|---|--|
| THE VEHICLE SUSTAINED DAMAGES AT THE N/S BODY.<br>DAMAGES SEE DETAILS. | | | | |

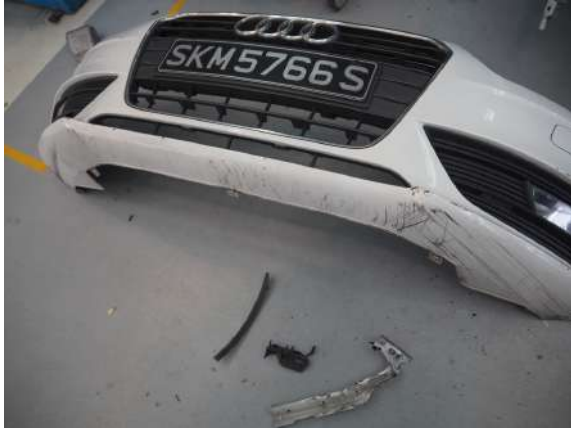
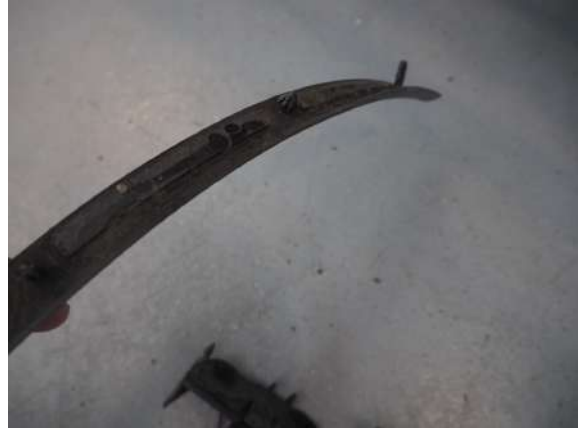
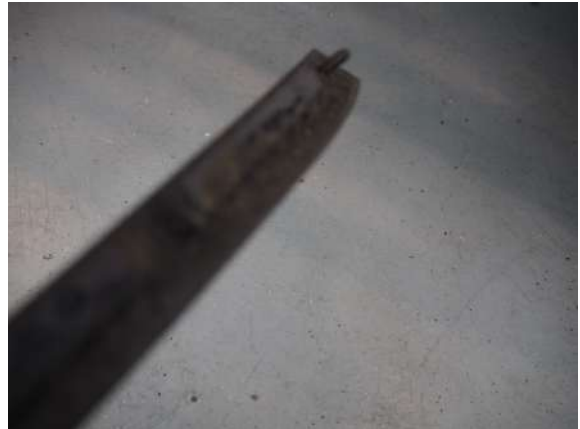
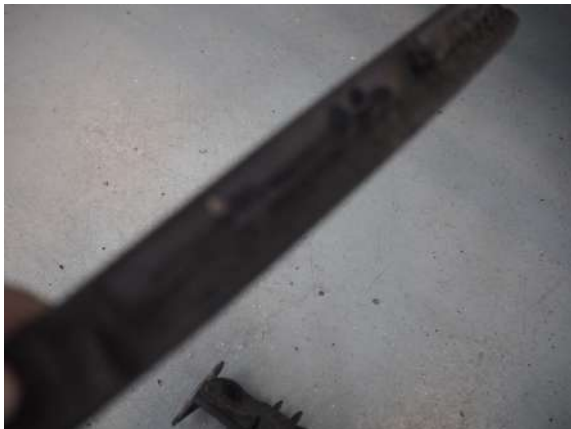
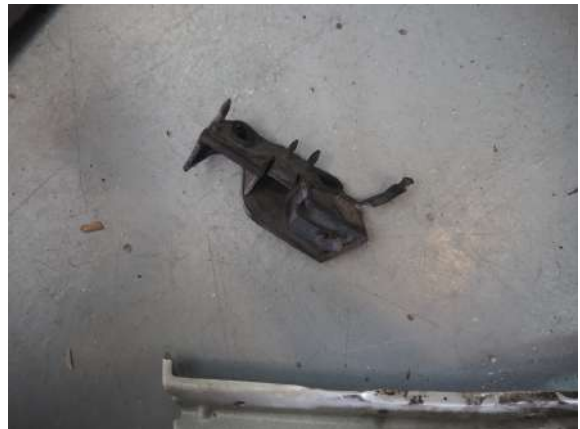
RE-INSPECTION

PHOTOGRAPHS FOR VEHICLE NO. SKM 5766S
