# LKK Auto Consultants Pte Ltd

## ADJUSTMENT ON REPAIR COST FOR VEHICLE NO. SLC 5080C

### PHOTOGRAPHS FOR VEHICLE NO. SLC 5080C

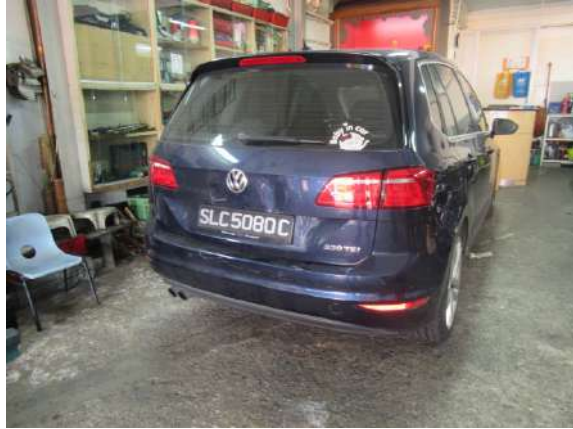
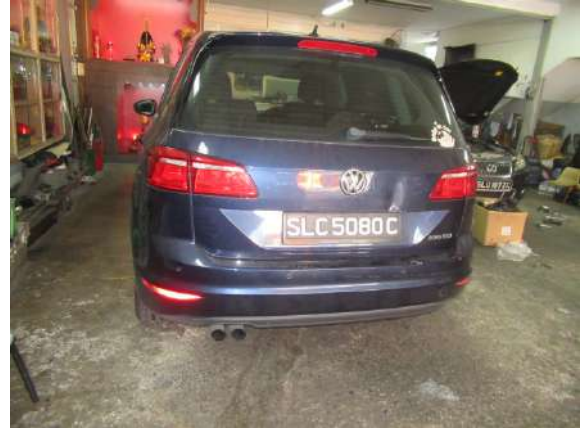
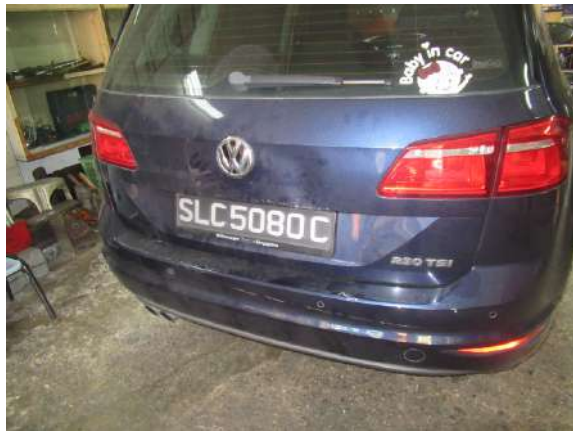
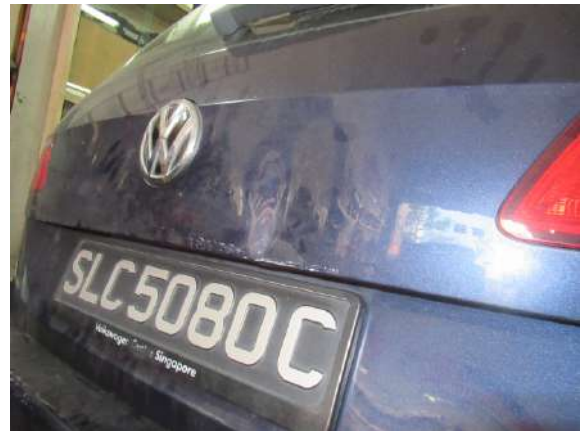
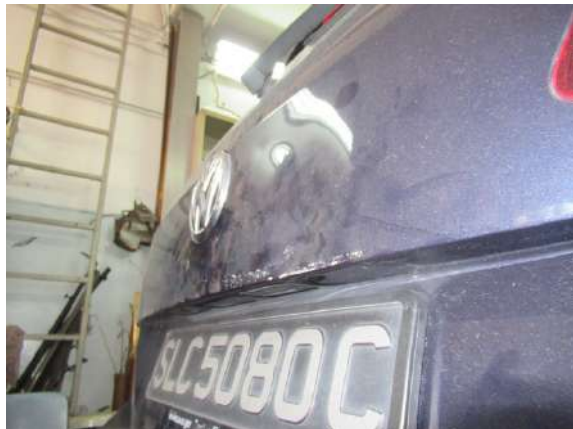
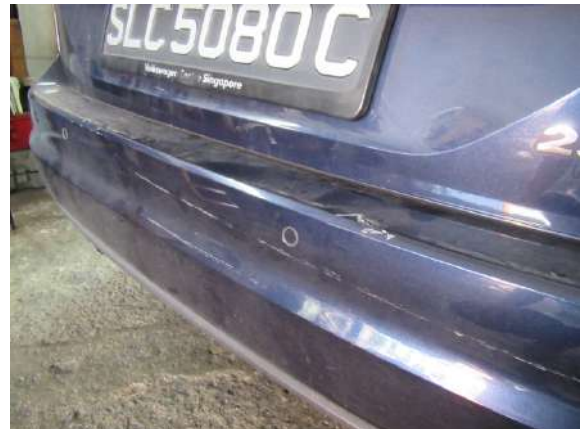
### INSPECTION

| Affiliated to Federation Internationale Des Experts En Automobile | | | | |
|---|---|---|---|--|
| THE VEHICLE SUSTAINED DAMAGES AT THE REAR PORTION.<br>DAMAGES SEE DETAILS. | | | | |
