Vehicle No. GBF 5938G  
Insured Veh. GBF 344C  
Claim No. D21001806MFCV  
Policy No. D-21097023MFCV  
Accident Date 14/06/2021  
Inspection Date 16/06/2021

## ADJUSTMENT ON REPAIR COST FOR VEHICLE NO. GBF 5938G

### PHOTOGRAPHS FOR VEHICLE NO. GBF 5938G

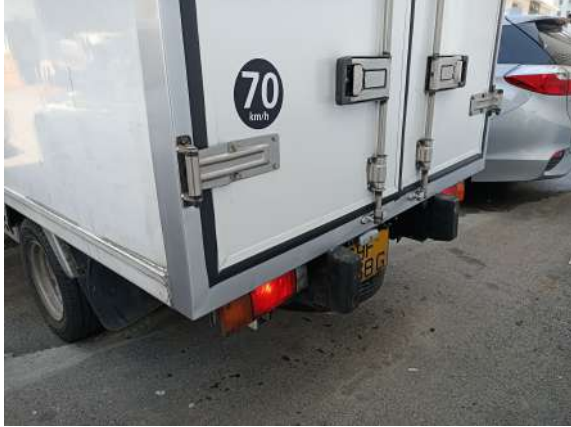
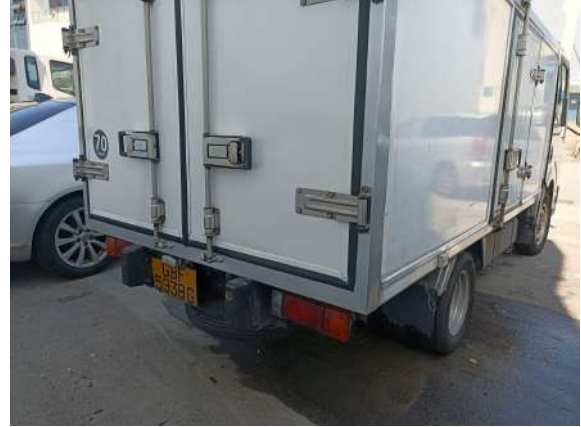
**RE-INSPECTION**

**PHOTOGRAPHS FOR VEHICLE NO. GBF 5938G**
