# Precise Appraiser Pte Ltd

### DAMAGED VEHICAL PARTICULARS

## DESCRIPTION OF DAMAGE

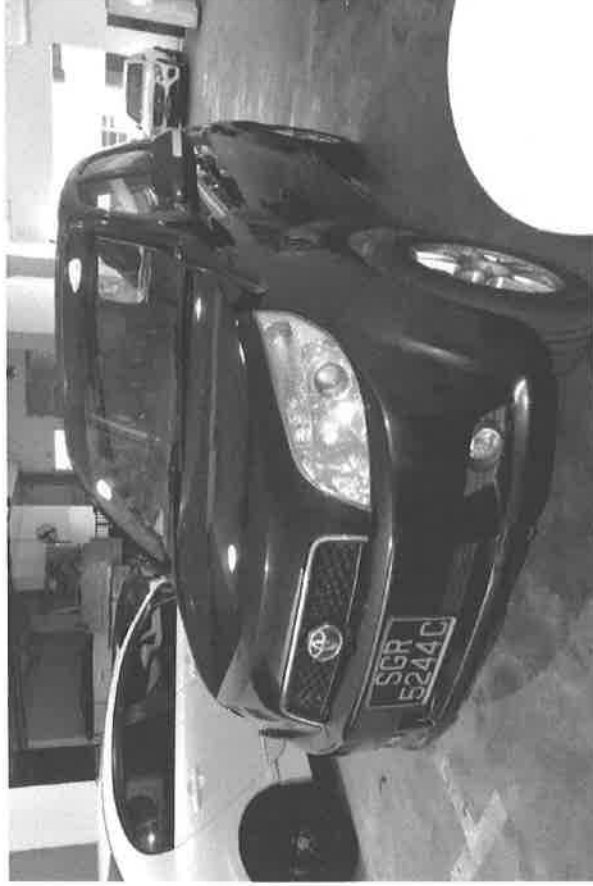
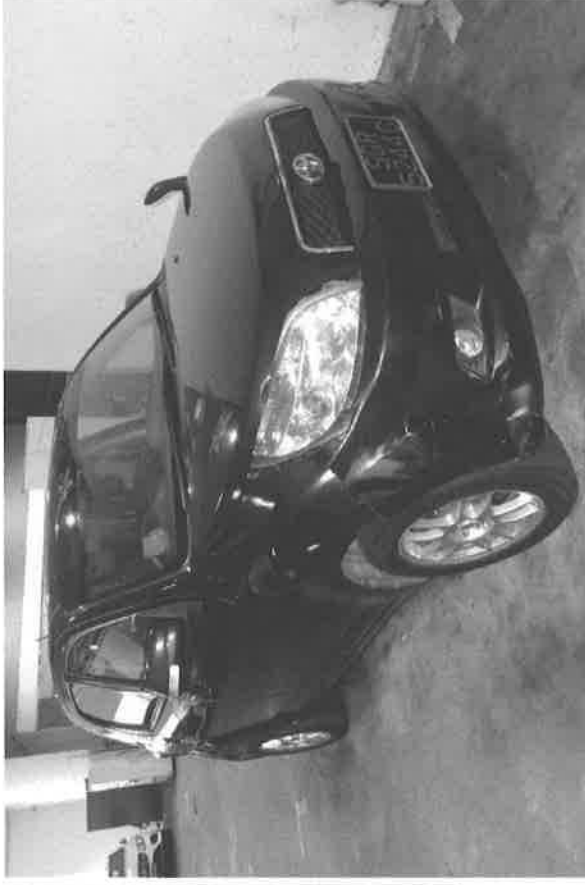
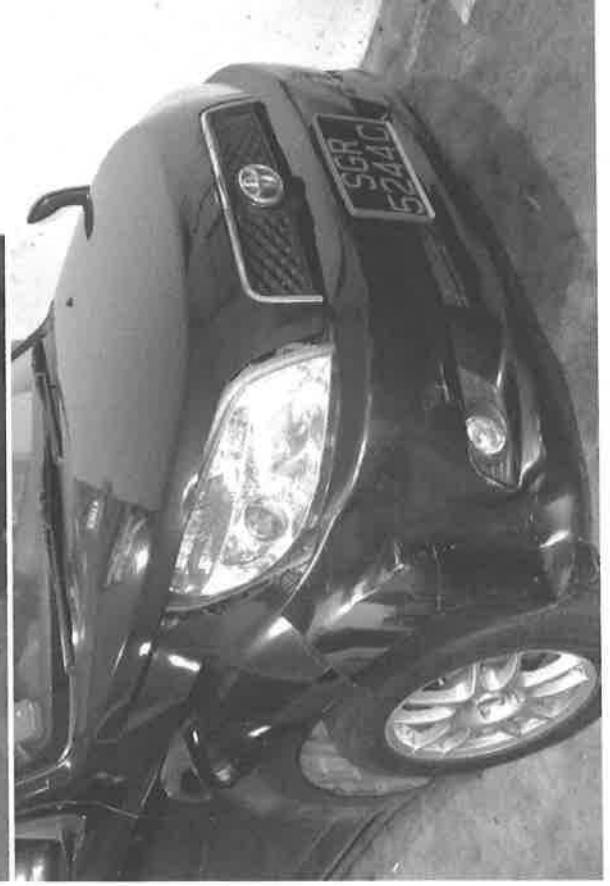
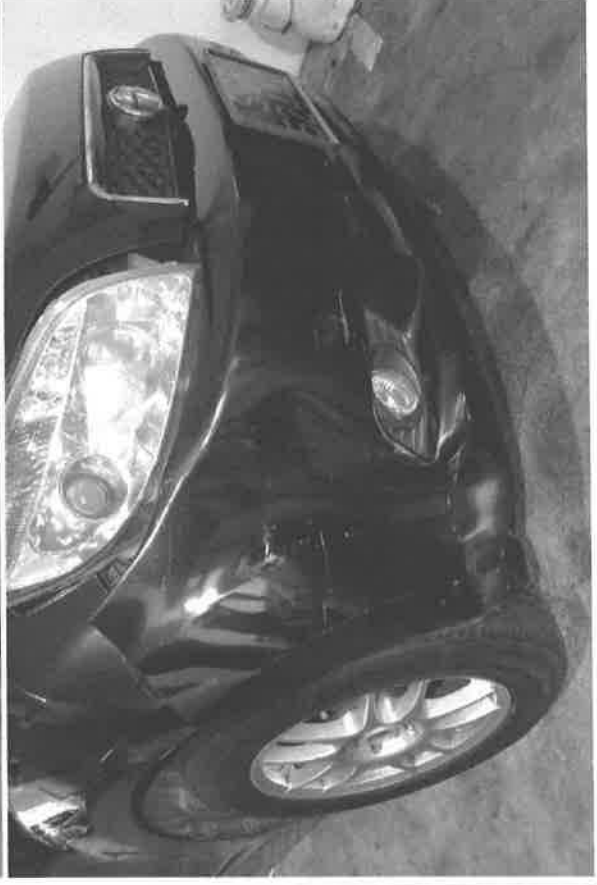
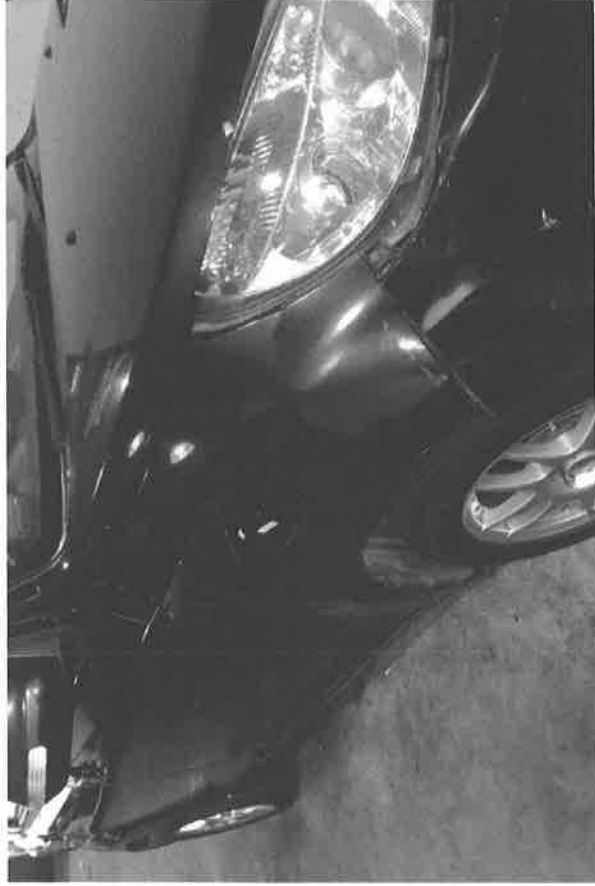
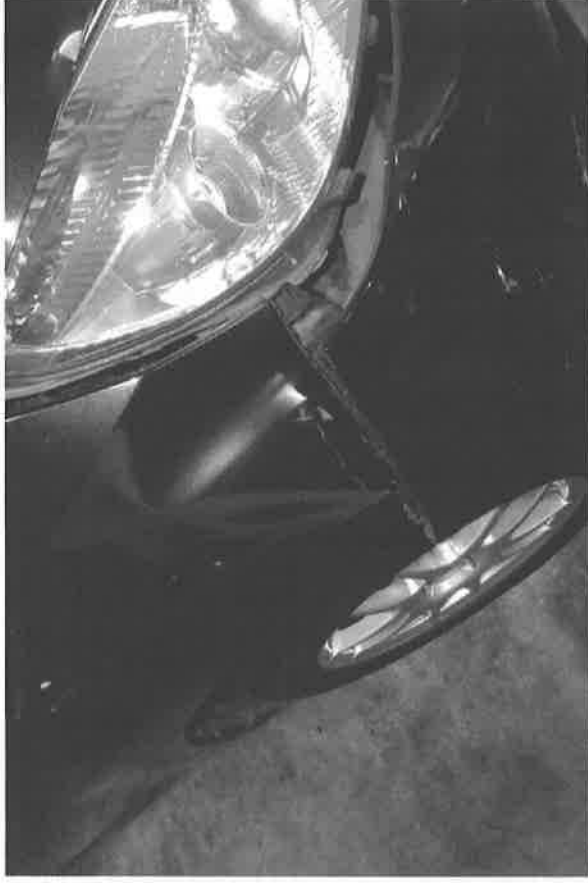
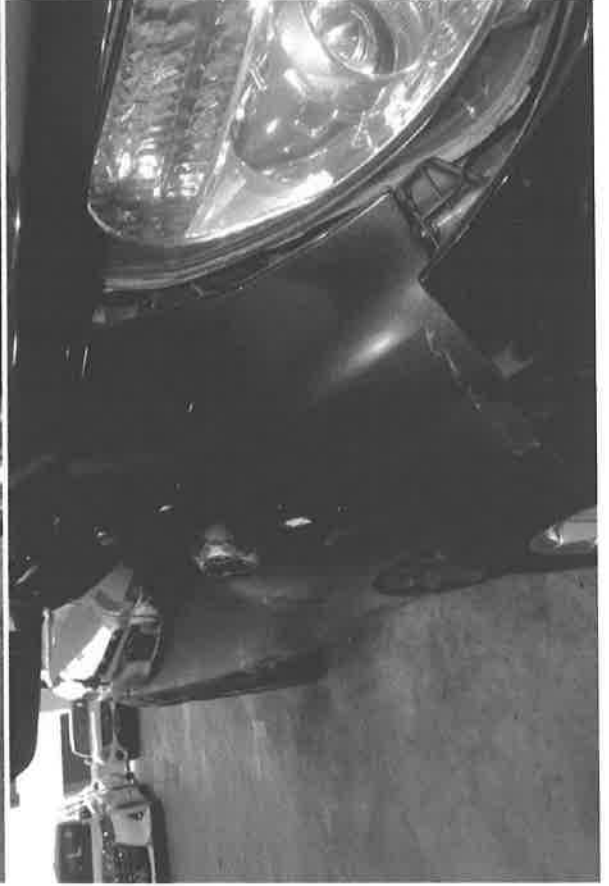
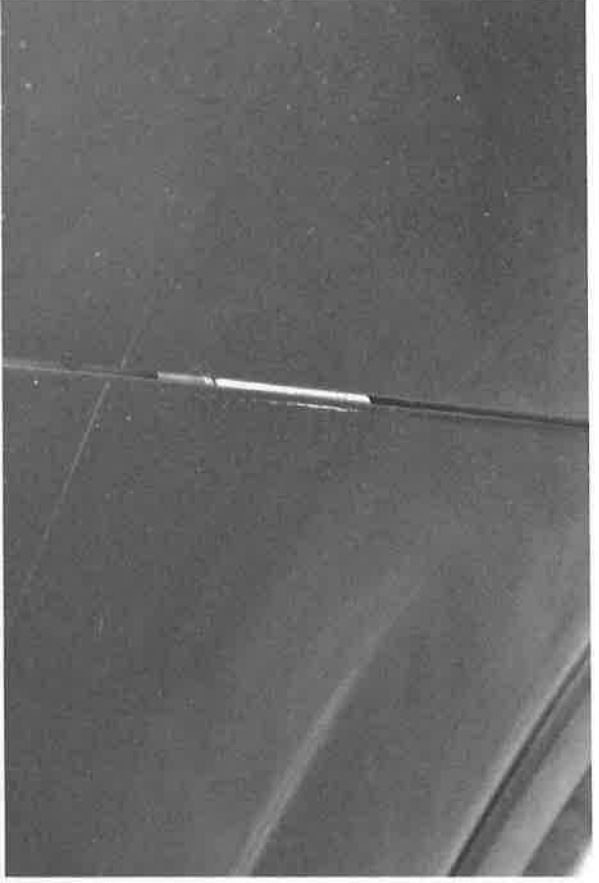
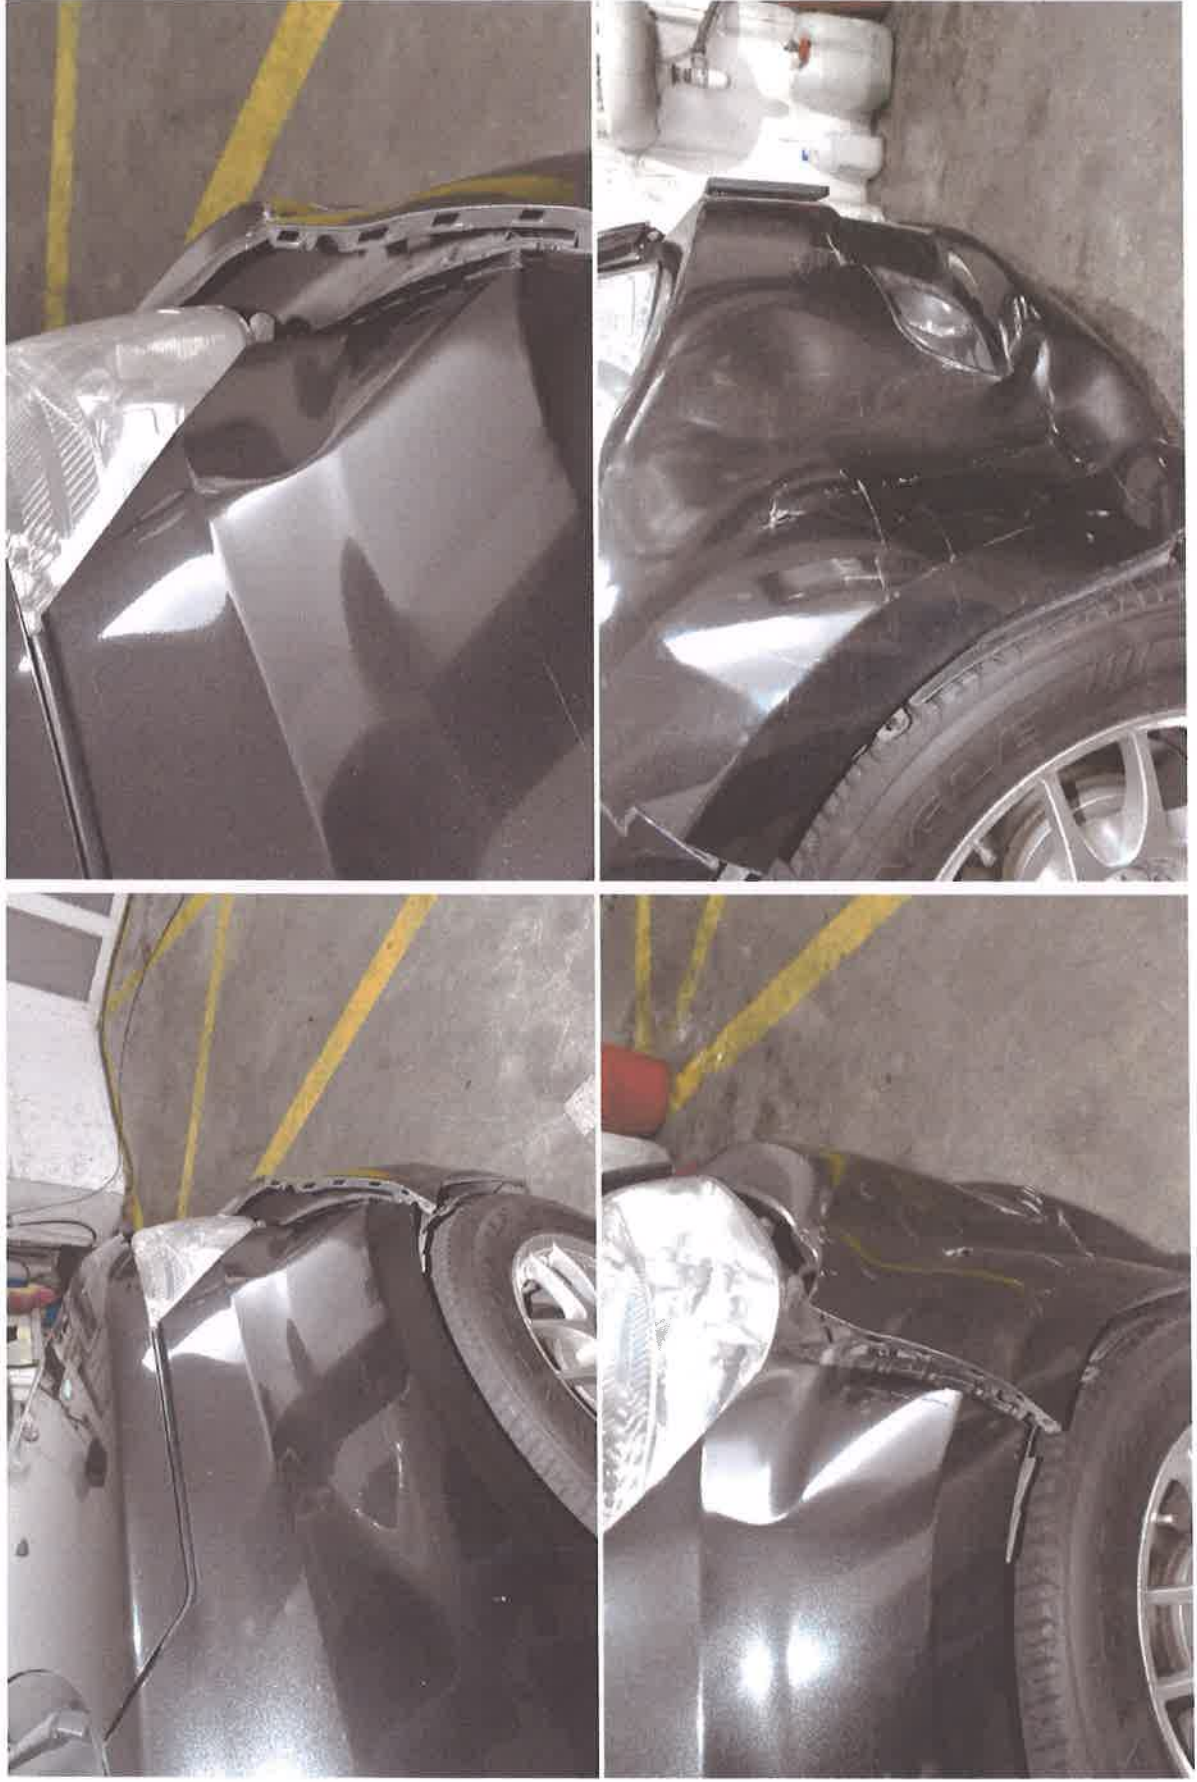
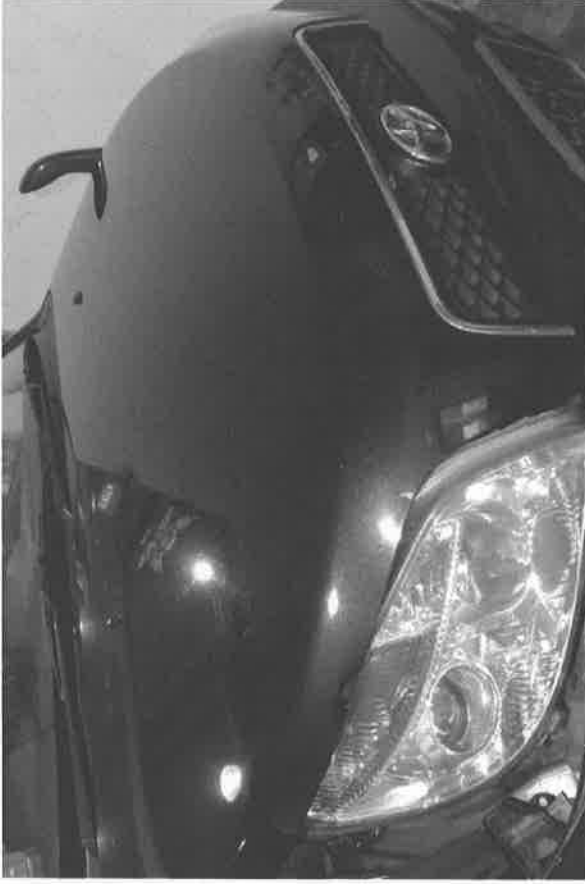
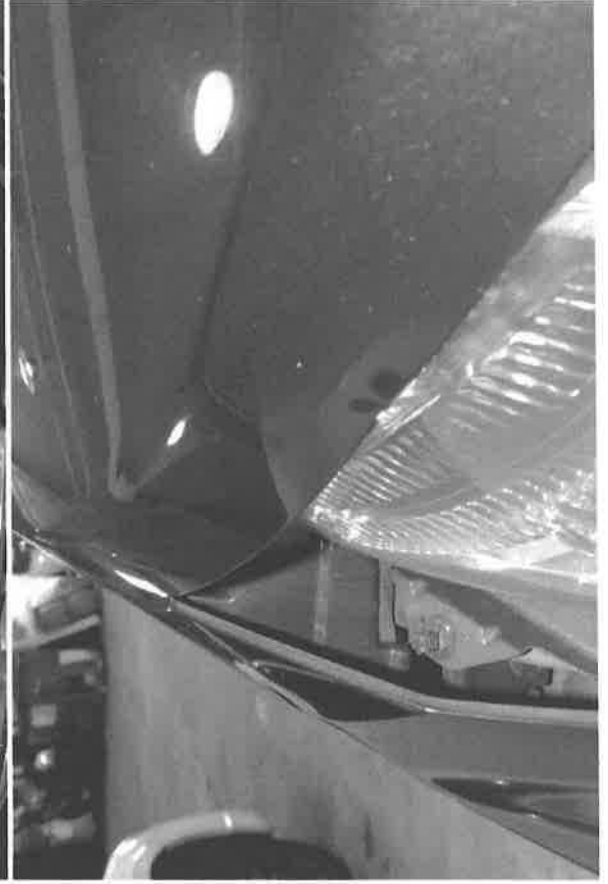
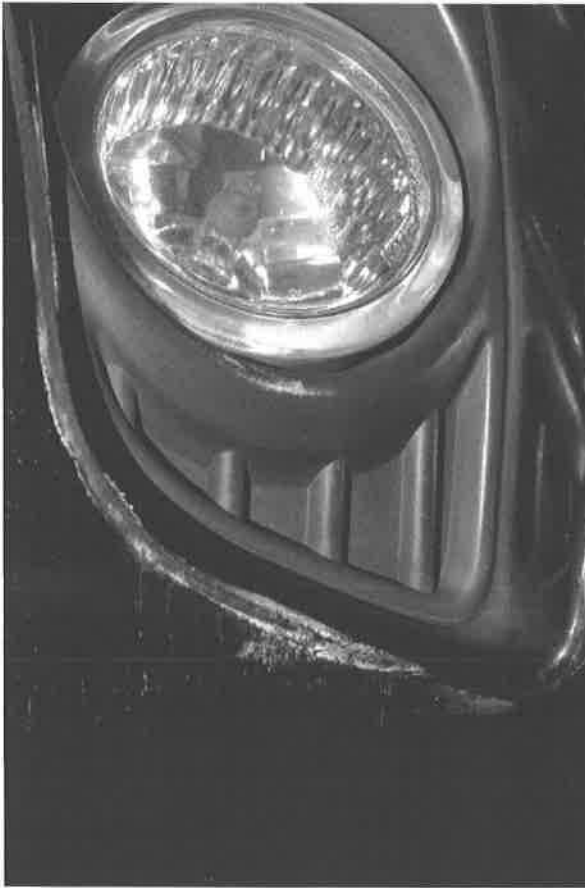
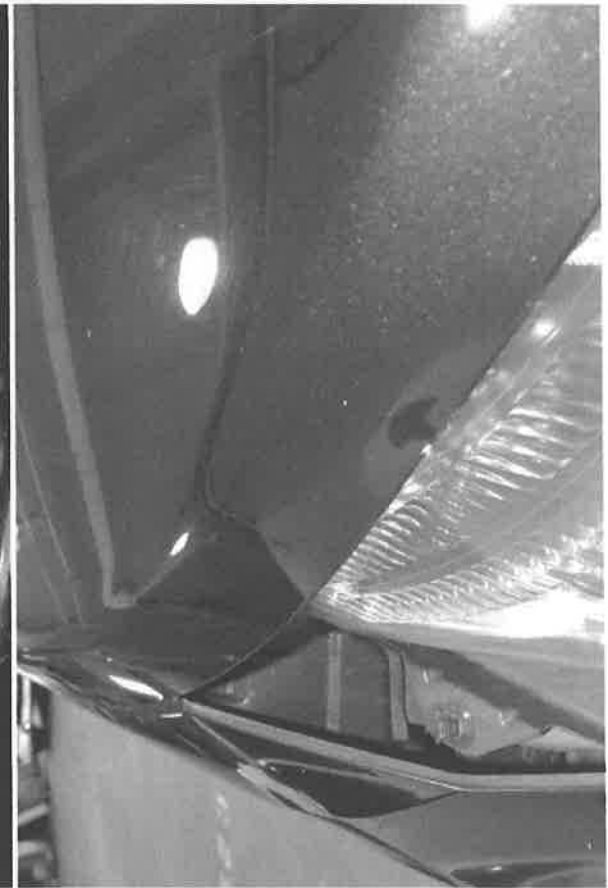
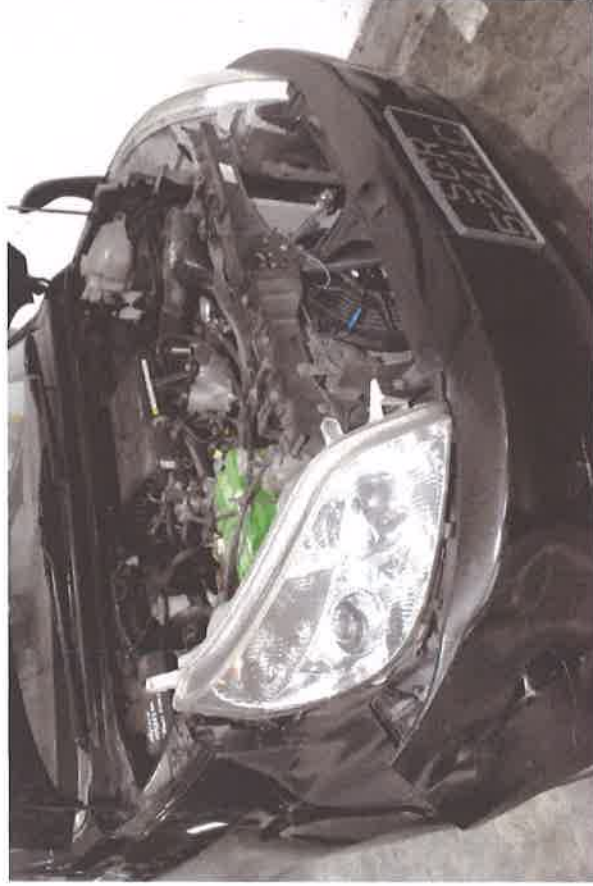
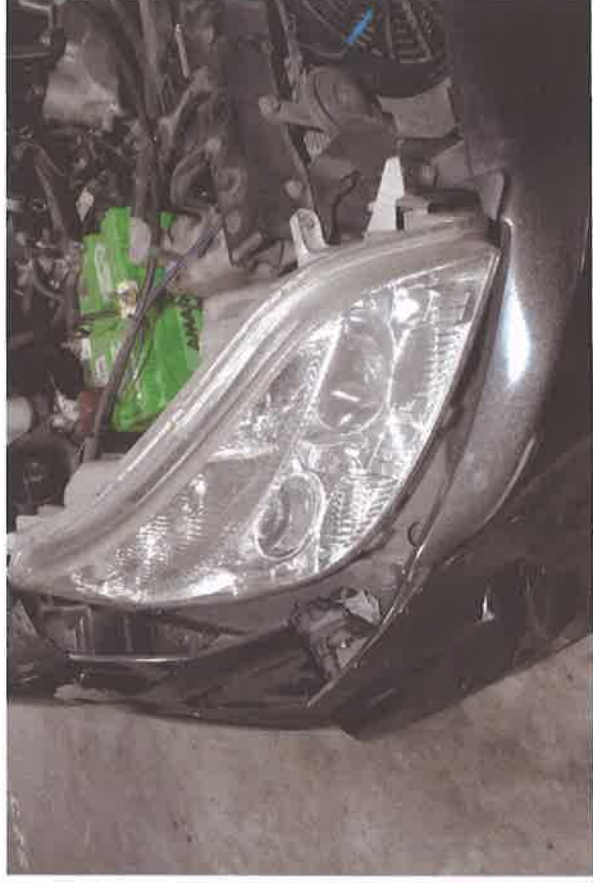
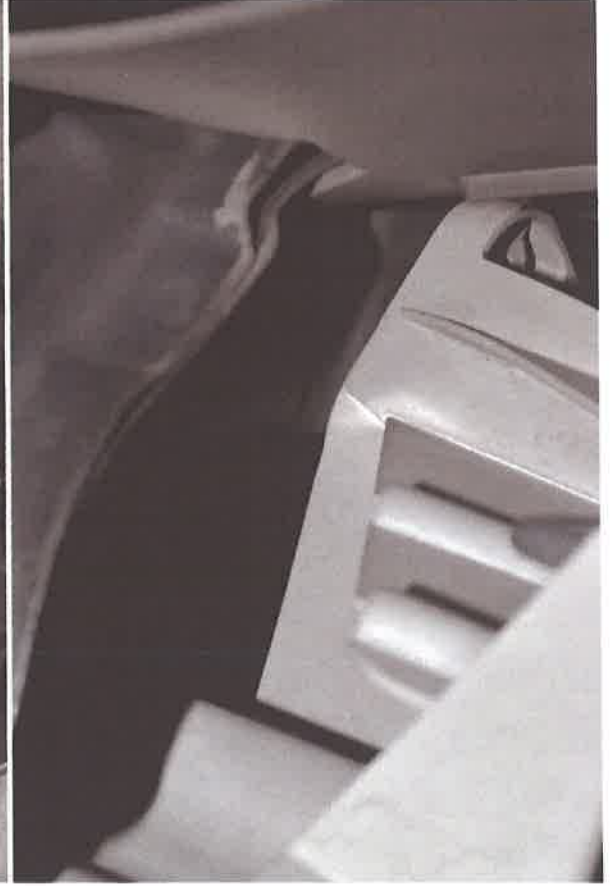
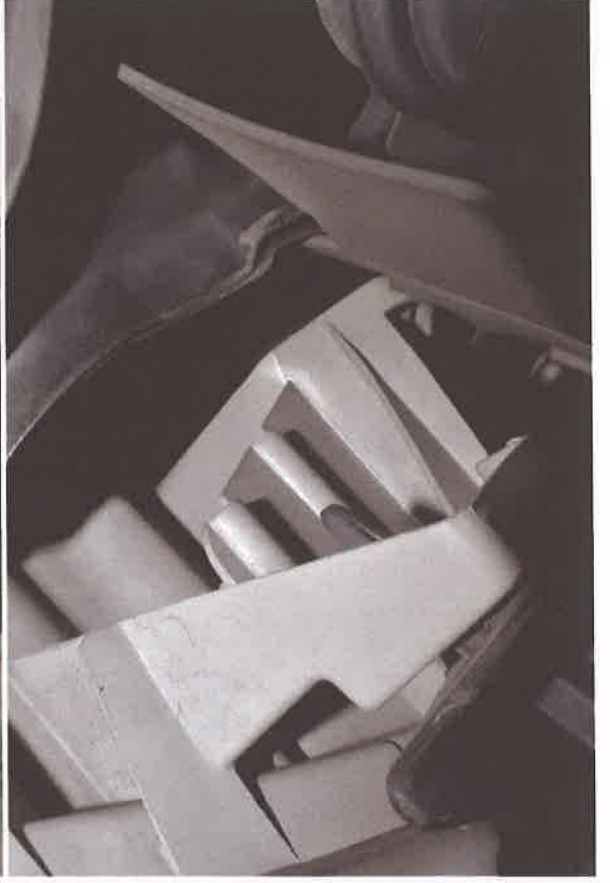
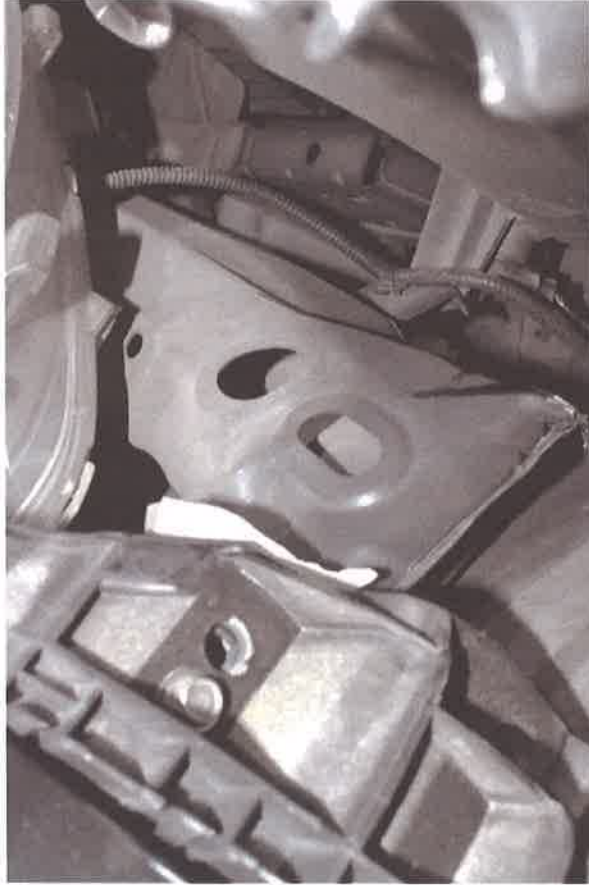
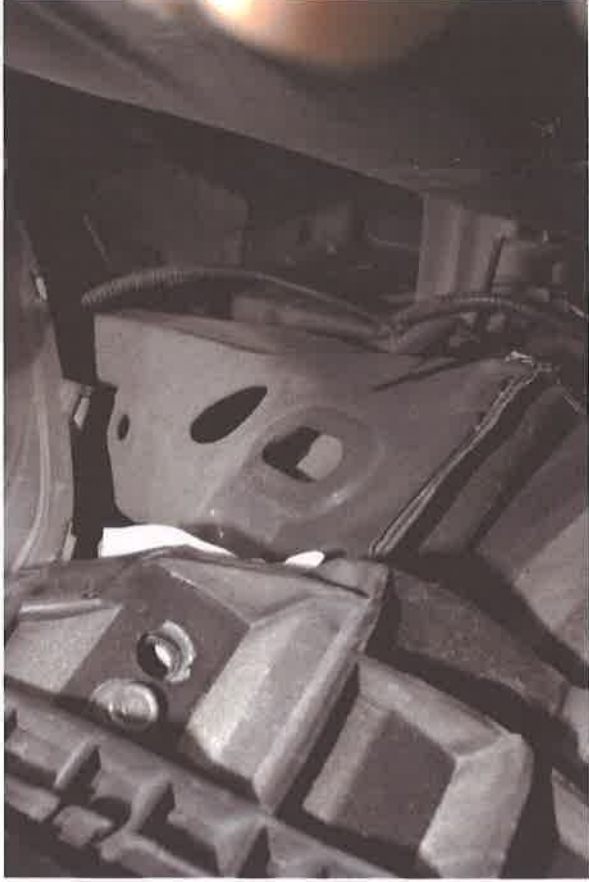
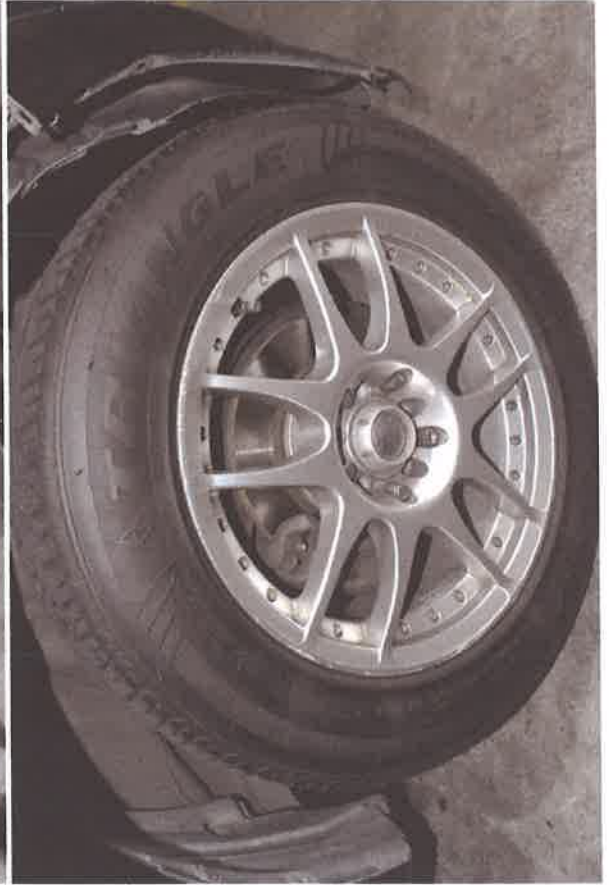
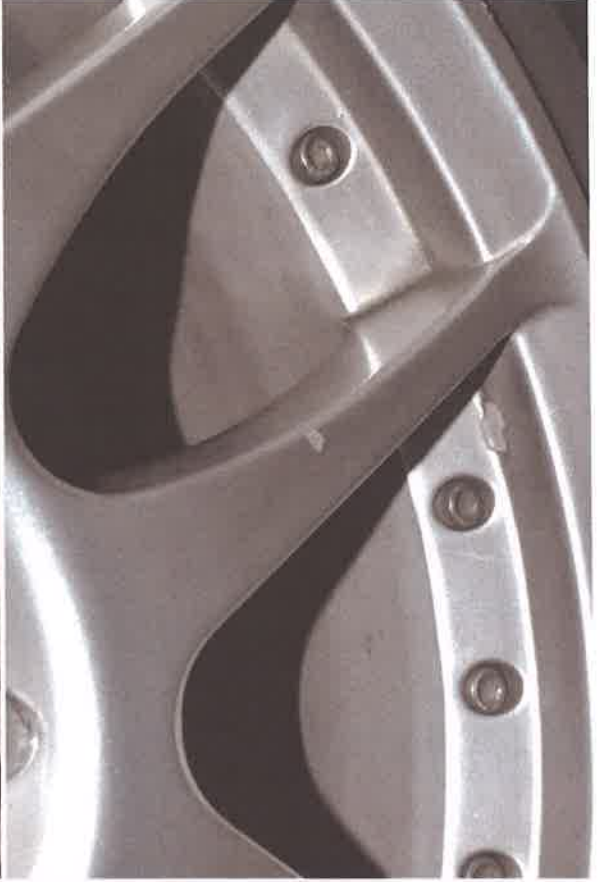
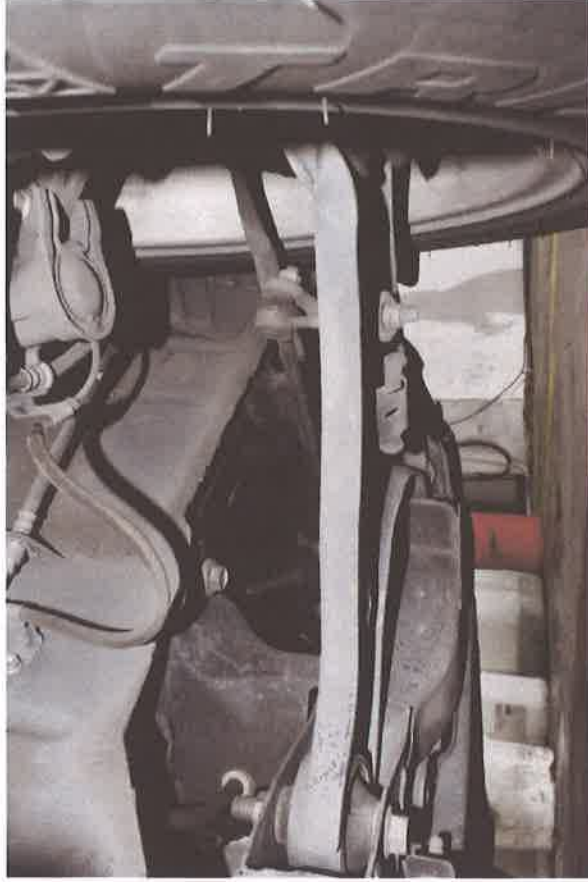
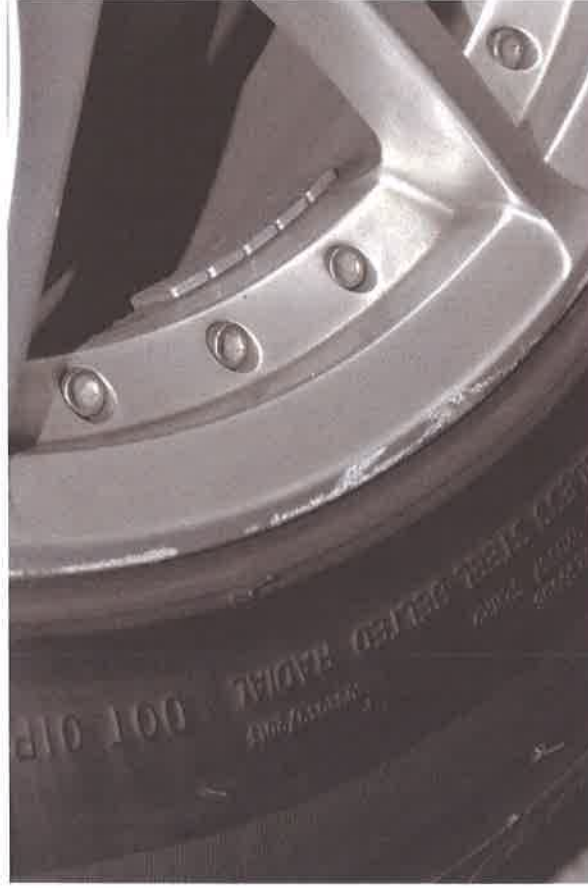
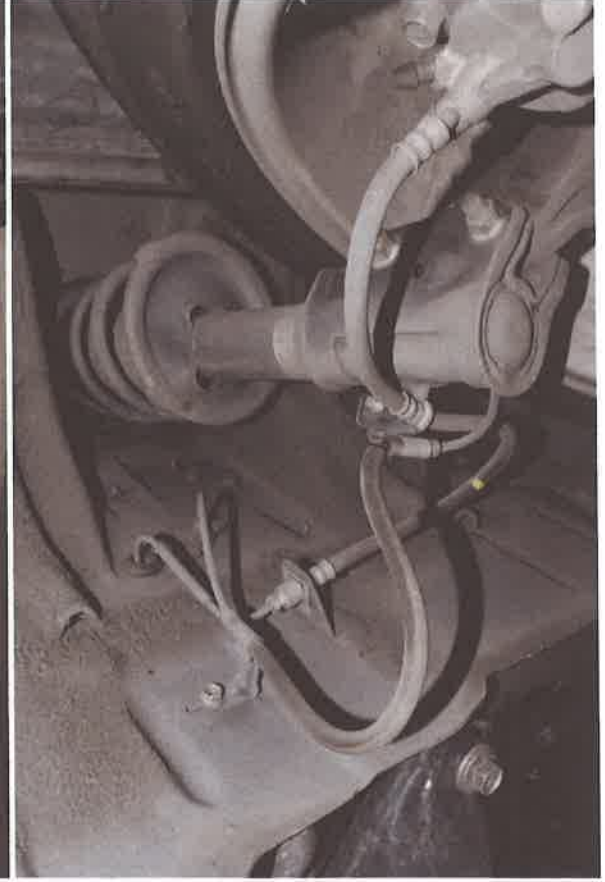
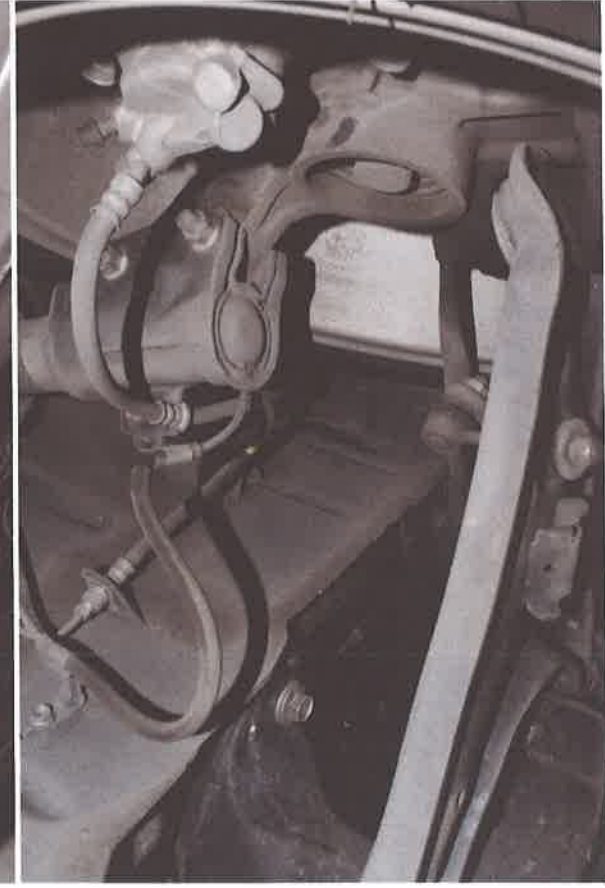
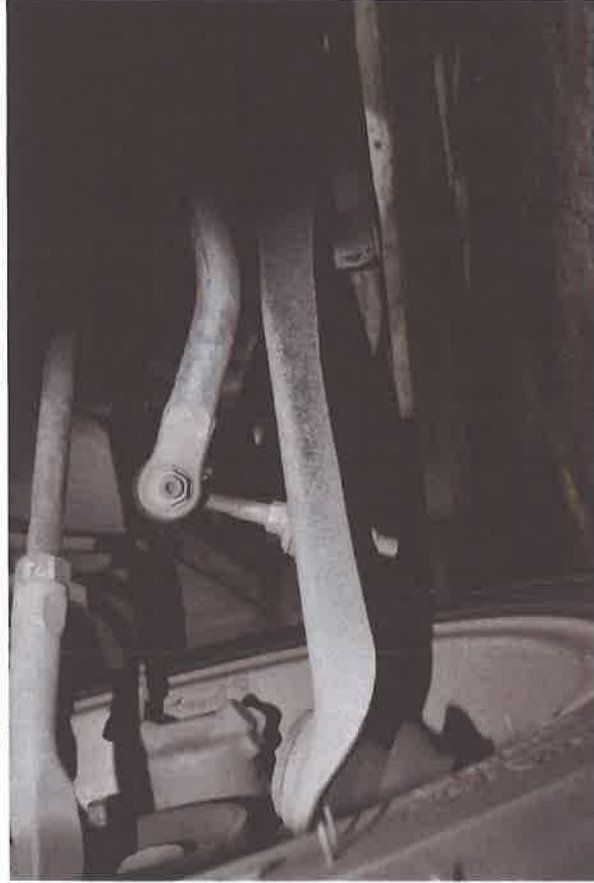
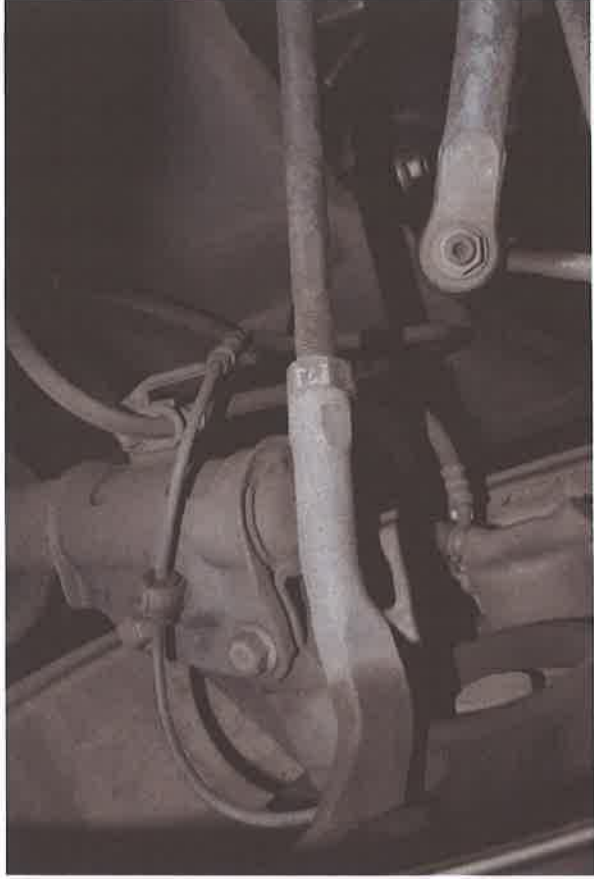
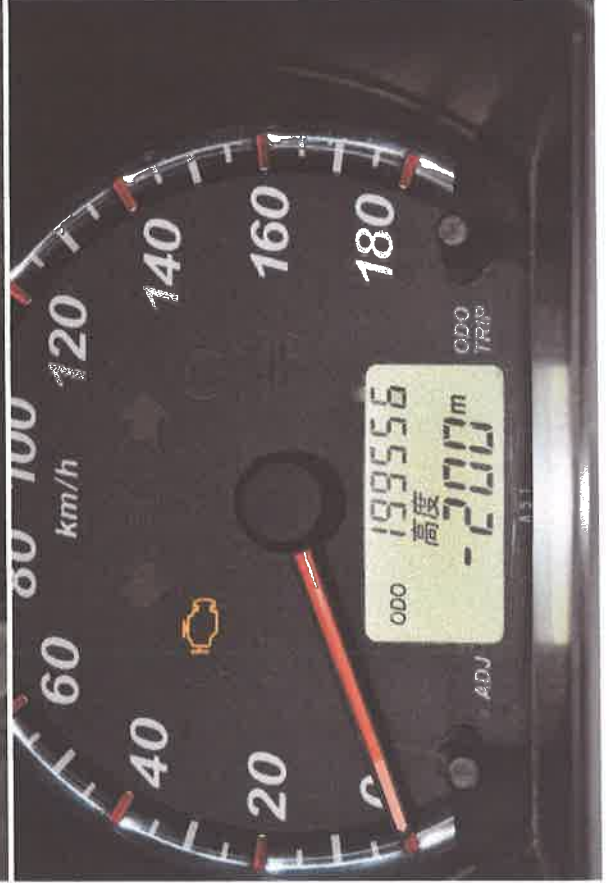
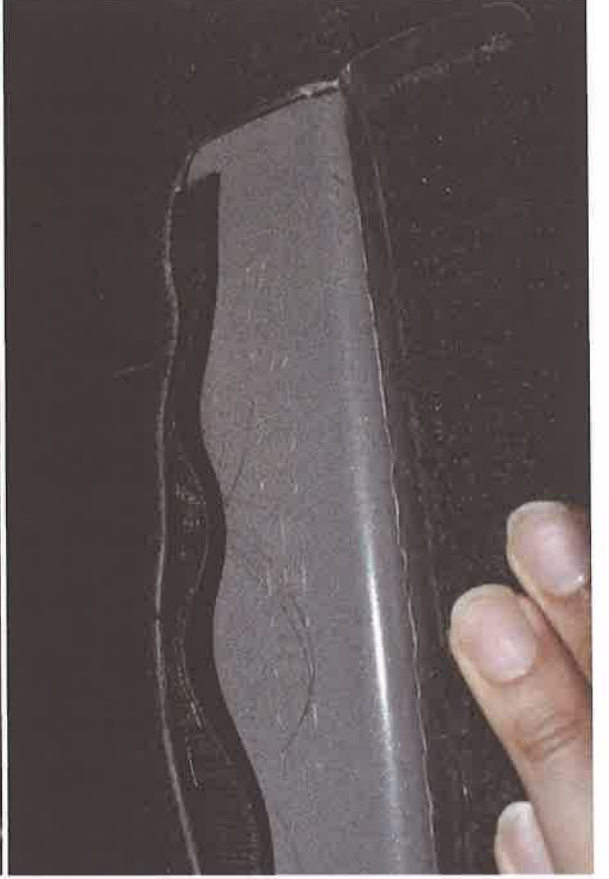
INSPECTION PHOTOS

At the time of inspection, this vehicle sustained damages to the **Front Rh portion**.

Front bumper, bonnet, front rh fender, support panel, front rh wheel housing dented. Front rh sport rim grazed, front rh undercarriage push in etc.
