Vehicle No. : SJV1401K  
Accident date : 17 November 2020

Final Repair Bill for Vehicle No. SJV1401K

### Annex C: Recommendation

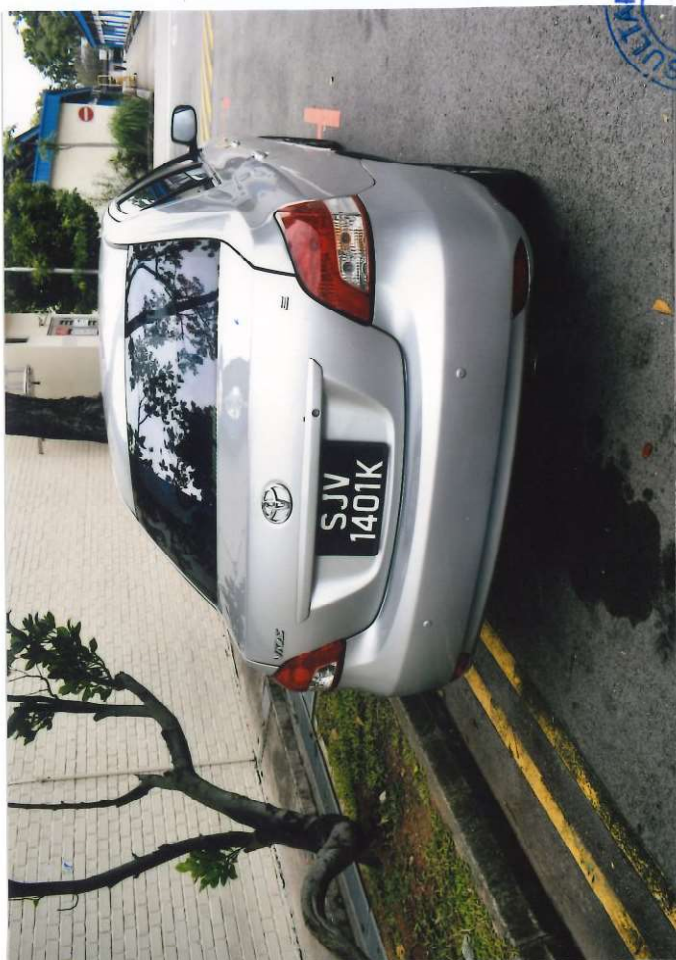
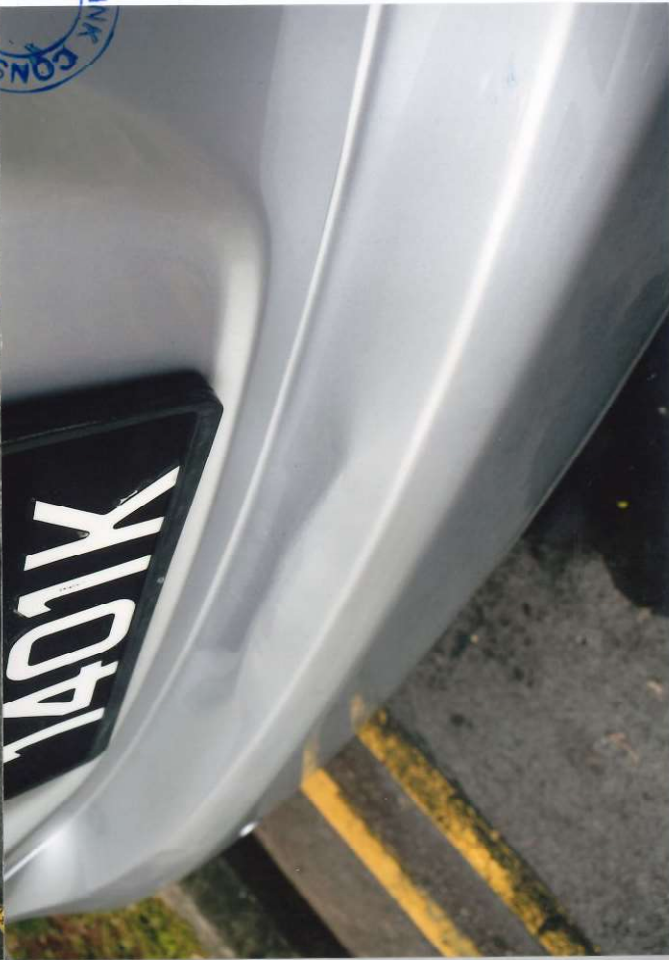
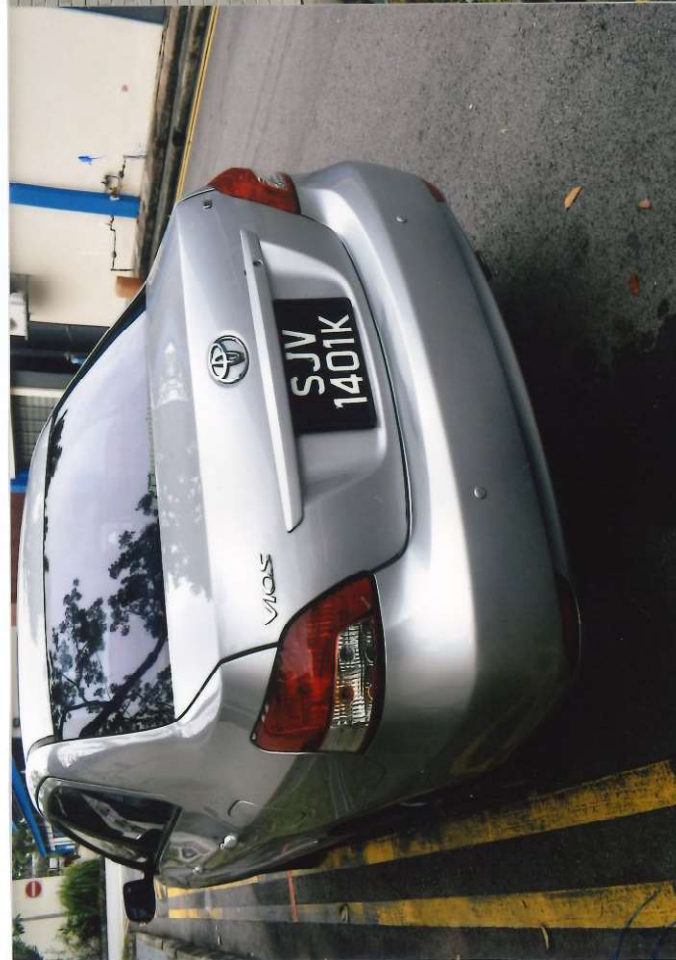
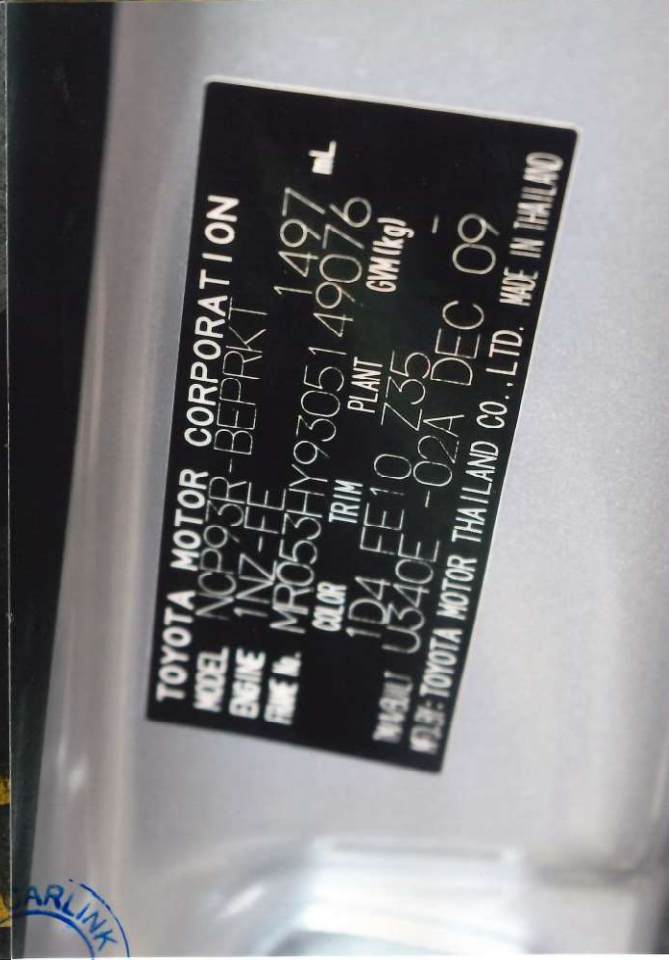
TOYOTA MOTOR CORPORATION  
MODEL NCP03R-BEPRKT 1497 mL  
ENGINE 1N7-EE  
FRAME NO. MR053HY93051 49076  
COLOR TRIM PLANT GVM(kg)  
1D4 EE10 Z35  
WABUJ U340E -02A DEC 09  
WJ3E TOYOTA MOTOR THAILAND CO.,LTD. MADE IN THAILAND
