## LKK Auto Consultants Pte Ltd

### PROFESSIONAL SERVICE FEE

Vehicle No. CB 6806G  
Insured Veh. SG 5920A  
Claim No. D21001977MFBP/1  
Policy No. D-20096309MFBP  
Accident Date 01/07/2021  
Inspection Date 14/07/2021

## ADJUSTMENT ON REPAIR COST FOR VEHICLE NO. CB 6806G

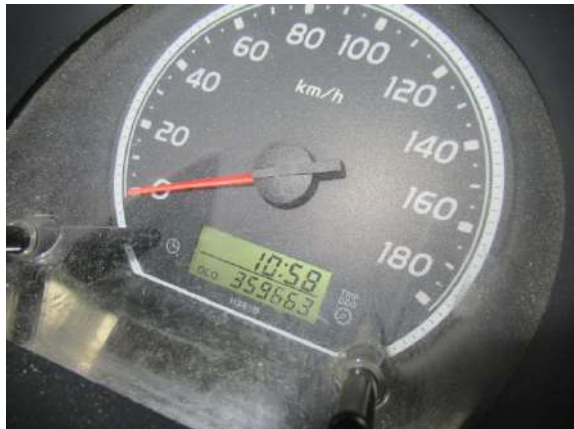
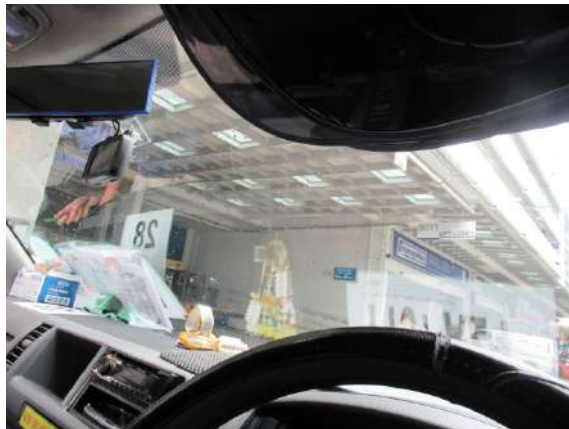
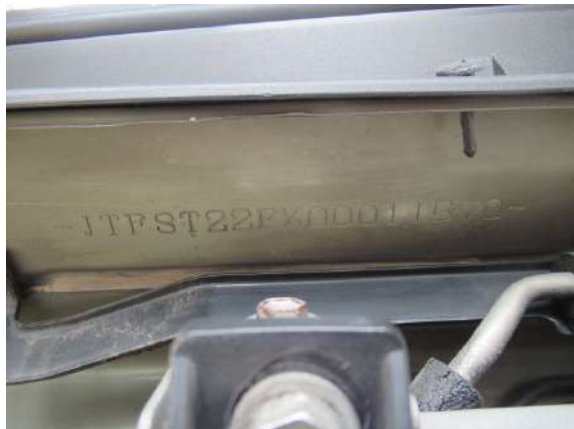
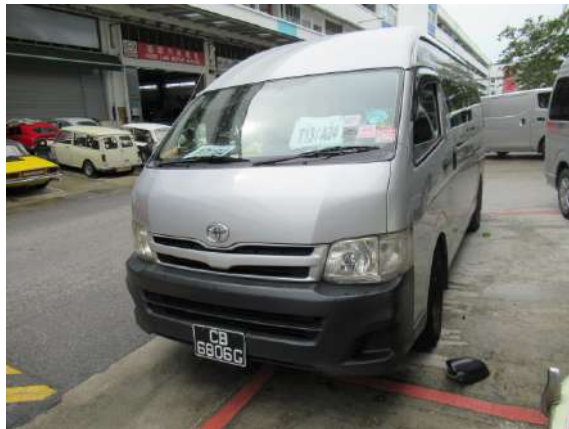
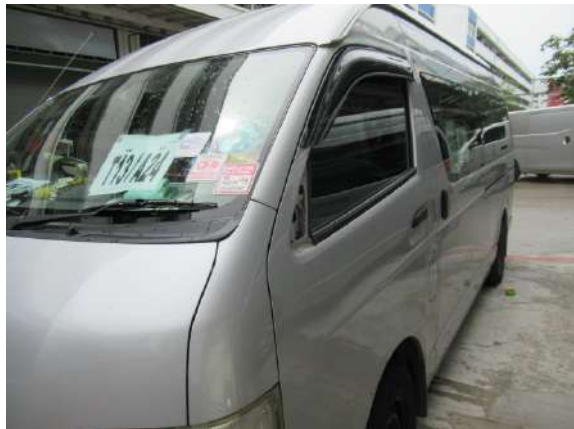
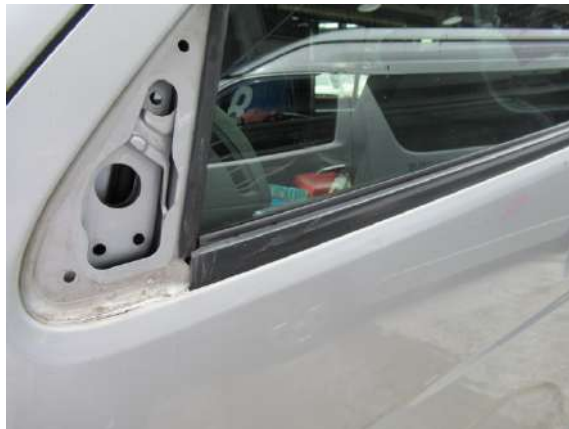
**PHOTOGRAPHS FOR VEHICLE NO. CB 6806G**

**INSPECTION**

| Affiliated to Federation Internationale Des Experts En Automobile | | | | |
|---|---|---|---|---|
| | THE VEHICLE SUSTAINED DAMAGES AT THE N/S FRONT PORTION.<br><br>DAMAGES SEE DETAILS. | | | |

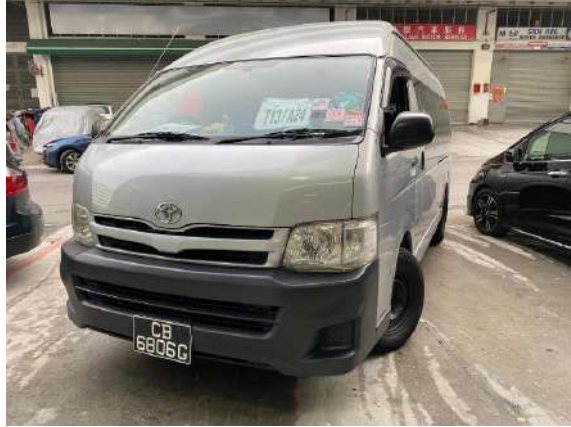
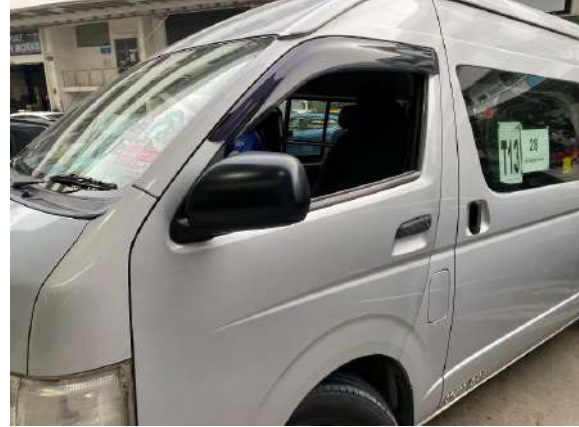
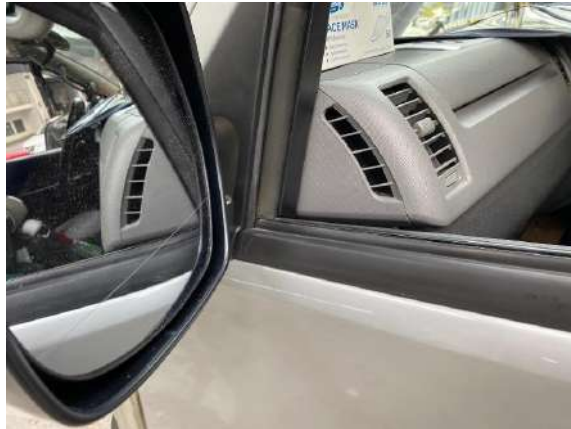
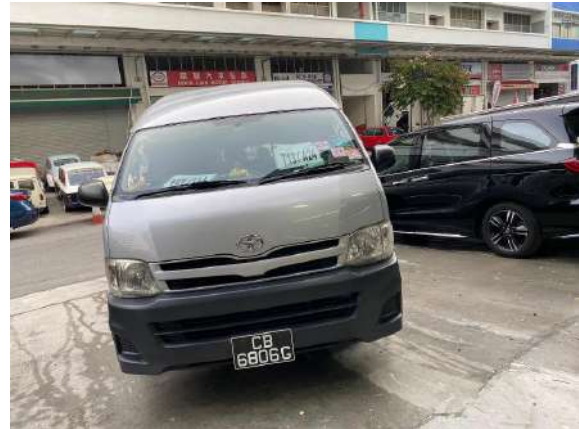
### PHOTOGRAPHS FOR VEHICLE NO. CB 6806G

### RE-INSPECTION
