Vehicle No. GBK 3115B  
Insured Veh. GV 3649K  
Claim No. SNM21D203804/C02  
Policy No. DMCVSNW00044382100  
Accident Date 05/07/2021  
Inspection Date 14/07/2021

## ADJUSTMENT ON REPAIR COST FOR VEHICLE NO. GBK 3115B

### PHOTOGRAPHS FOR VEHICLE NO. GBK 3115B

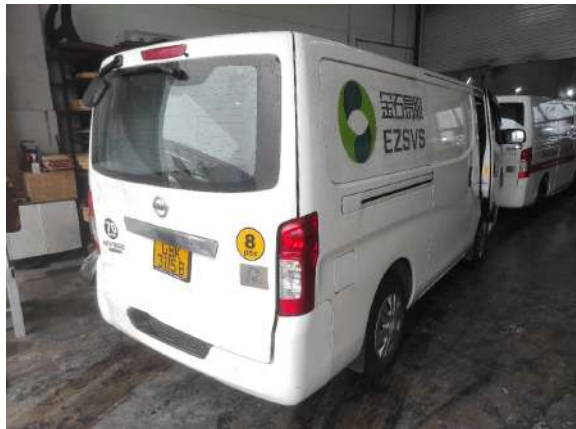
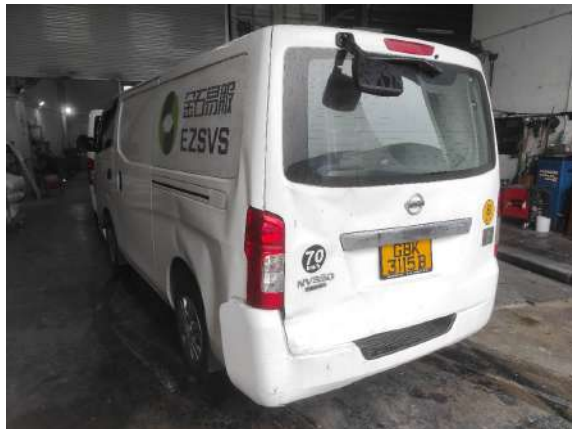
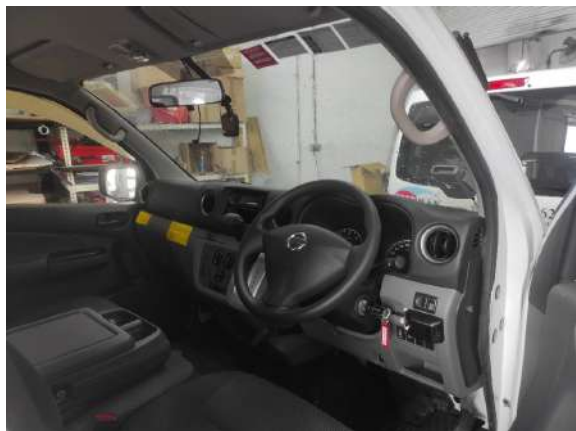
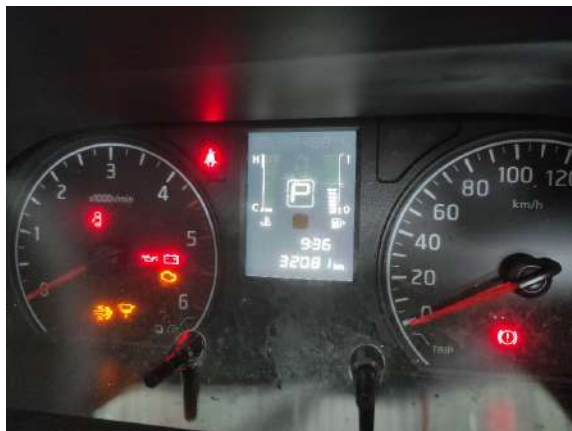
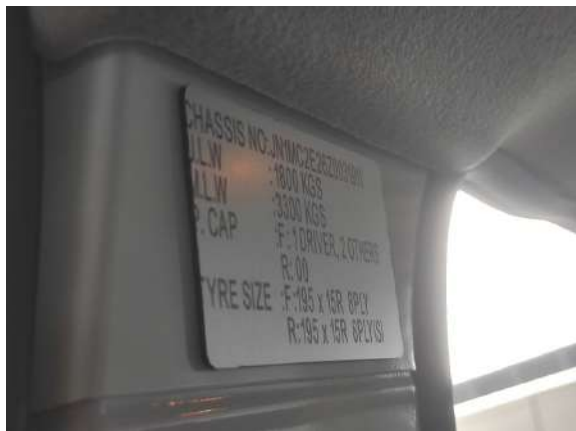
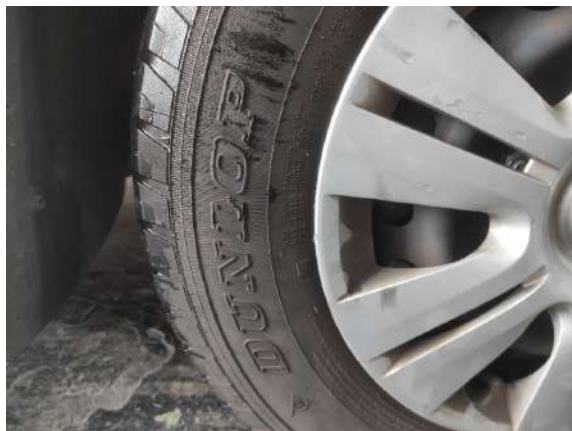
| Affiliated to Federation Internationale Des Experts En Automobile | | | | |
|---|---|---|---|---|
| | THE VEHICLE SUSTAINED DAMAGES AT THE REAR O/S PORTION.<br><br>DAMAGES SEE DETAILS. | | | |

### INSPECTION

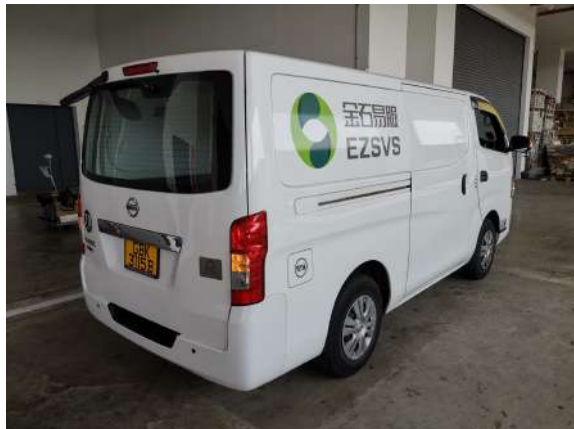
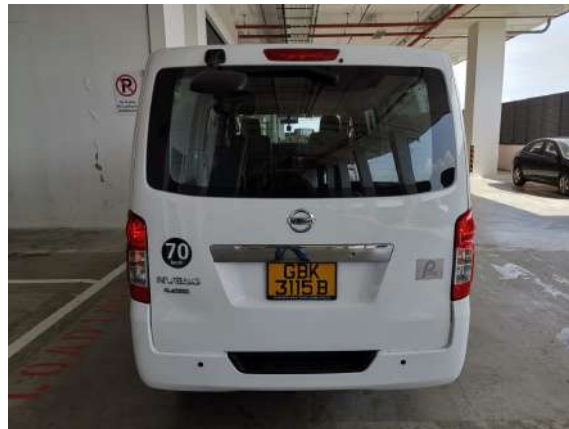
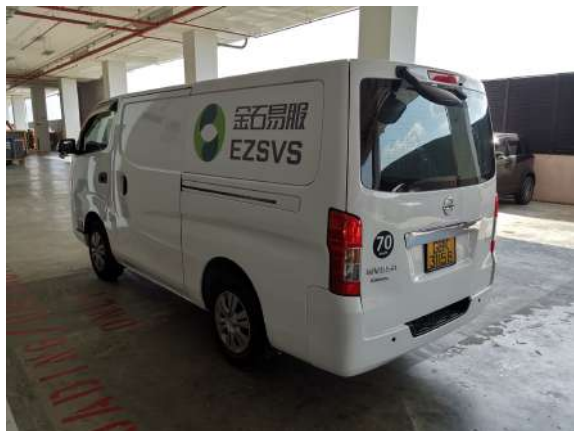
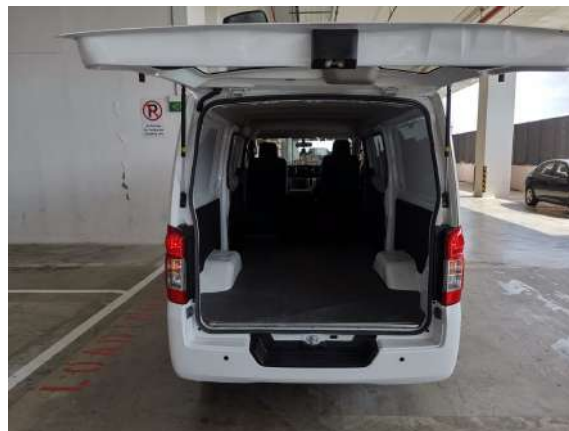
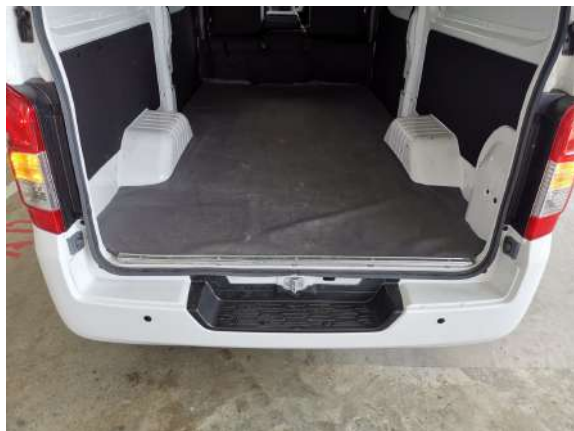
PHOTOGRAPHS FOR VEHICLE NO. GBK 3115B

RE-INSPECTION
