## LKK Auto Consultants Pte Ltd

### PROFESSIONAL SERVICE FEE

Vehicle No. SHB 5537E  
Insured Veh. GBC 6228G  
Claim No. SNM21D204023/LKKDS  
Policy No. DMCVSNW0076992001  
Accident Date 19/07/2021  
Inspection Date 22/07/2021

## ADJUSTMENT ON REPAIR COST FOR VEHICLE NO. SHB 5537E

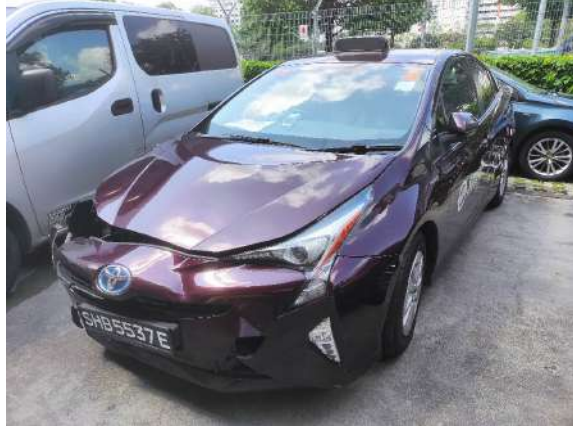
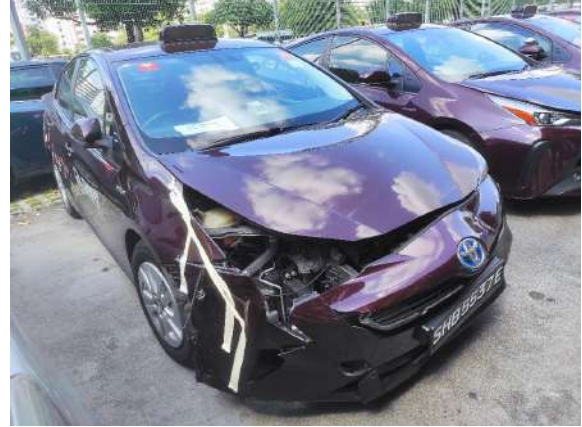
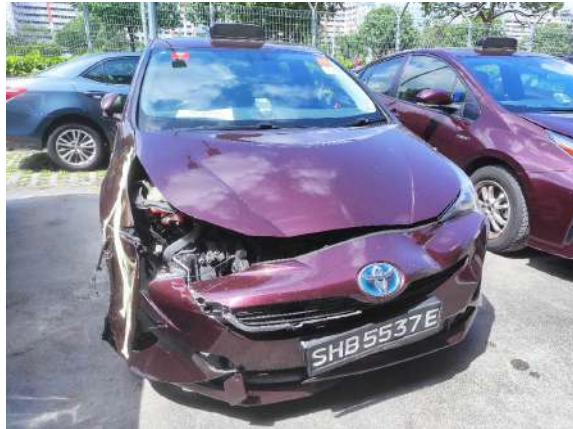
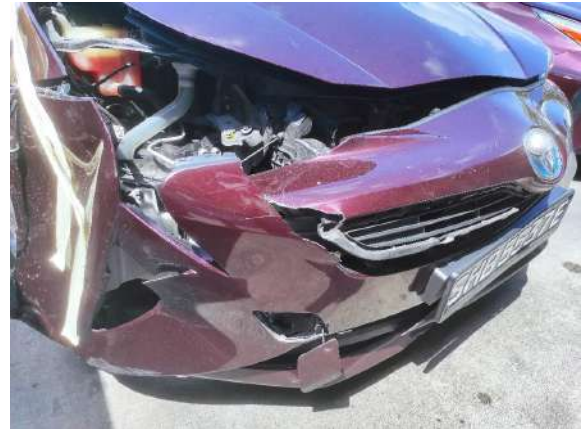
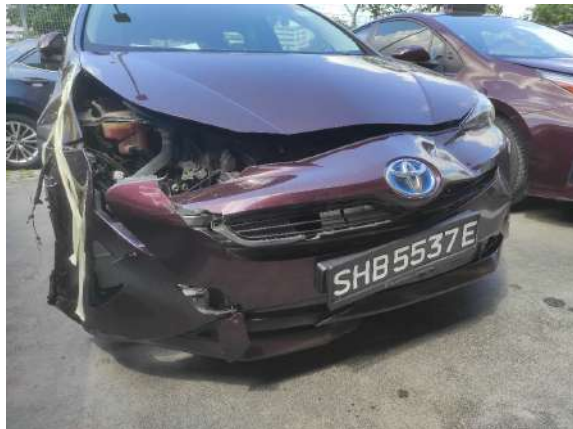
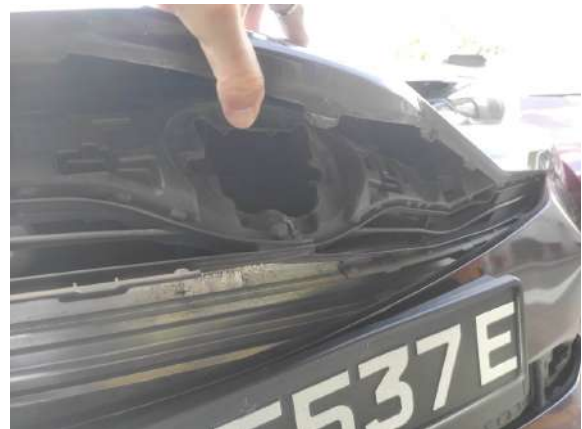
### PHOTOGRAPHS FOR VEHICLE NO. SHB 5537E

### INSPECTION

| Affiliated to Federation Internationale Des Experts En Automobile | | | | |
|---|---|---|---|--|
| THE VEHICLE SUSTAINED DAMAGES AT THE O/S FRONT PORTION.<br>DAMAGES SEE DETAILS. | | | | |
