ACCIDENT DAMAGED VEHICLE INSPECTION REPORT

Registration No : SLC2637S
Make : HYUNDAI
Model : LF SONATA 2.0 GLS A/T
Year : 2016

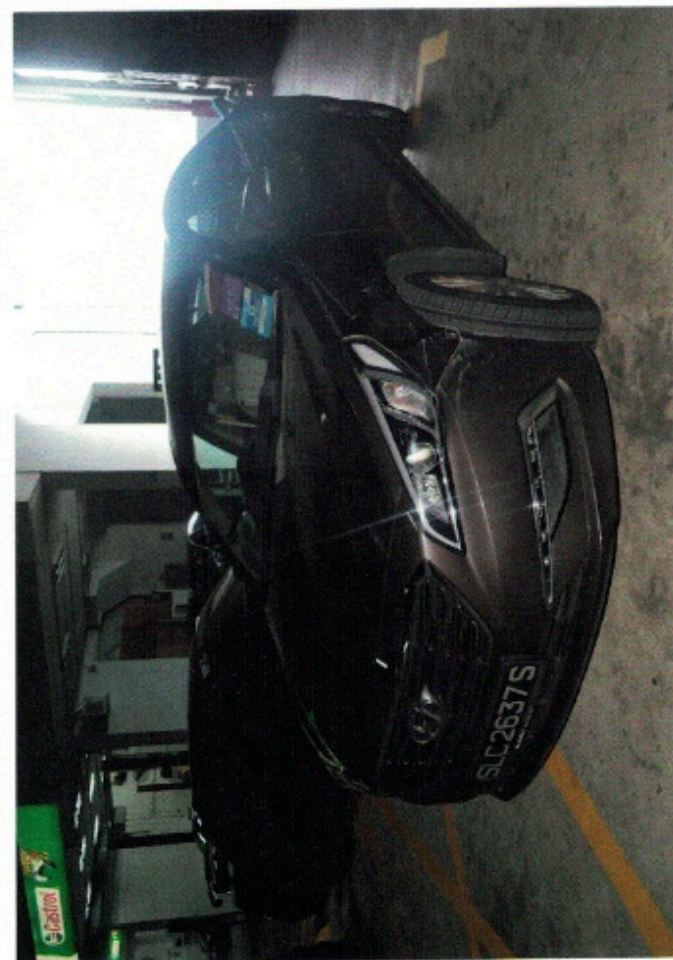
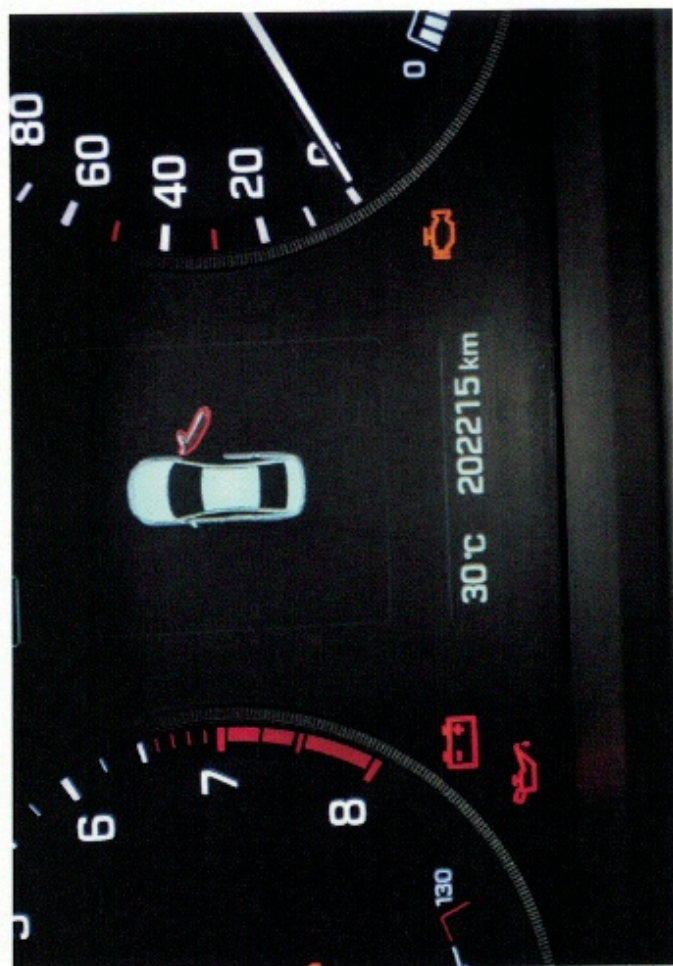
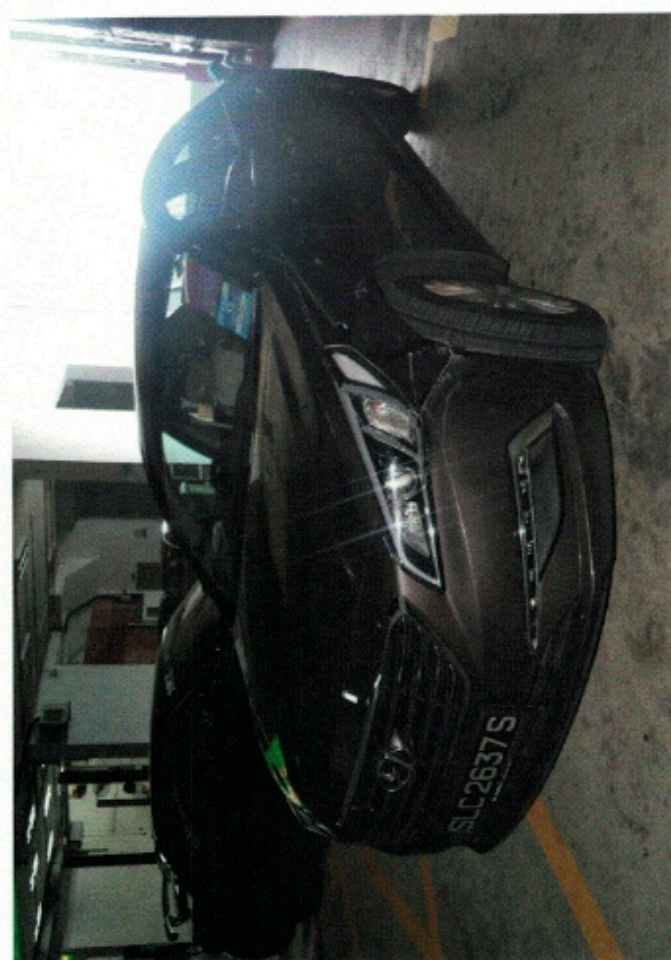
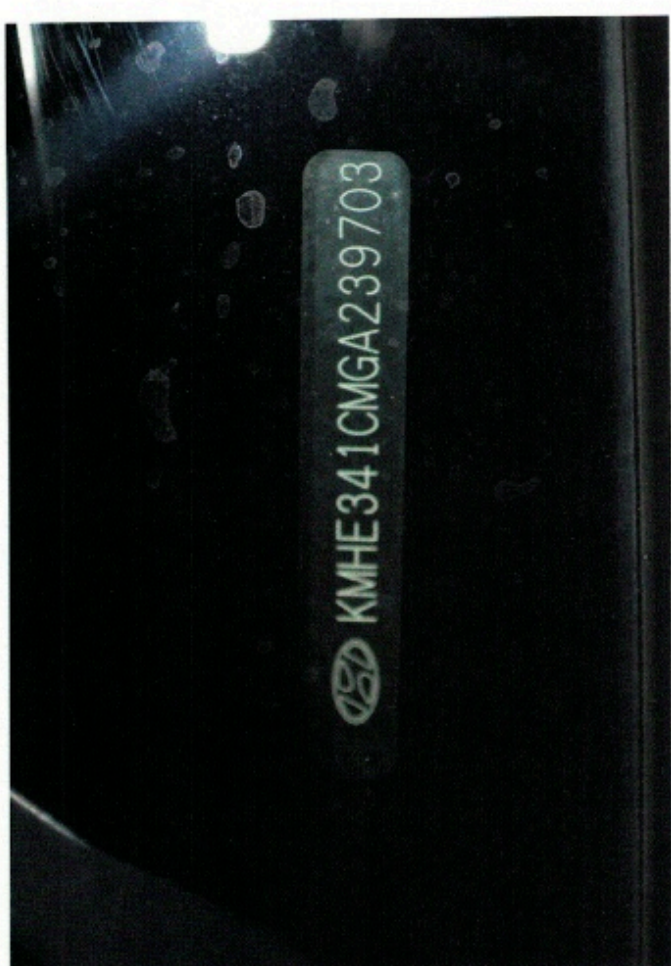
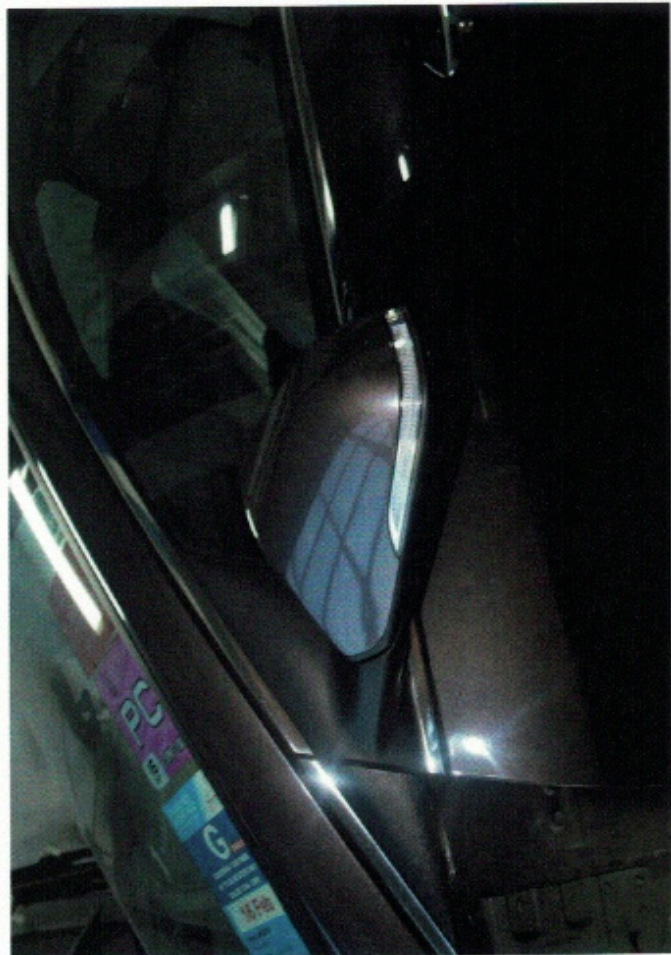
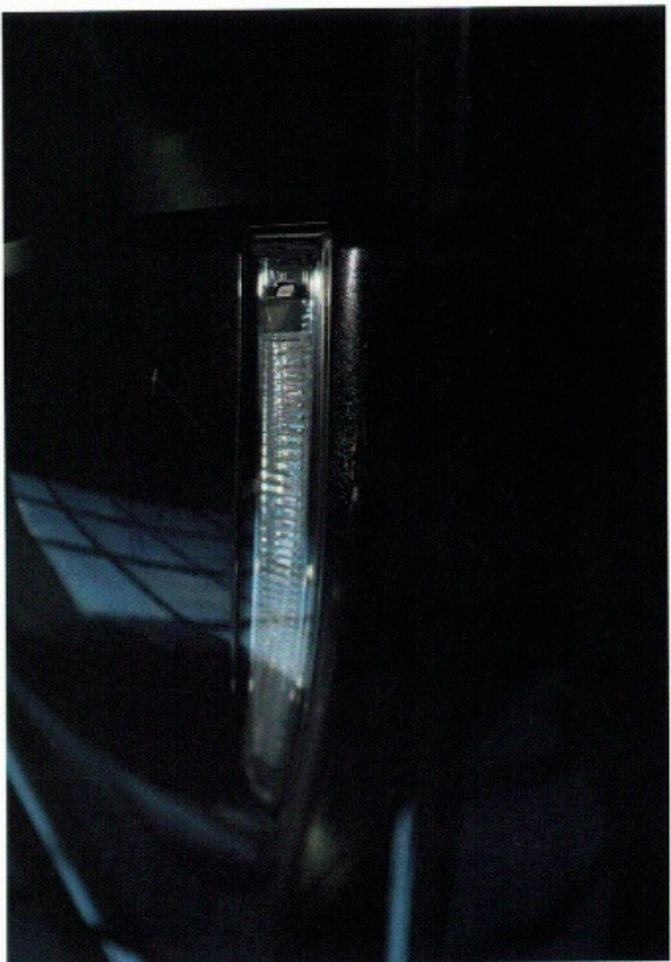
The vehicle sustained damage at the front left portion.
For details, refer to assessment for repairs and photographs attached.

Enclosed Eighty (80) photographs depicting damage to the vehicle.

The impact was confined to the front left portion of the vehicle.
The damages appeared to be consistent as per the accident report statement.
Please refer the attached schedule and photographs for details.
