## ADJUSTMENT ON REPAIR COST FOR VEHICLE NO. SMF 8572C

PHOTOGRAPHS FOR VEHICLE NO. SMF 8572C

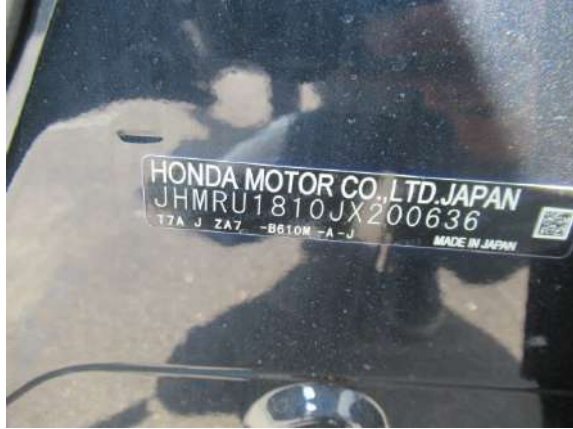
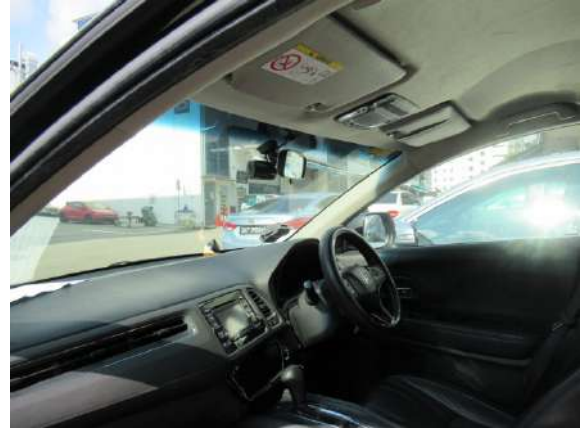
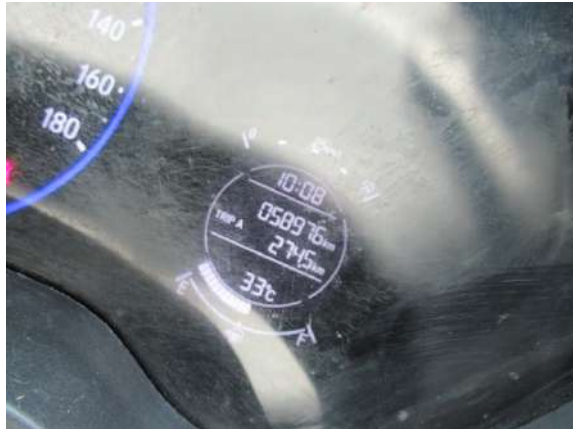
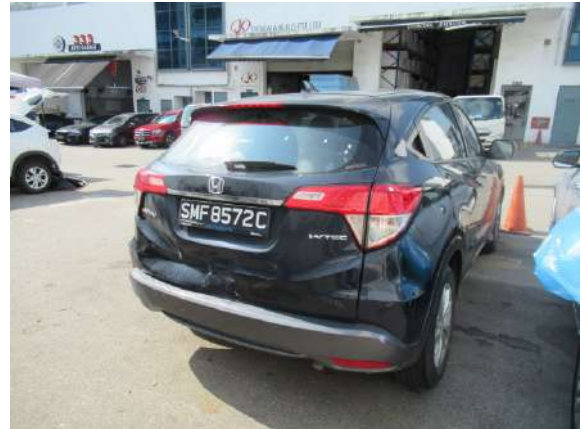
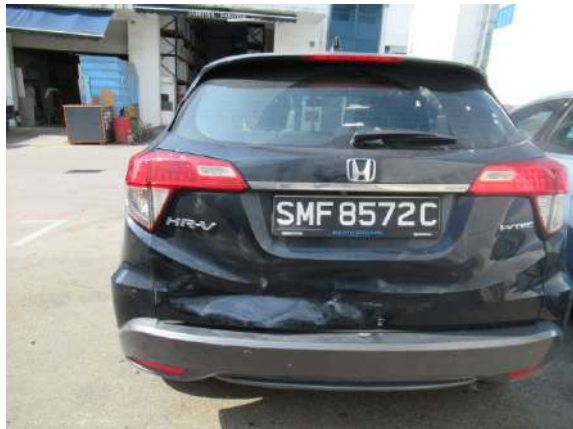
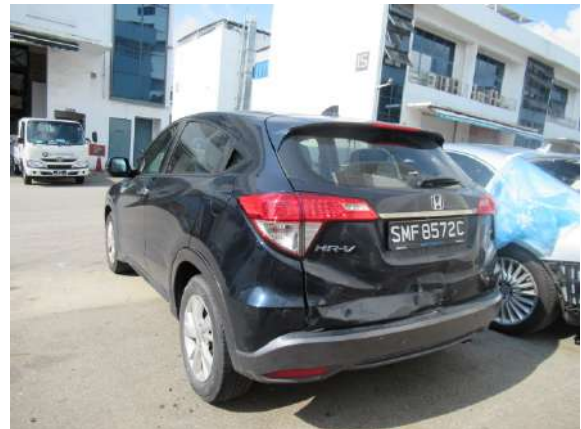
INSPECTION

| Affiliated to Federation Internationale Des Experts En Automobile | | | | |
|---|---|---|---|--|
| THE VEHICLE SUSTAINED DAMAGES AT THE REAR PORTION.<br>DAMAGES SEE DETAILS. | | | | |

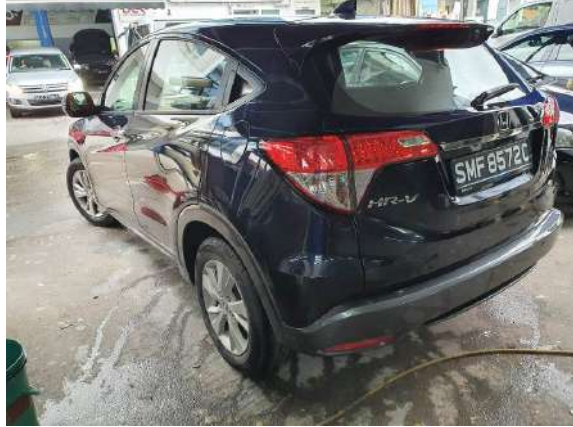
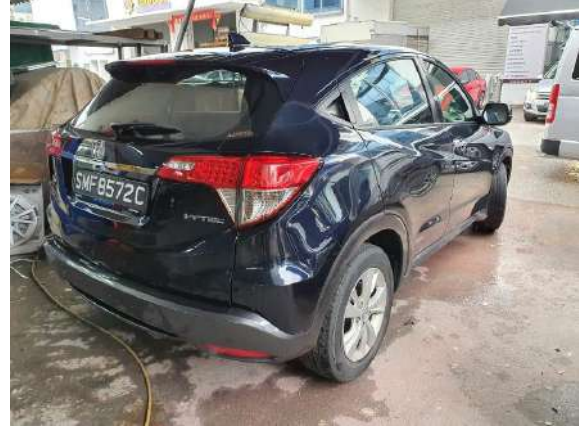
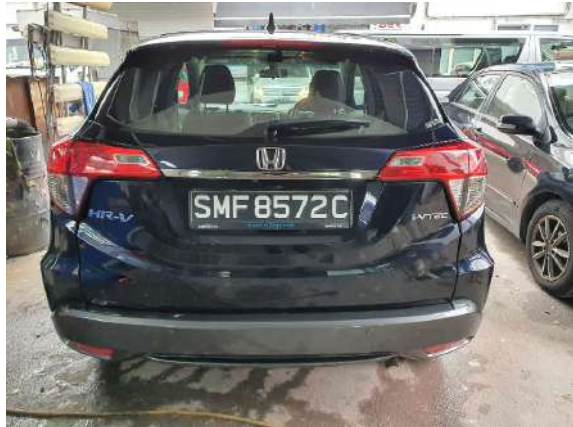
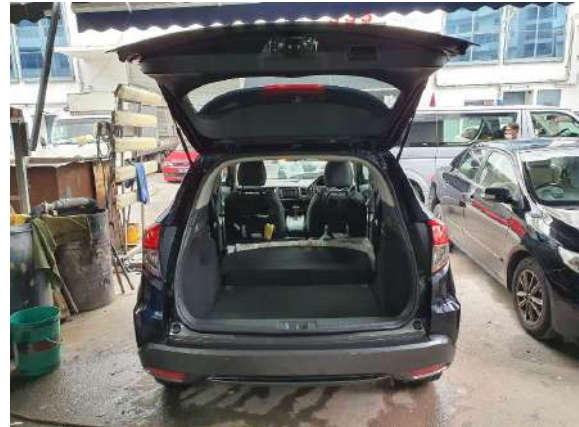
**PHOTOGRAPHS FOR VEHICLE NO. SMF 8572C**

**RE-INSPECTION**
