Vehicle No. SMN 3363E  
Insured Veh. SBS 3352R  
Claim No. D21002227MFBP/1  
Policy No. D-21097502MFBP  
Accident Date 17/07/2021  
Inspection Date 04/08/2021

## ADJUSTMENT ON REPAIR COST FOR VEHICLE NO. SMN 3363E

PHOTOGRAPHS FOR VEHICLE NO. SMN 3363E

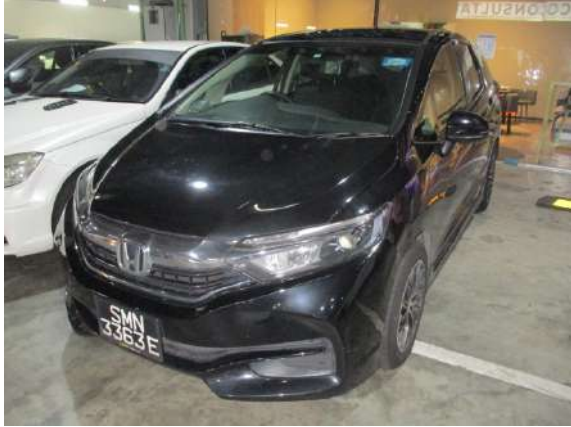
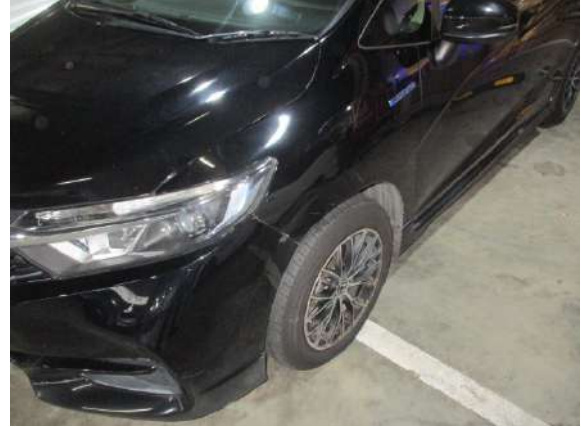
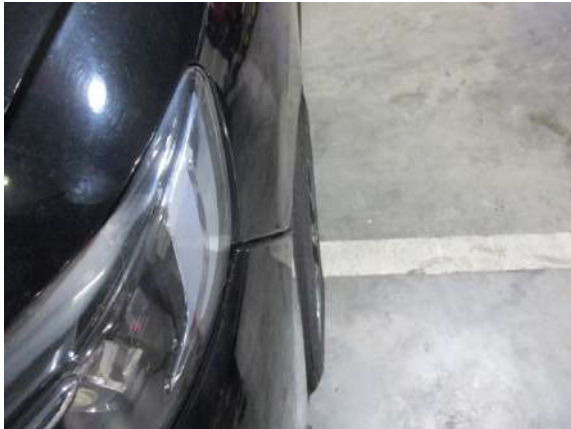
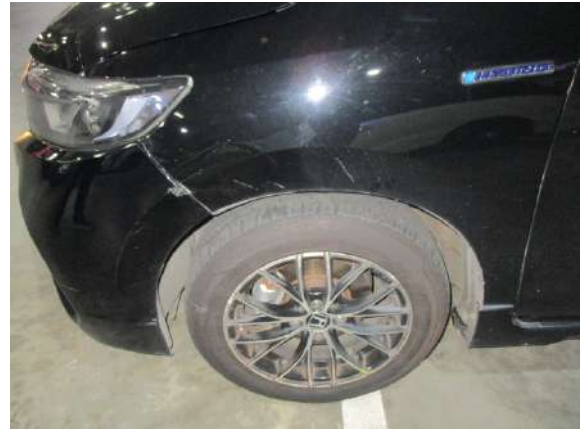
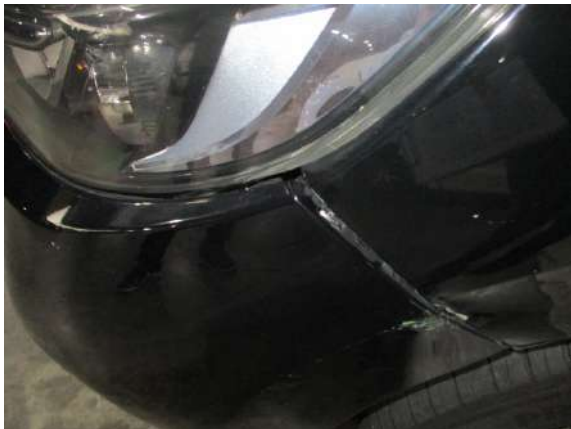
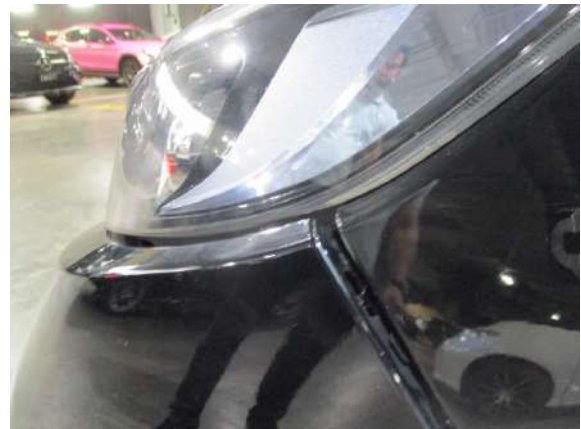
INSPECTION

| Affiliated to Federation Internationale Des Experts En Automobile | | | | |
|---|---|---|---|--|
| THE VEHICLE SUSTAINED DAMAGES AT THE N/S FRONT PORTION.THE UNDERCARRIAGE AFFECTED DUE TO COLLISION.<br><br>DAMAGES SEE DETAILS. | | | | |

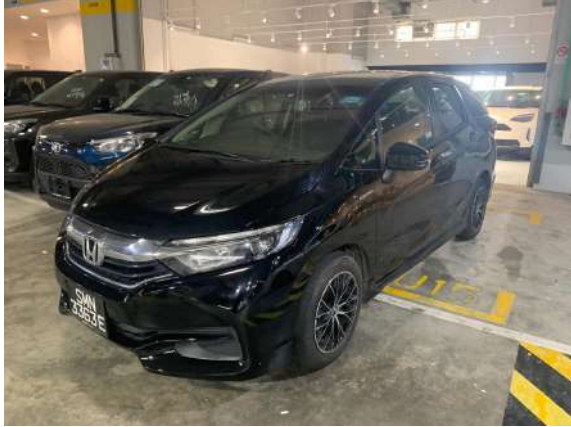
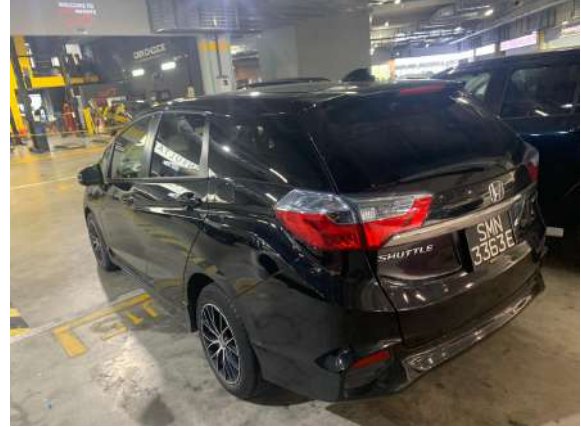
**PHOTOGRAPHS FOR VEHICLE NO. SMN 3363E**

**RE-INSPECTION**
