## LKK Auto Consultants Pte Ltd

Vehicle No. SKQ 505R  
Insured Veh. YN 5612G  
Claim No. D21002202MFCV  
Policy No.  
Accident Date 29/07/2021  
Inspection Date 11/08/2021

## ADJUSTMENT ON REPAIR COST FOR VEHICLE NO. SKQ 505R

### PHOTOGRAPHS FOR VEHICLE NO. SKQ 505R

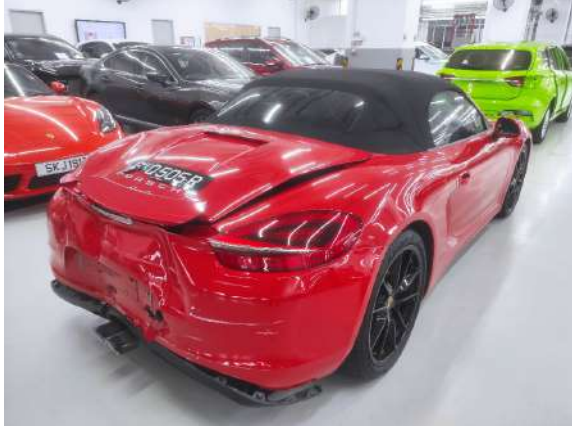
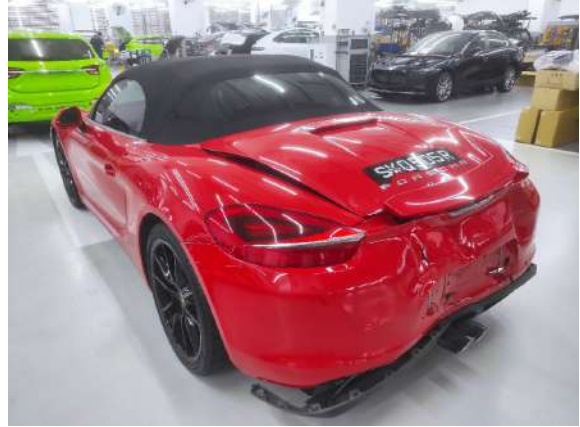
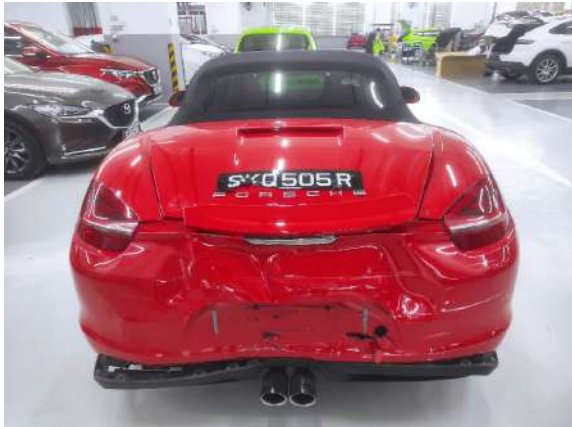
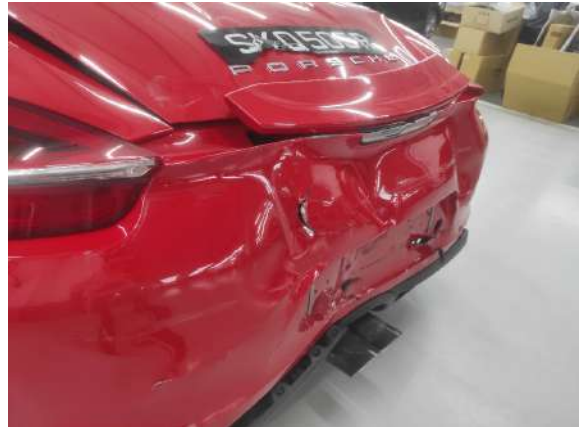
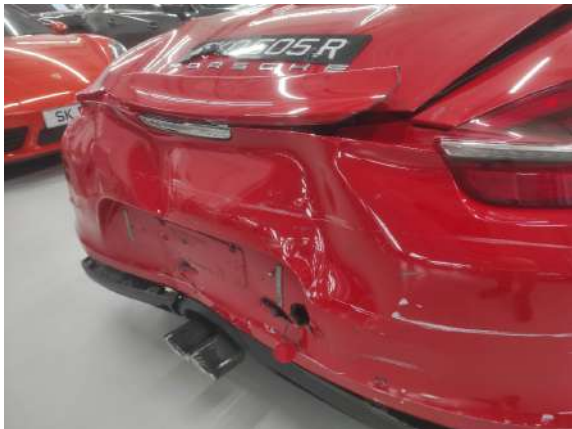
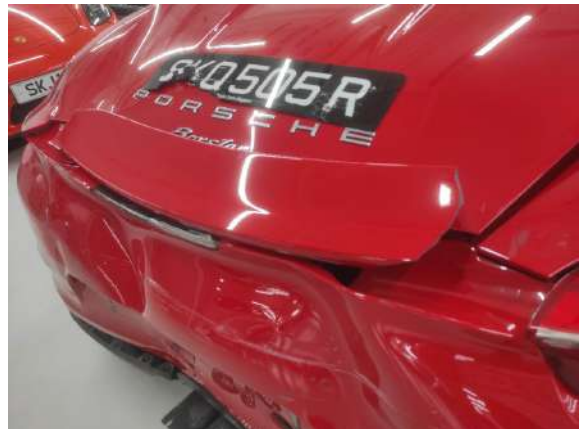
### INSPECTION

| Affiliated to Federation Internationale Des Experts En Automobile | | | | |
|---|---|---|---|--|
| THE VEHICLE SUSTAINED DAMAGES AT THE FRONT & REAR PORTION.<br><br>DAMAGES SEE DETAILS. | | | | |
