PRIORITY SERVICES (SG) PTE LTD

Vehicle Inspection Report

PARTICULARS OF DAMAGED VEHICLE

Registration Plate No	: SLW 9181 M	Odometer Reading	: 66108 km
Make / Model	: Honda Vezel (A)	Radio / CD	: Yes
Year	: 2018	Air-conditioner	: Yes
Colour	: Pearl White	Wing Mirror	: Yes
Engine Capacity	: 1496 cc	View Cam	: Yes
Engine No	: -	Seat Belts	: Yes
Chassis / Frame No	: RU11231990	Accessories	: -
Carrying Capacity	: 4

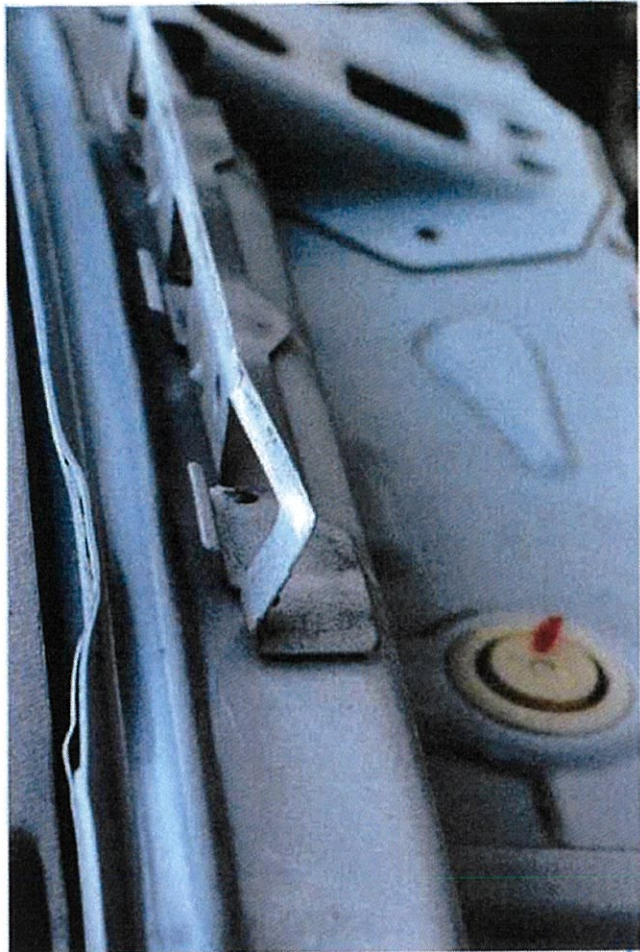
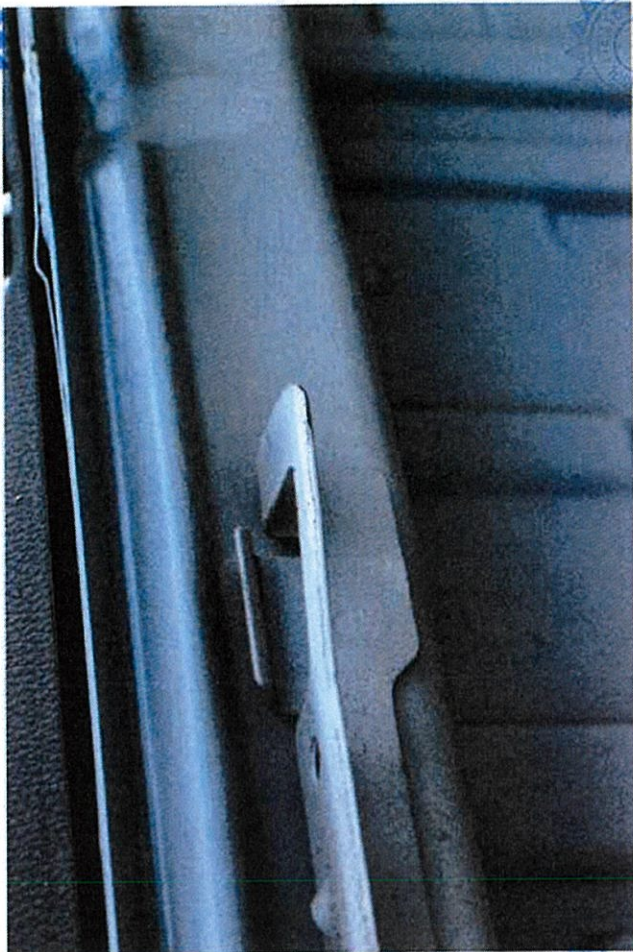
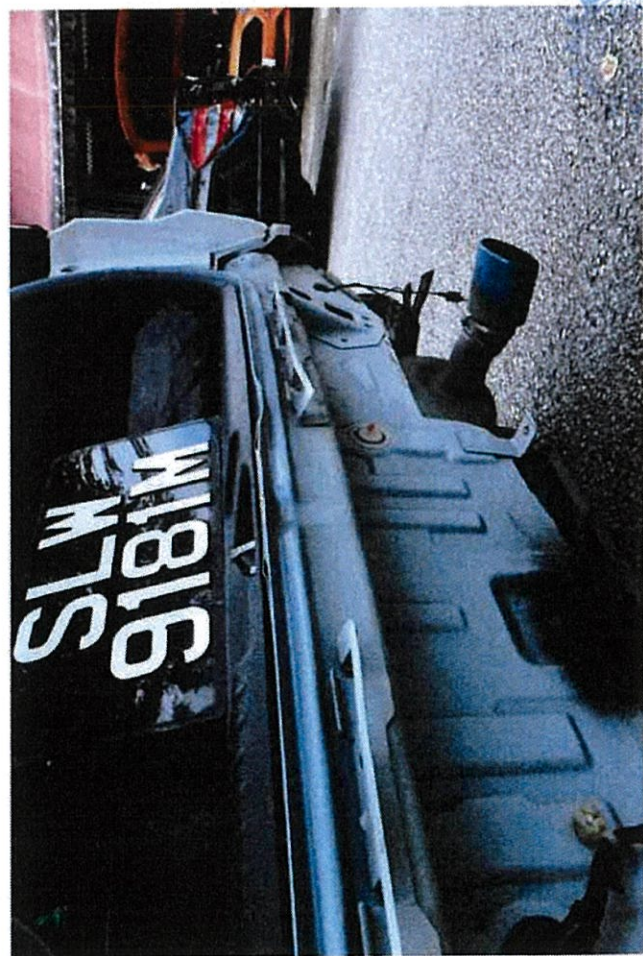
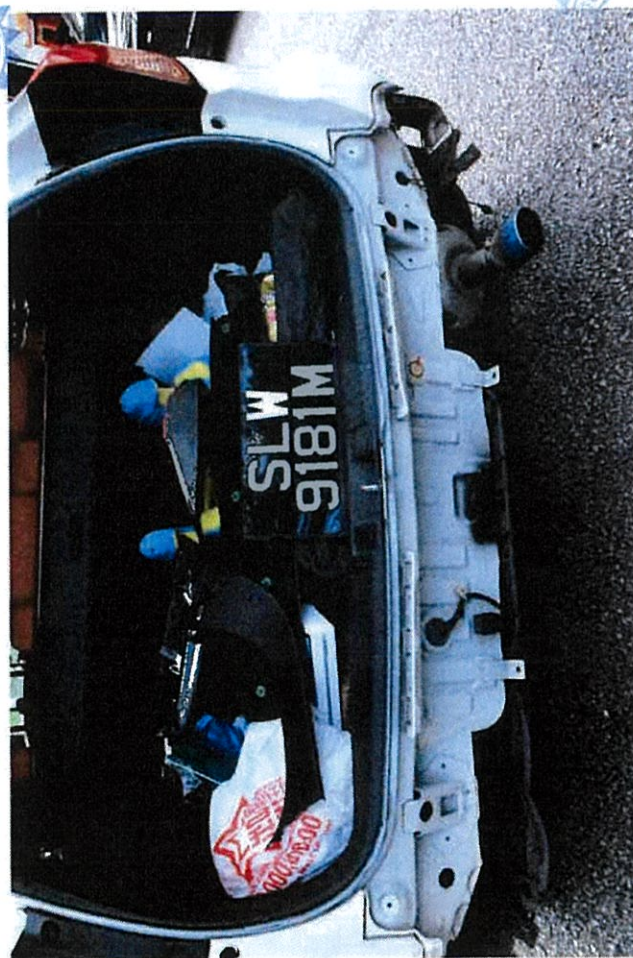
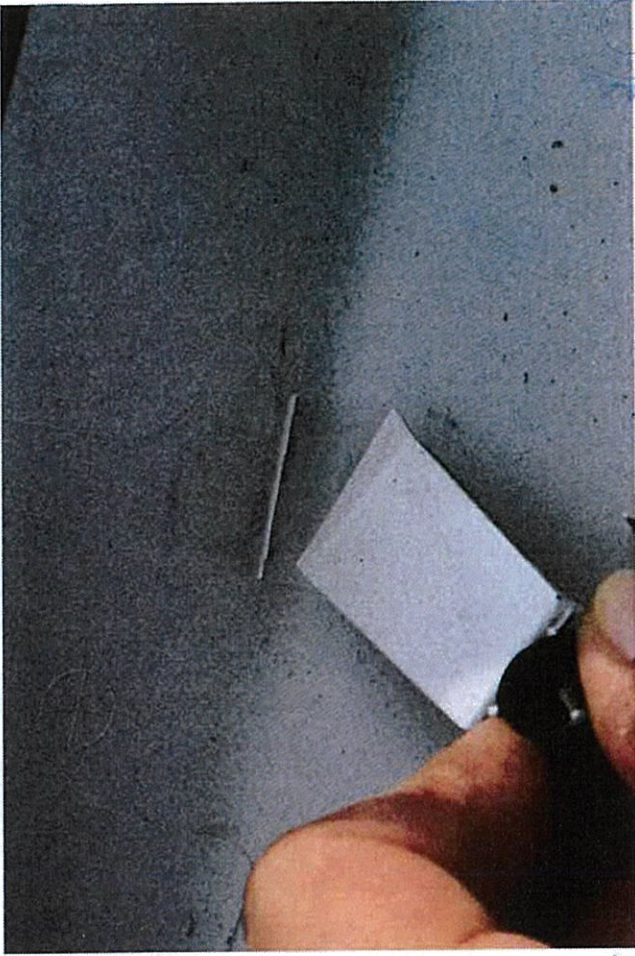
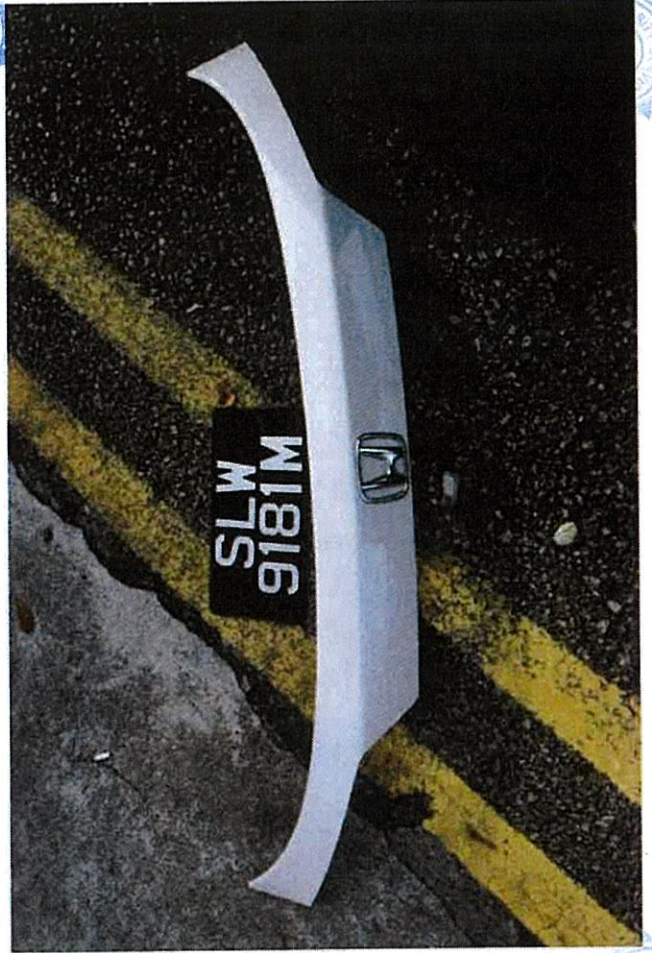
Encl. Photographs of the damaged vehicle taken by us during inspection.

Other parts were also found damaged. (see schedule for details)
