Vehicle No. GBD 410E  
Insured Veh. SMW 6984X  
Claim No. SNM21D204178  
Policy No. DMPCSNW00011482100  
Accident Date 27/07/2021  
Inspection Date 11/08/2021

# LKK Auto Consultants Pte Ltd

## ADJUSTMENT ON REPAIR COST FOR VEHICLE NO. GBD 410E

### PHOTOGRAPHS FOR VEHICLE NO. GBD 410E

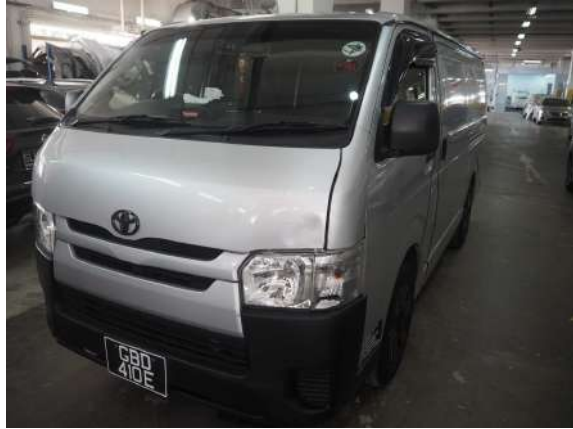
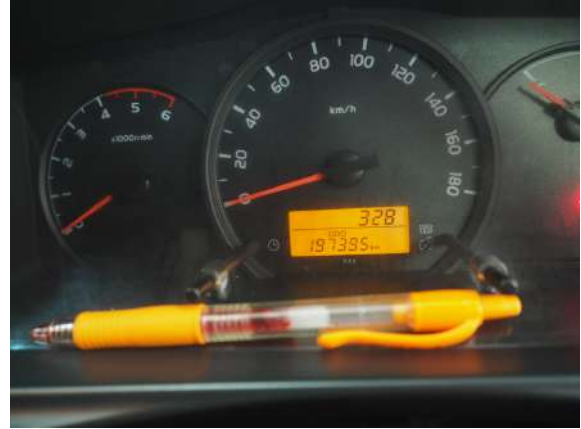
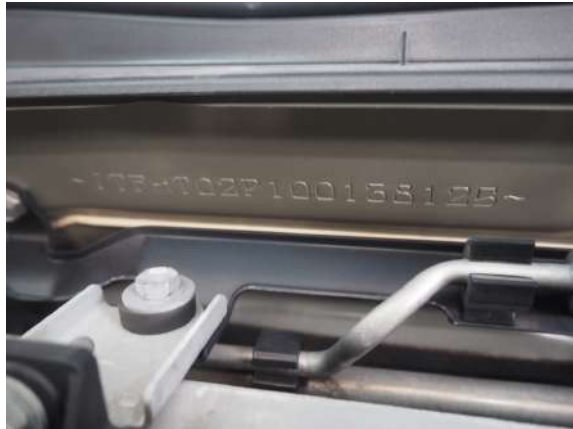
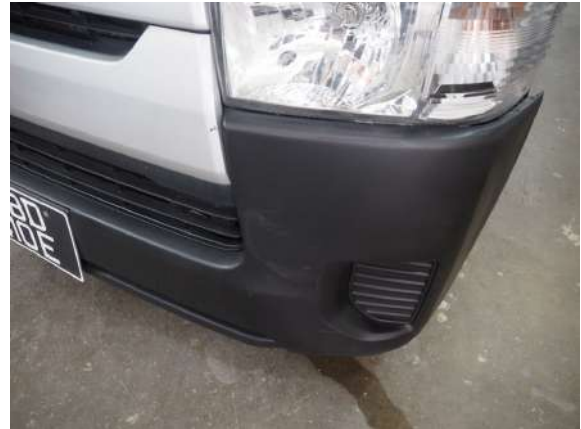
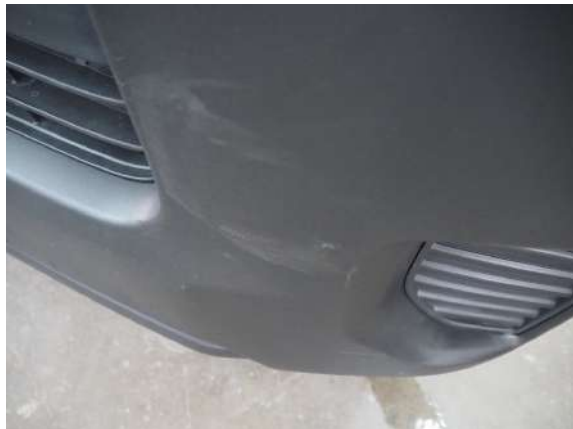
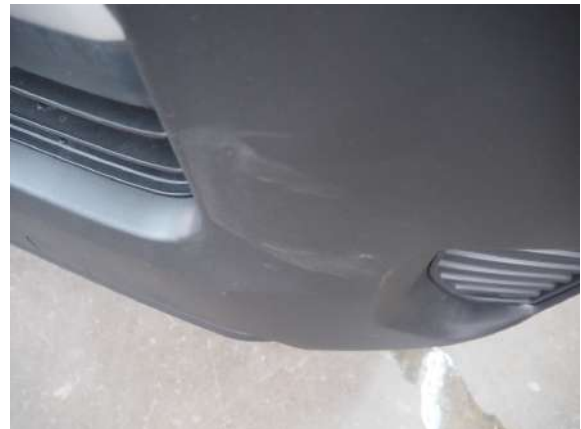
### INSPECTION

| Affiliated to Federation Internationale Des Experts En Automobile | | | | |
|---|---|---|---|--|
| THE VEHICLE SUSTAINED DAMAGES AT THE FRONT N/S PORTION.<br><br>DAMAGES SEE DETAILS. | | | | |

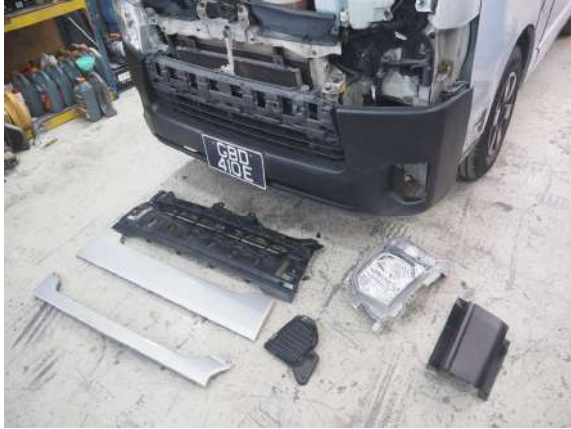
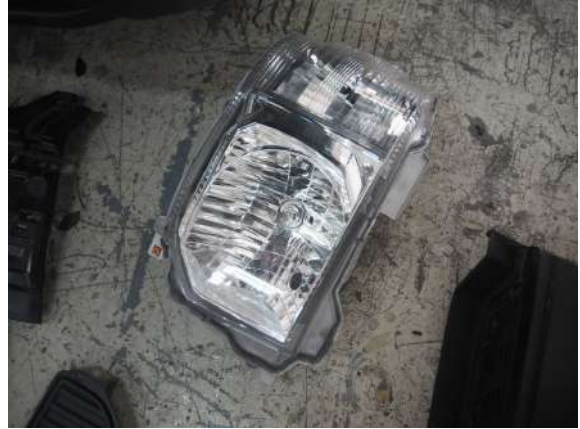
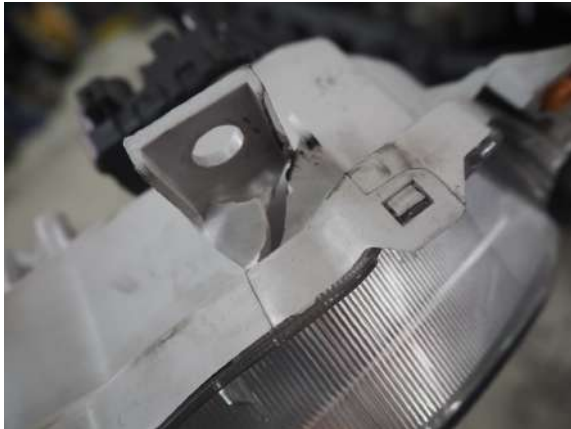
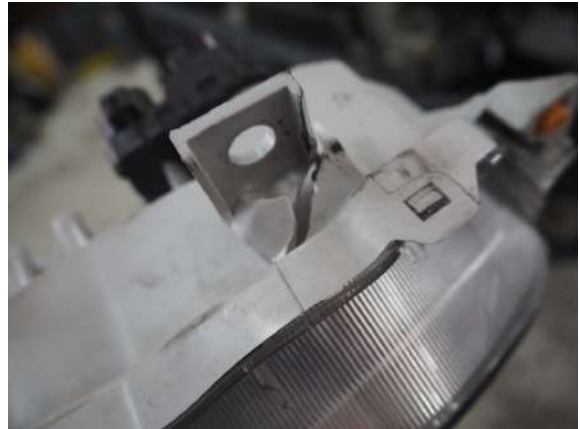
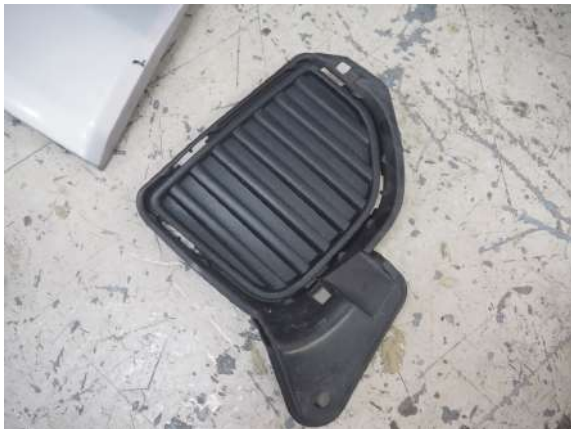
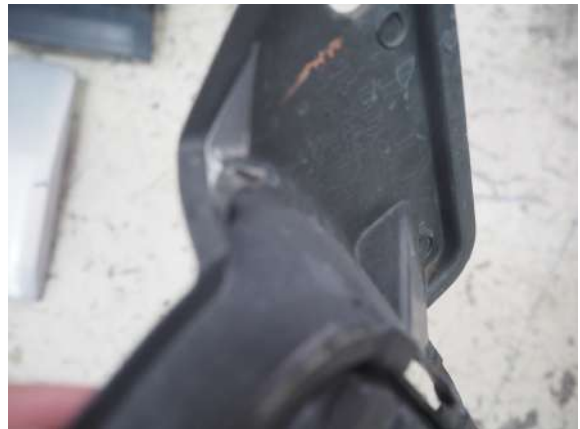
**RE-INSPECTION**

**PHOTOGRAPHS FOR VEHICLE NO. GBD 410E**
