Report No: 0135-20-TCA

ACCIDENT VEHICLE SURVEY REPORT

<i>Vehicle Reg No.:</i>	SJU3505L	<i>Odometer:</i>	102782km
<i>Make & Model:</i>	Toyota Wish 2.0 A	<i>Colour:</i>	Silver
<i>Chassis number:</i>	JTDGJ20W405001456	<i>Date of accident:</i>	08/10/2019
<i>Year of Regn.:</i>	30/11/2009	<i>Date inspected:</i>	10/10/2019
<i>Repairer at:</i>	Twincar Automotive Pte Ltd 2 Kaki Bukit Ave 2 #01-17 Kaki Bukit Auto Hub Singapore 417921	<i>Date inspected (After Repair):</i>	15/10/2019

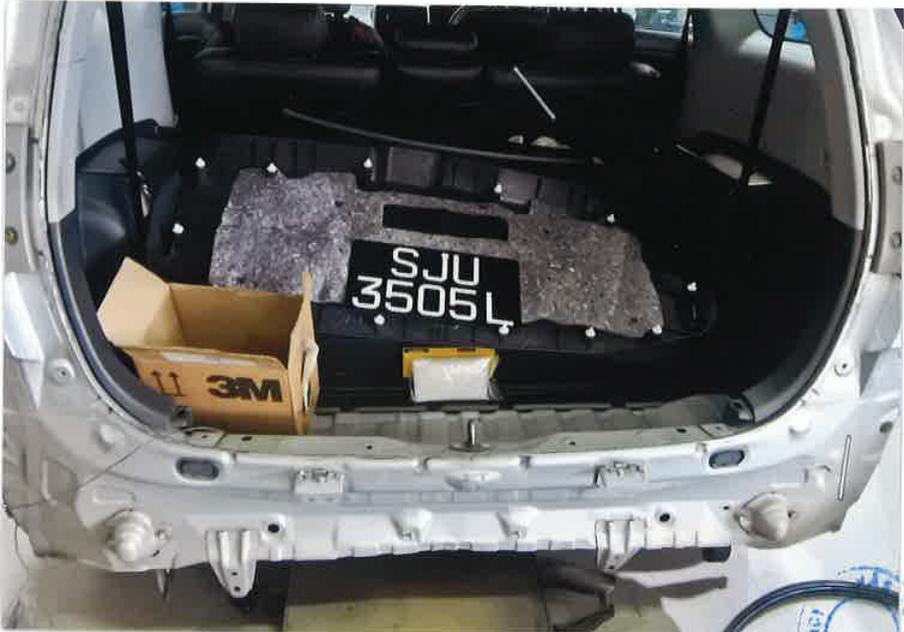
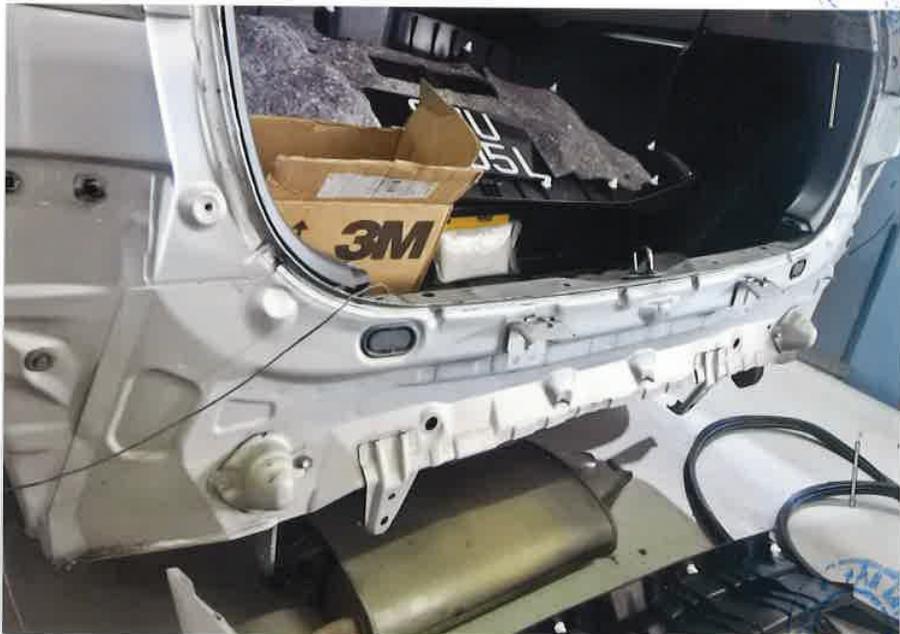
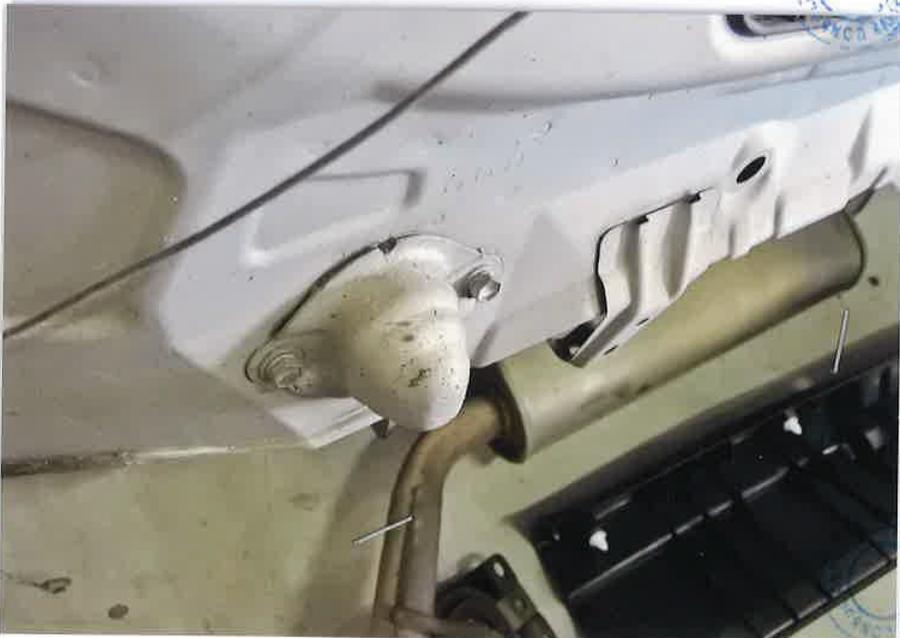
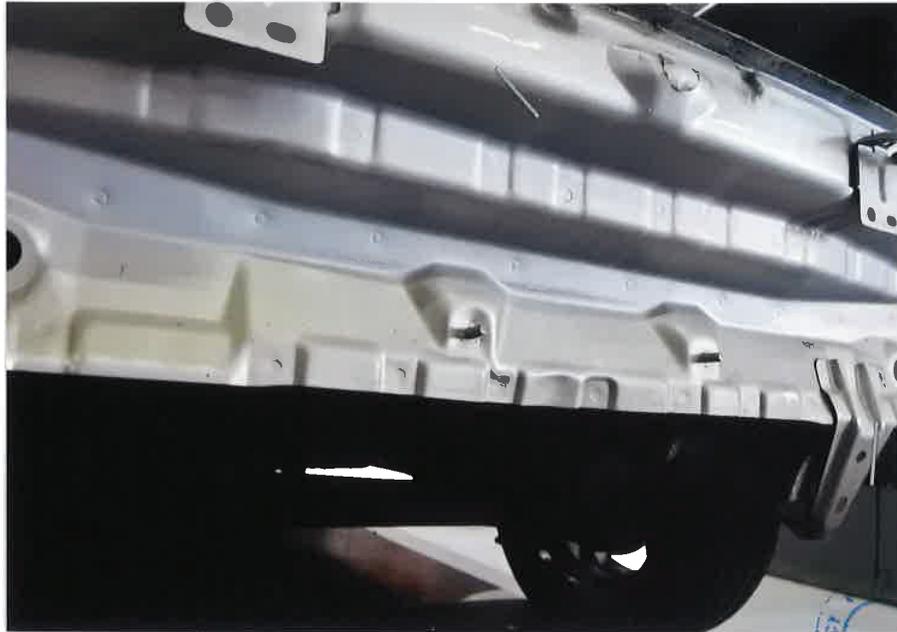
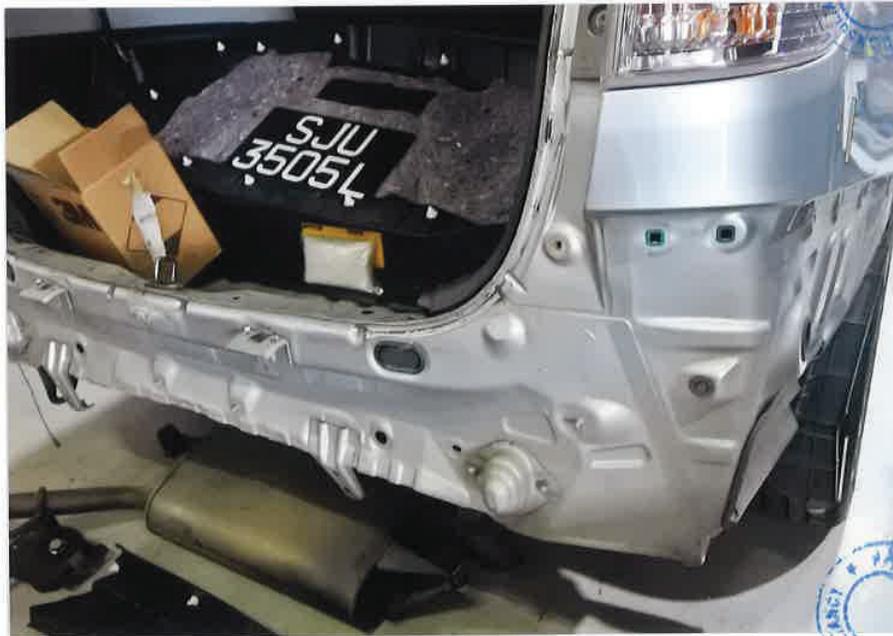
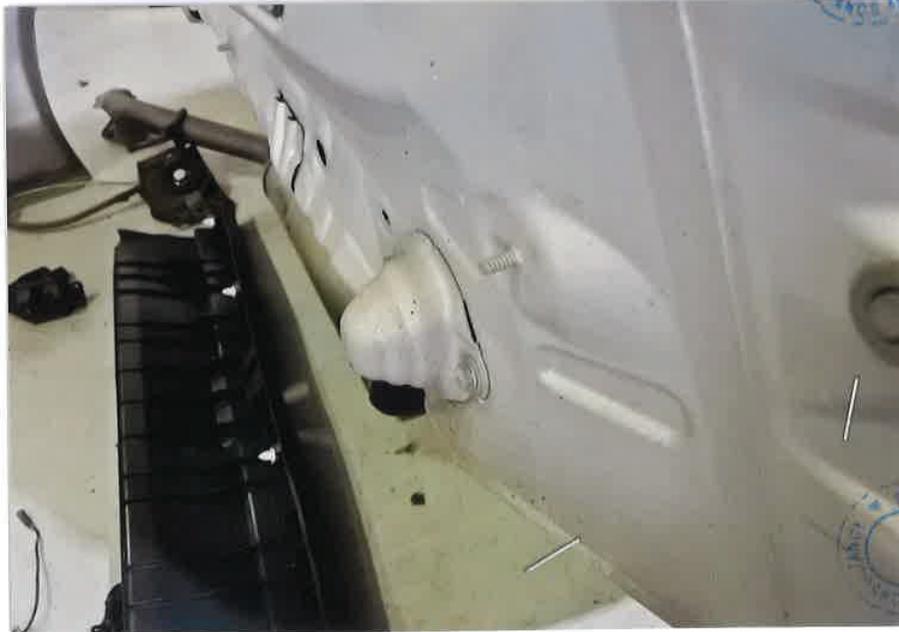
We had carried out re-inspection during works in progress and post repair inspection on the above vehicle. Attached in Annex B are the re-inspection photos, showing the work in progress and our re-inspection to the hidden part that were damaged.
