Vehicle No. GBB 1888P  
Insured Veh. SJY 6821H  
Claim No. SNM21D204679/C02  
Policy No. DMPCSNW00045322105  
Accident Date 21/08/2021  
Inspection Date 24/08/2021

## ADJUSTMENT ON REPAIR COST FOR VEHICLE NO. GBB 1888P

PHOTOGRAPHS FOR VEHICLE NO. GBB 1888P

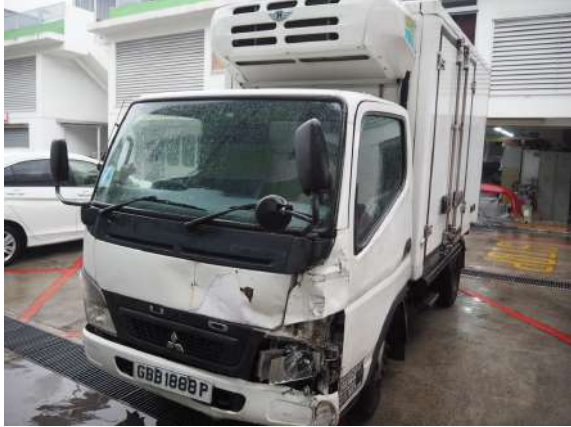
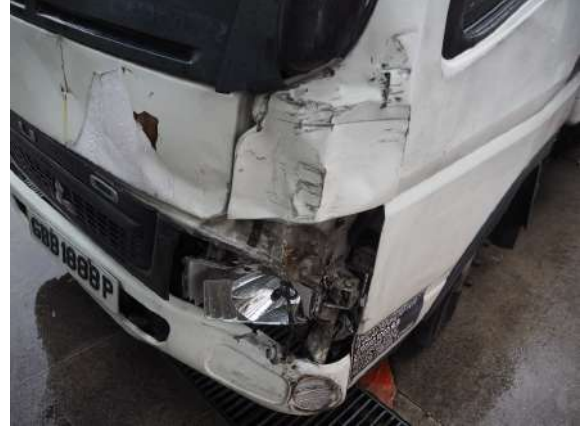
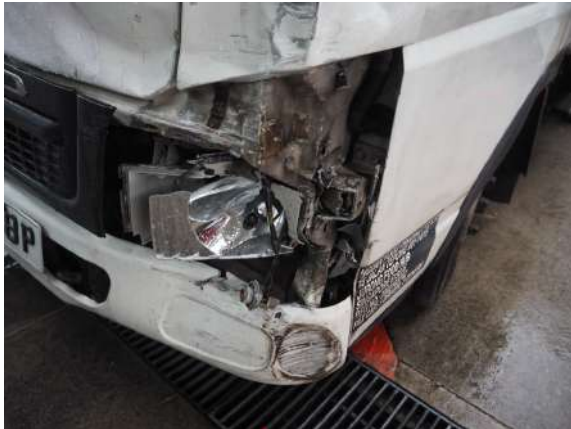
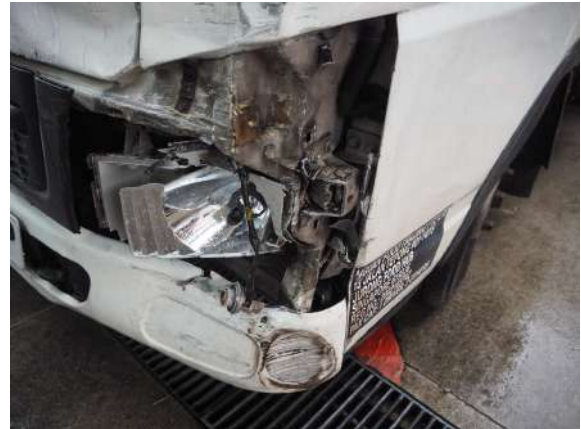
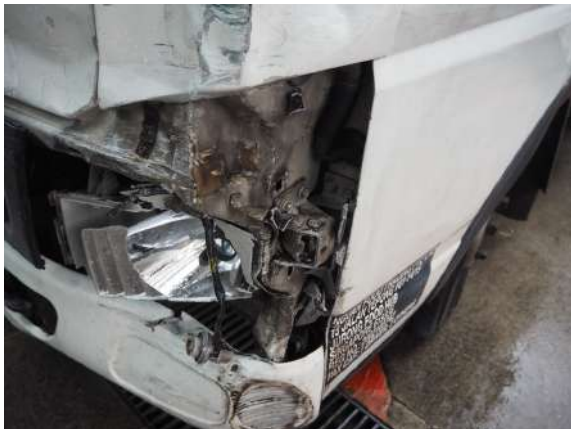
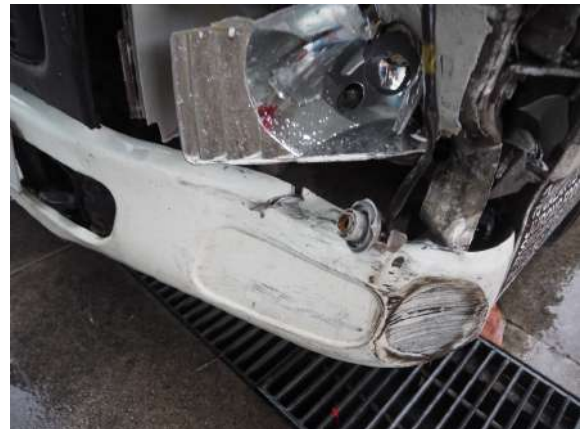
| Affiliated to Federation Internationale Des Experts En Automobile | | | | |
|---|---|---|---|--|
| | THE VEHICLE SUSTAINED DAMAGES AT THE FRONT N/S PORTION.<br>DAMAGES SEE DETAILS. | | | |

INSPECTION

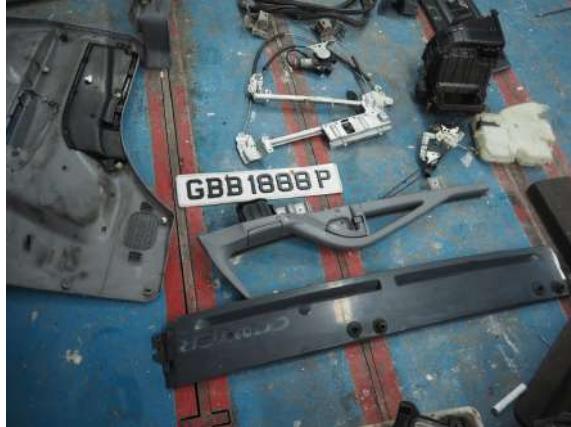
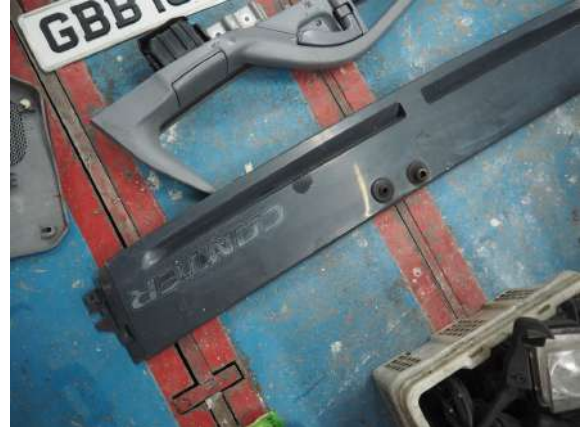
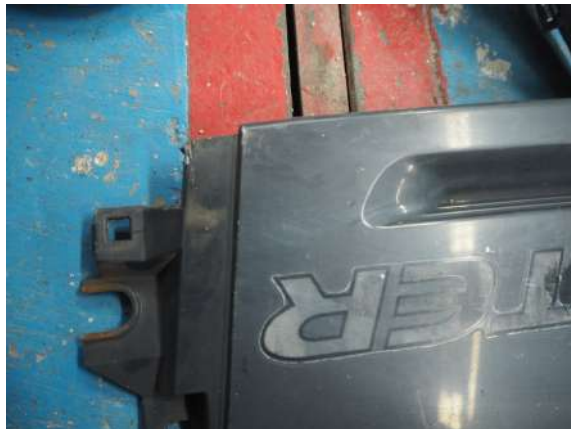
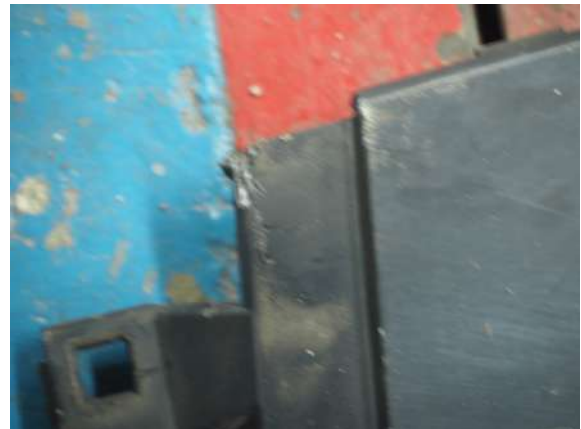
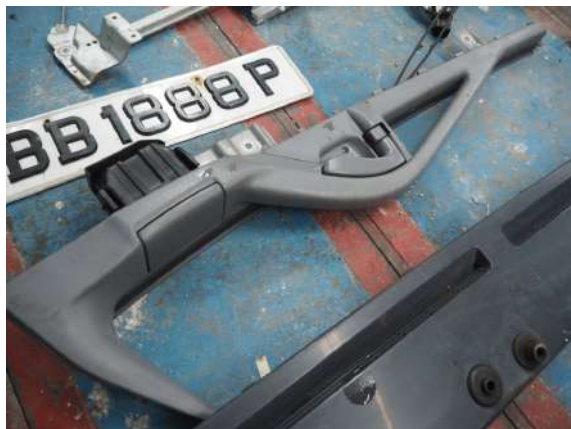
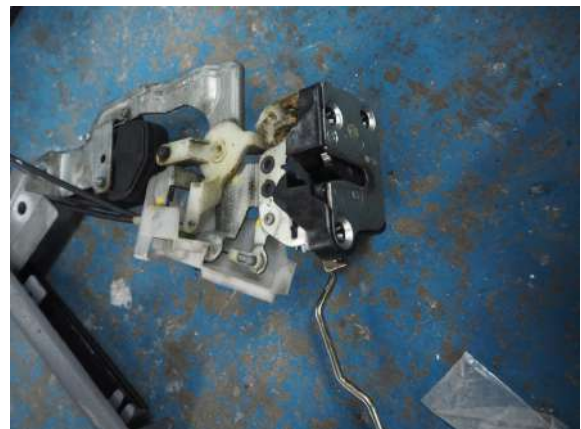
PHOTOGRAPHS FOR VEHICLE NO. GBB 1888P

RE-INSPECTION
