Vehicle No. SHA 9498M  
Insured Veh. SLD 4343X  
Claim No. SNM21D204800/C02  
Policy No. DMHCSNW00008372001  
Accident Date 26/08/2021  
Inspection Date 27/08/2021

## ADJUSTMENT ON REPAIR COST FOR VEHICLE NO. SHA 9498M

### PHOTOGRAPHS FOR VEHICLE NO. SHA 9498M

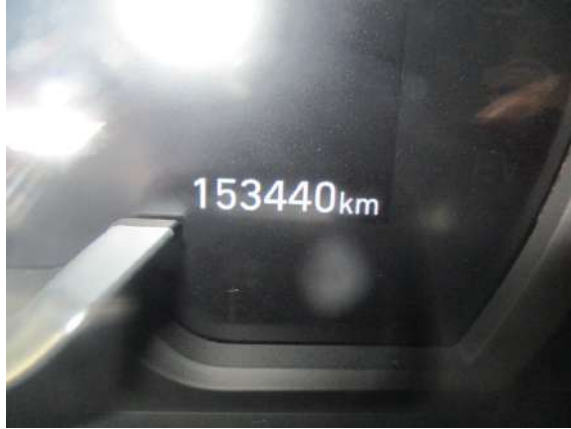
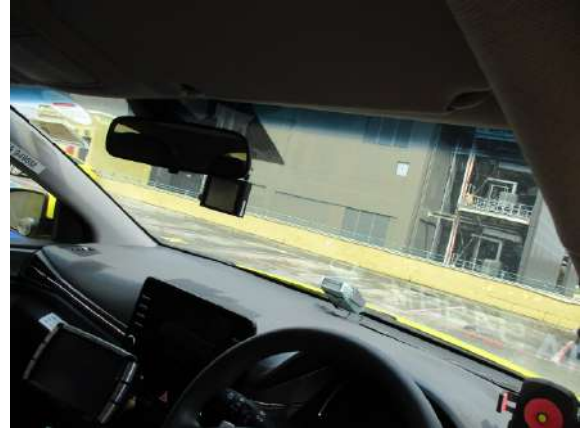
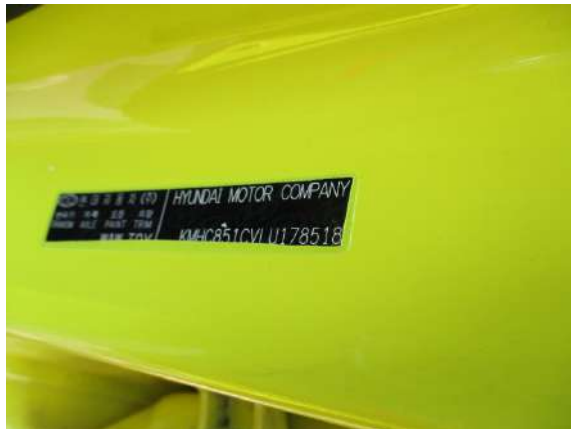
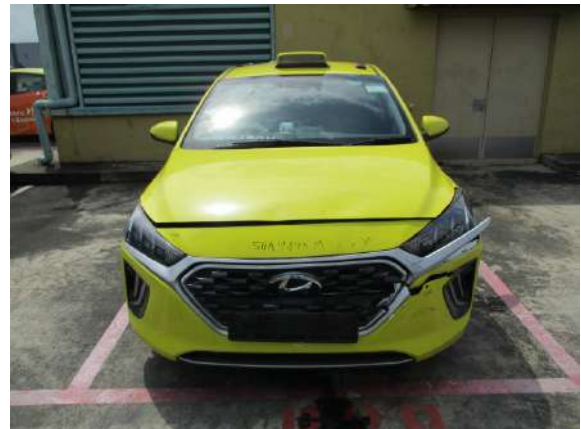
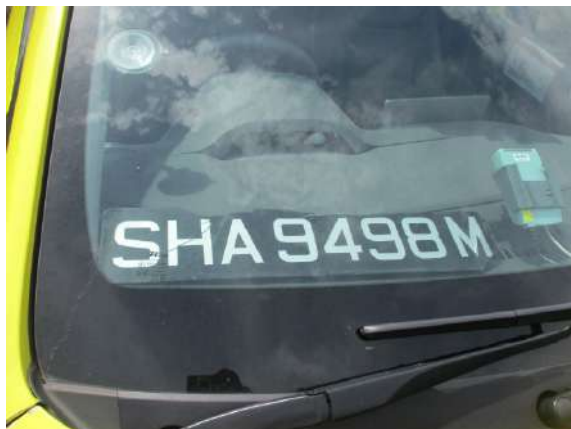
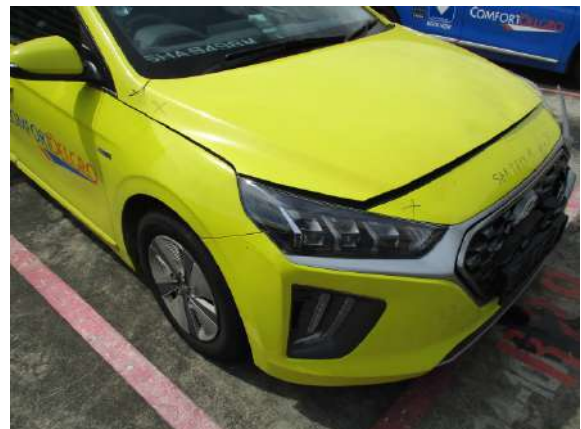
### INSPECTION

| Affiliated to Federation Internationale Des Experts En Automobile | | | | |
|---|---|---|---|--|
| THE VEHICLE SUSTAINED DAMAGES AT THE FRONT AND REAR PORTION.<br><br>DAMAGES SEE DETAILS. | | | | |
