# LKK Auto Consultants Pte Ltd

### 1. Policy Particulars :- THIRD PARTY CLAIM

### 4. Description of Damages

## ADJUSTMENT ON REPAIR COST FOR VEHICLE NO. SHC 4644E

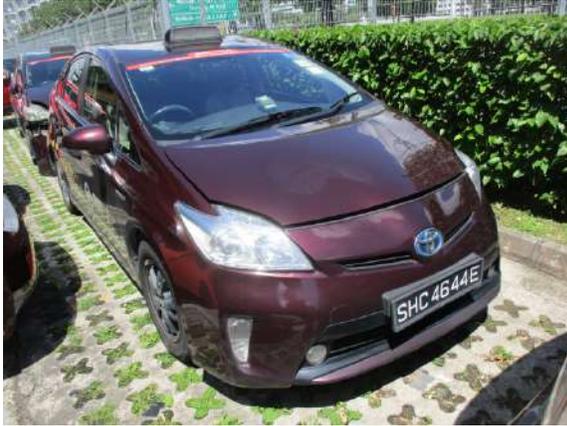
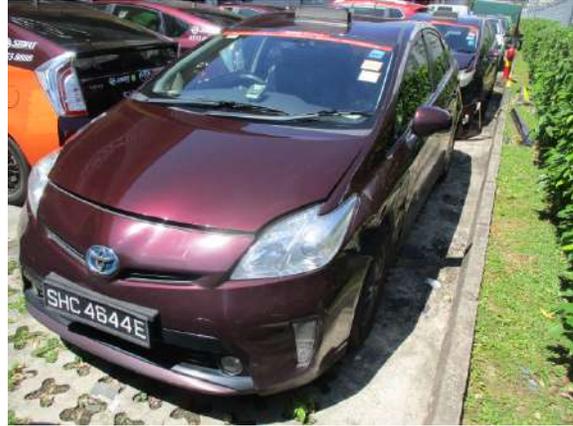
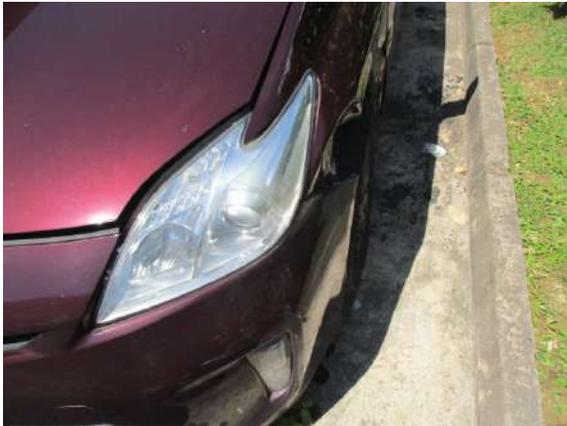
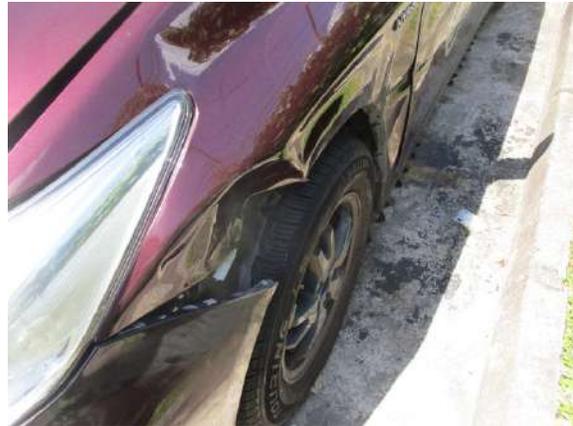
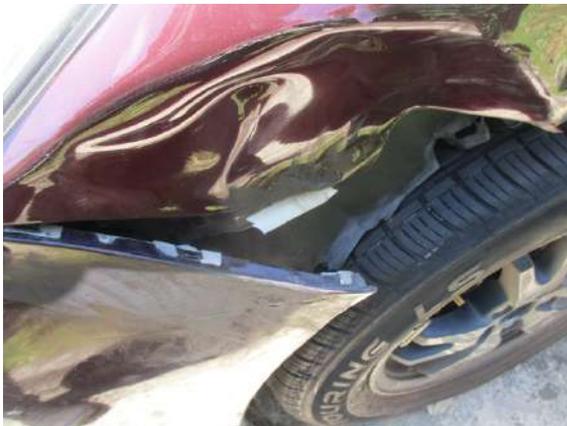
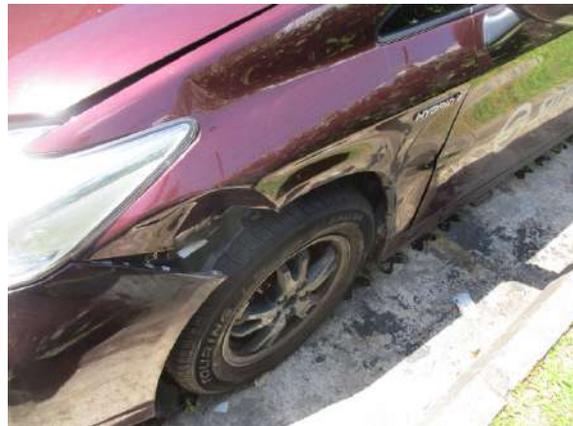
PHOTOGRAPHS FOR VEHICLE NO. SHC 4644E

INSPECTION

THE VEHICLE SUSTAINED DAMAGES AT THE N/S BODY.THE UNDERCARRIAGE AFFECTED DUE TO COLLISION.

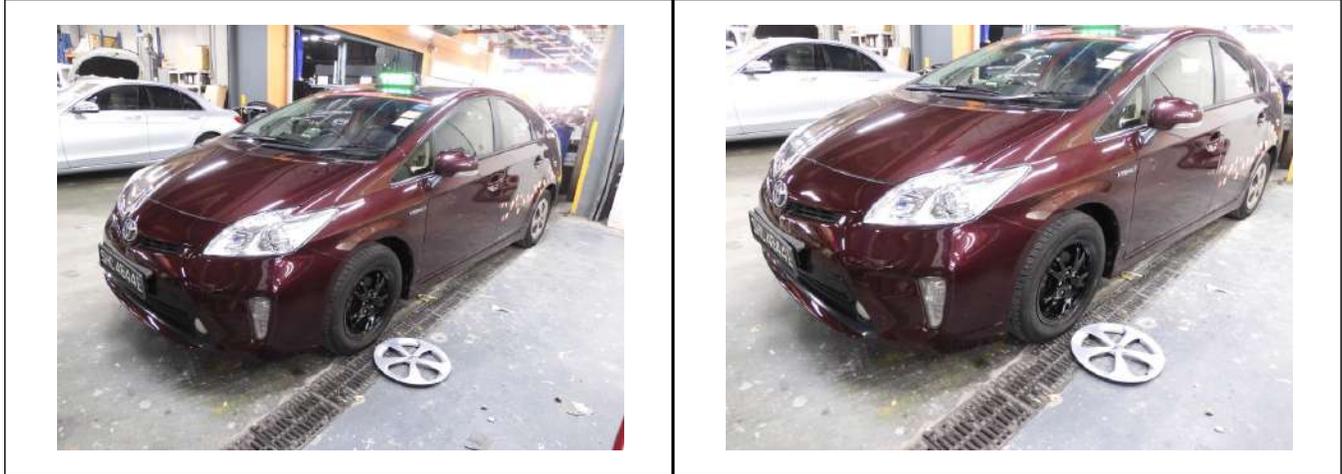
**PHOTOGRAPHS FOR VEHICLE NO. SHC 4644E**

**RE-INSPECTION**
