AUTOMOTIVE APPRAISER AND SURVEYING SERVICES

VEHICLE INSPECTION REPORT

To: Tong Heng Motor Work Report No : TP/0026/08/2021
Block 6, # 01-26
Kranji Loop
Singapore 739542 Date : 30 August 2021

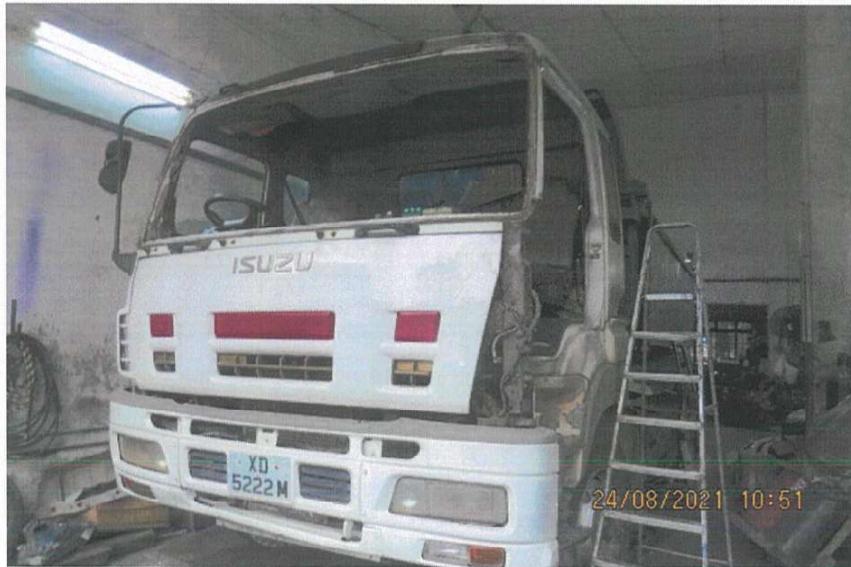
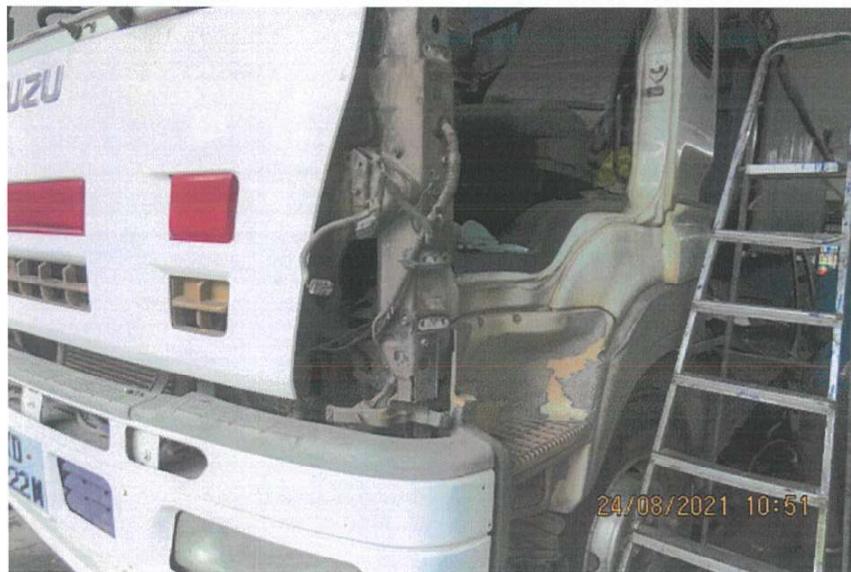
Photographs: **FOLLOW-UP SURVEYED PHOTOGRAPHS** Attachment to report no. TP/0026/08/2021
(After Dismantling And Damaged Parts)

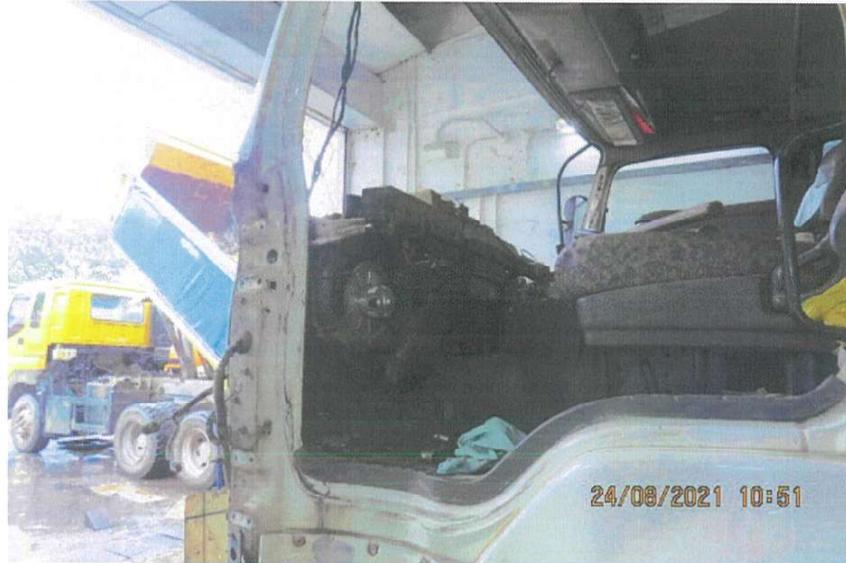
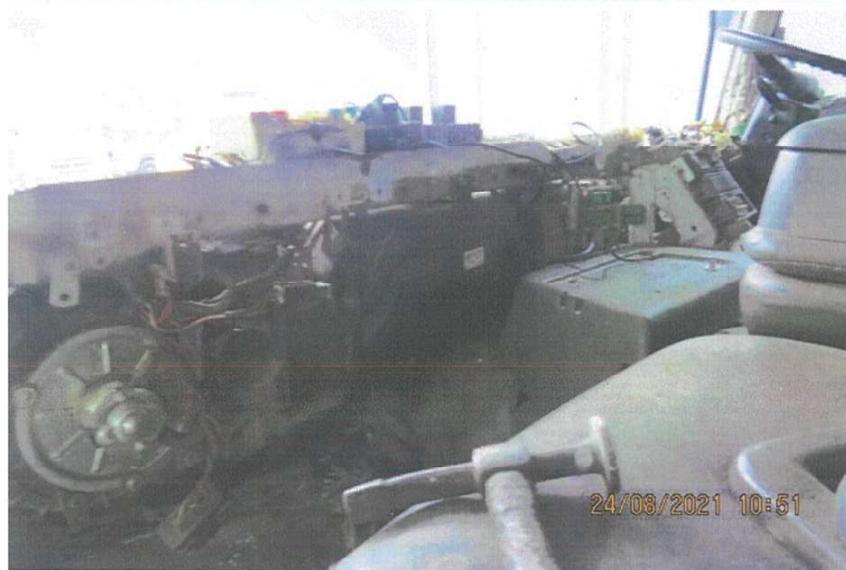
Photographs: FOLLOW-UP SURVEYED PHOTOGRAPHS Attachment to report no. TP/0026/08/2021
(After Dismantling And Damaged Parts)

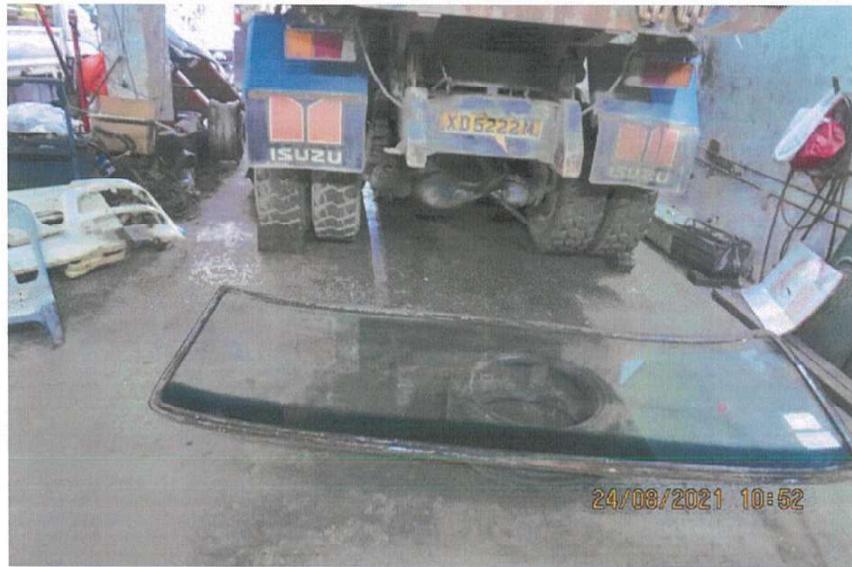
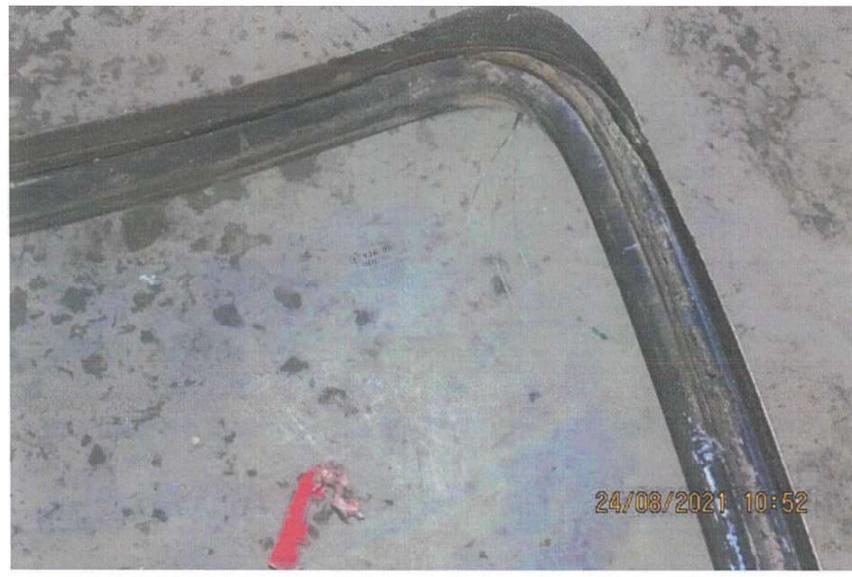
Photographs: FOLLOW-UP SURVEYED PHOTOGRAPHS Attachment to report no. TP/0026/08/2021
(After Dismantling And Damaged Parts)

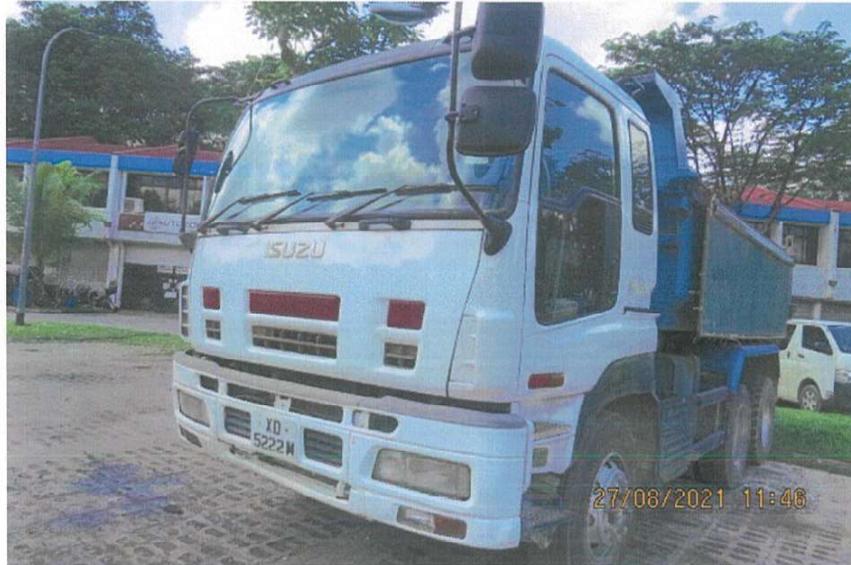
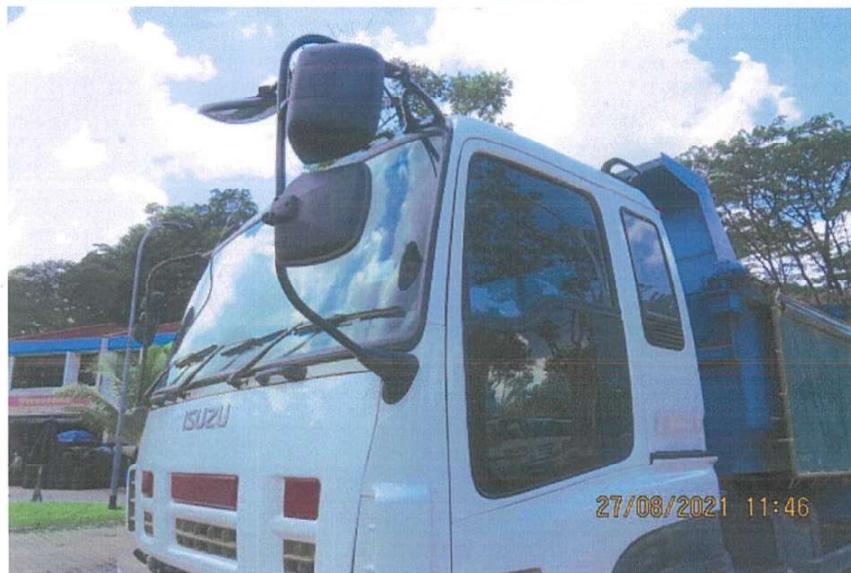
Photographs: FOLLOW-UP SURVEYED PHOTOGRAPHS Attachment to report no. TP/0026/08/2021
(After Repair/Painting)

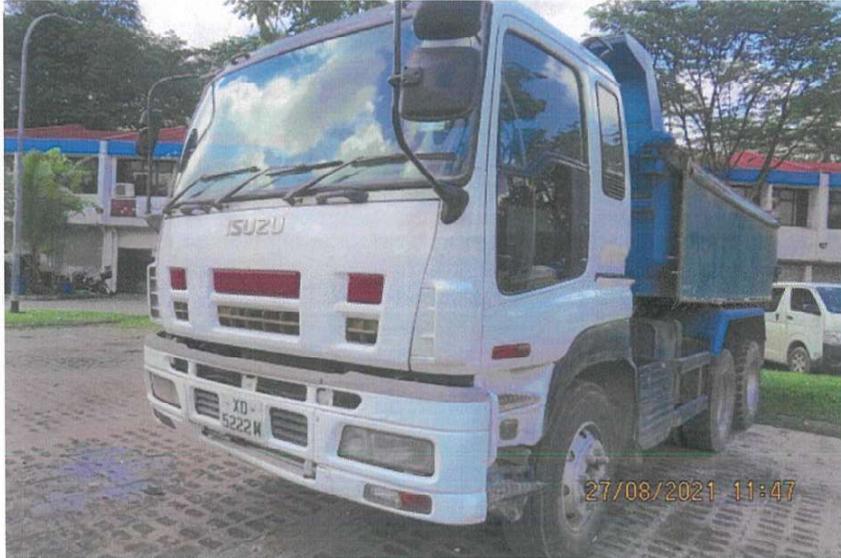
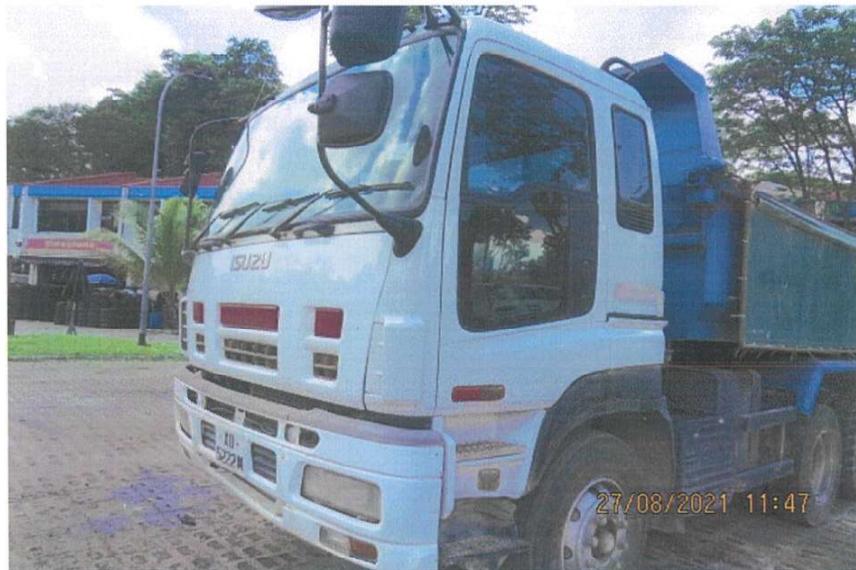
Photographs: **FOLLOW-UP SURVEYED PHOTOGRAPHS** Attachment to report no. TP/0026/08/2021
(After Repair/Painting)

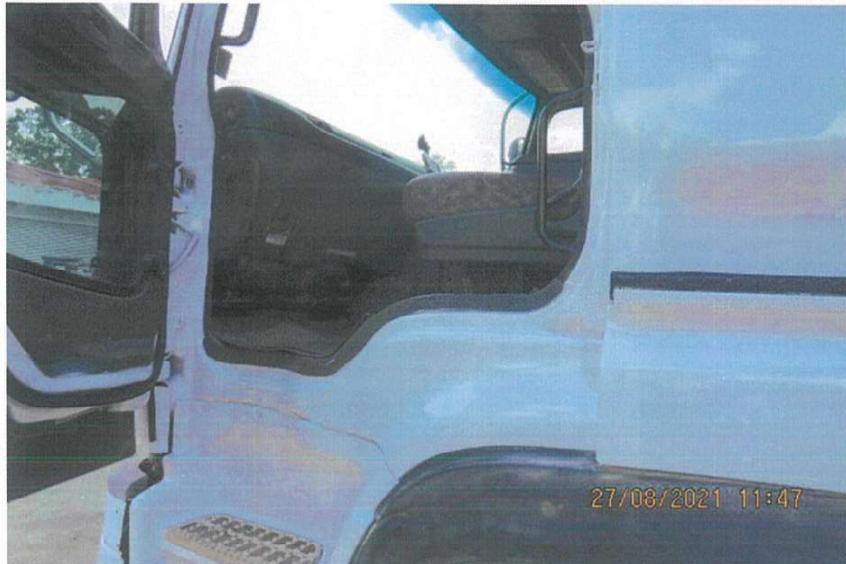
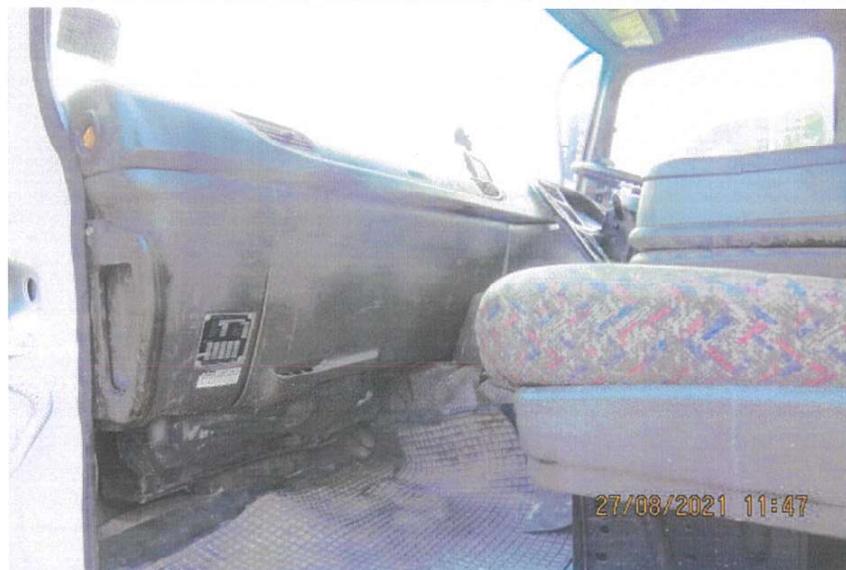
Photographs: FOLLOW-UP SURVEYED PHOTOGRAPHS Attachment to report no. TP/0026/08/2021
(After Repair/Painting)
