## LKK Auto Consultants Pte Ltd

## ADJUSTMENT ON REPAIR COST FOR VEHICLE NO. GBE 5293M

### PHOTOGRAPHS FOR VEHICLE NO. GBE 5293M

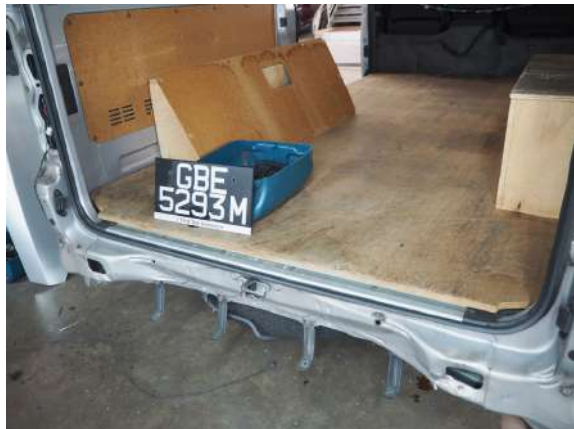
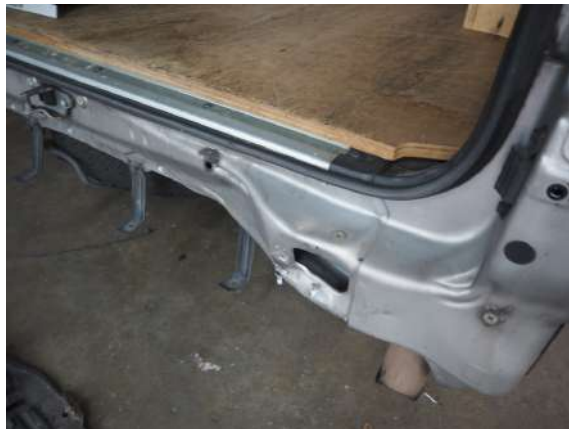
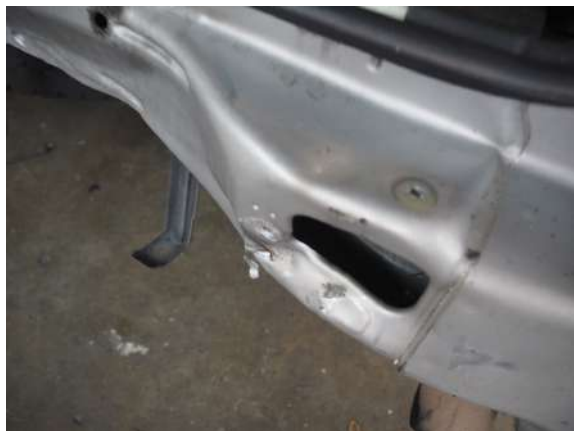
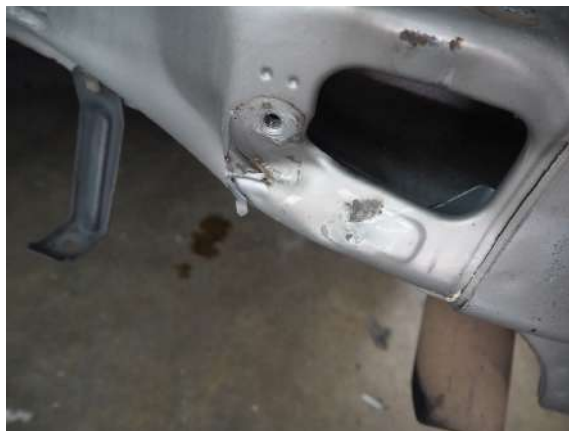
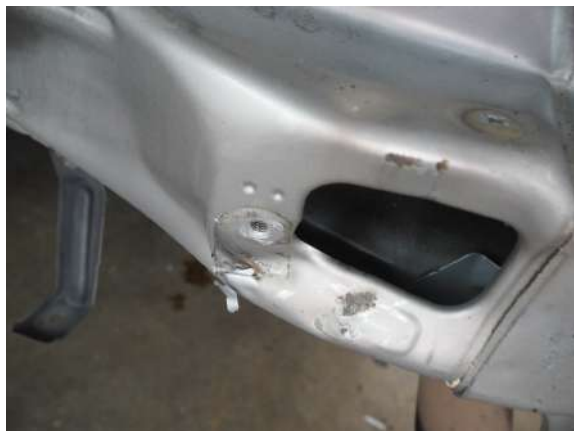
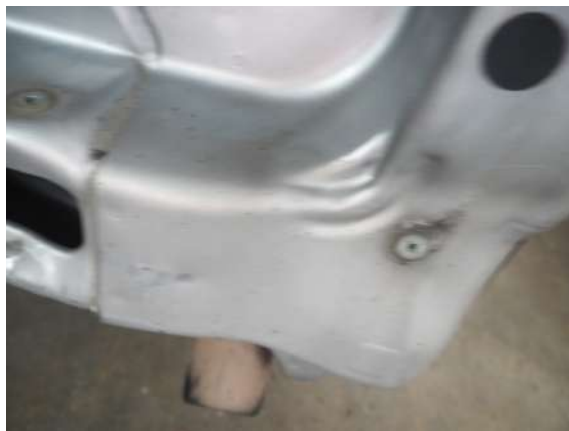
PHOTOGRAPHS FOR VEHICLE NO. GBE 5293M

| Affiliated to Federation Internationale Des Experts En Automobile | | | | |
|---|---|---|---|--|
| THE VEHICLE SUSTAINED DAMAGES AT THE REAR PORTION.<br><br>DAMAGES SEE DETAILS. | | | | |

RE-INSPECTION
