## **ACCIDENT VEHICLE INSPECTION REPORT**

Report no : 273M0821.UEM  
Vehicle no : SGT3380U

Make/model : **HONDA CITY CVT**  
Chassis no : MRHGD86907P030111  
Engine no : L15A25801199  
Date of registration : 09 April 2007 COE Expiry Date: 8 April 2022  
Engine capacity : 1497 cc  
Colour : Black

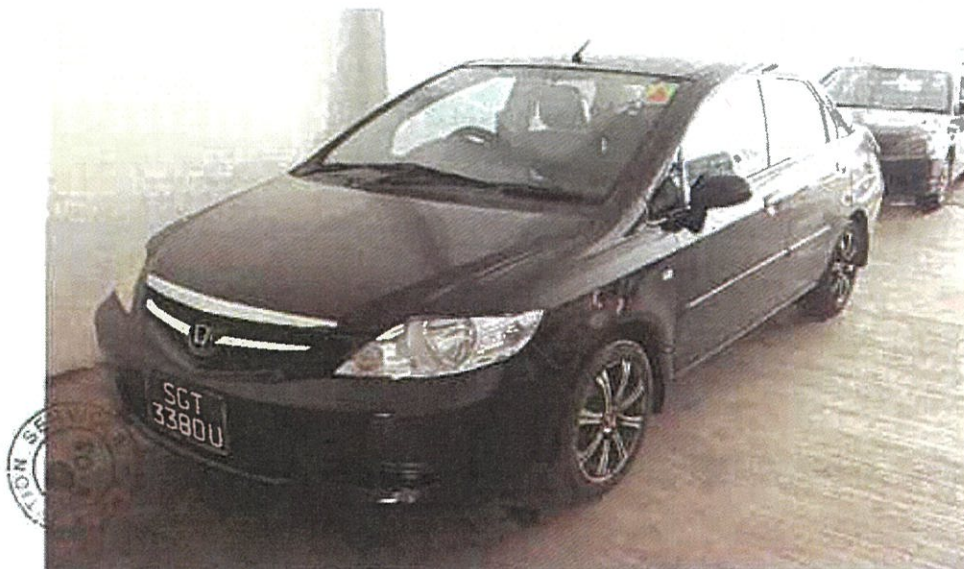
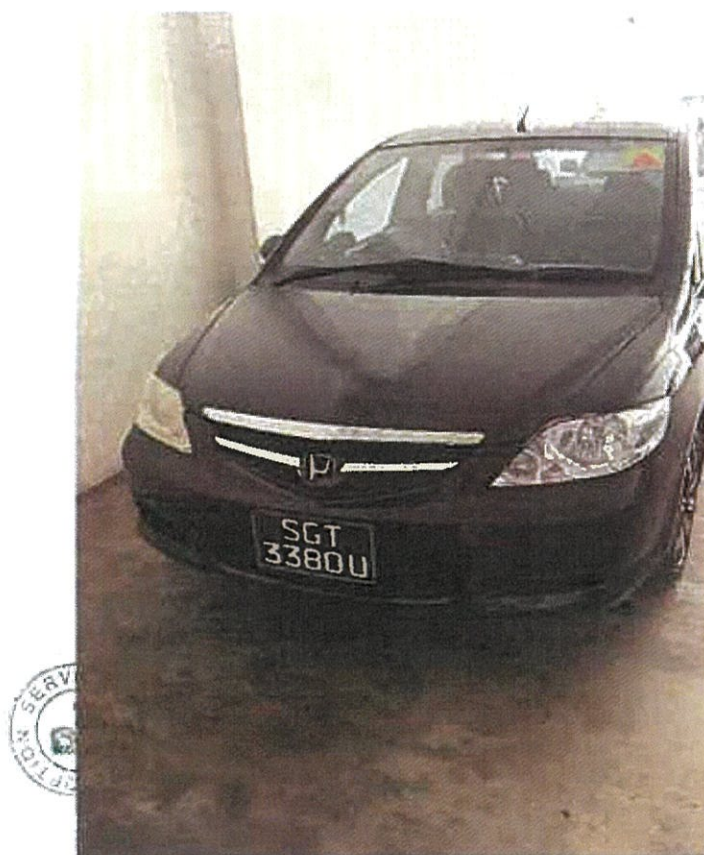
**POST REPAIR**

(b) The estimated number of days for the repairs would be Six (6)  
(1<sup>st</sup> Re-inspection conducted on 17 August 2021)  
(Post Repair Inspection conducted on 21 August 2021)

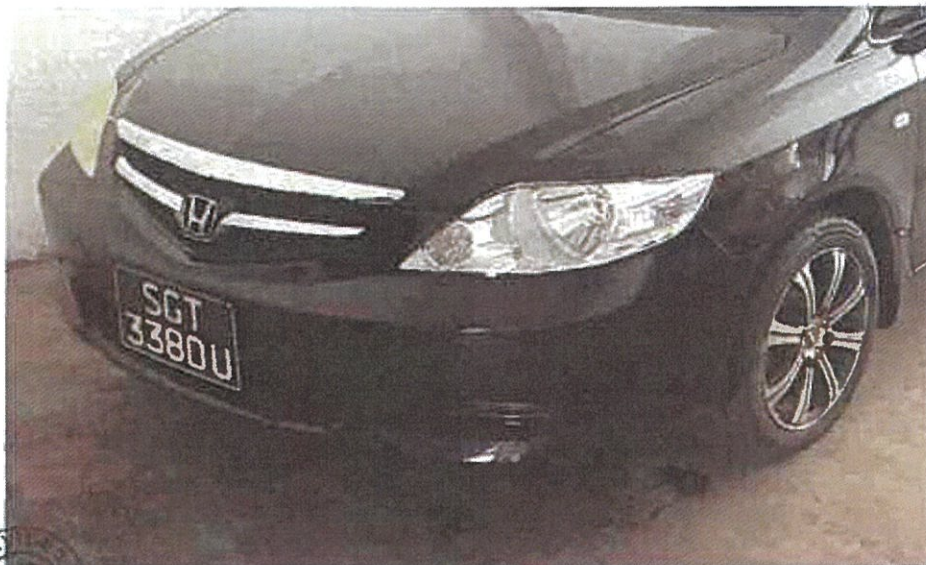
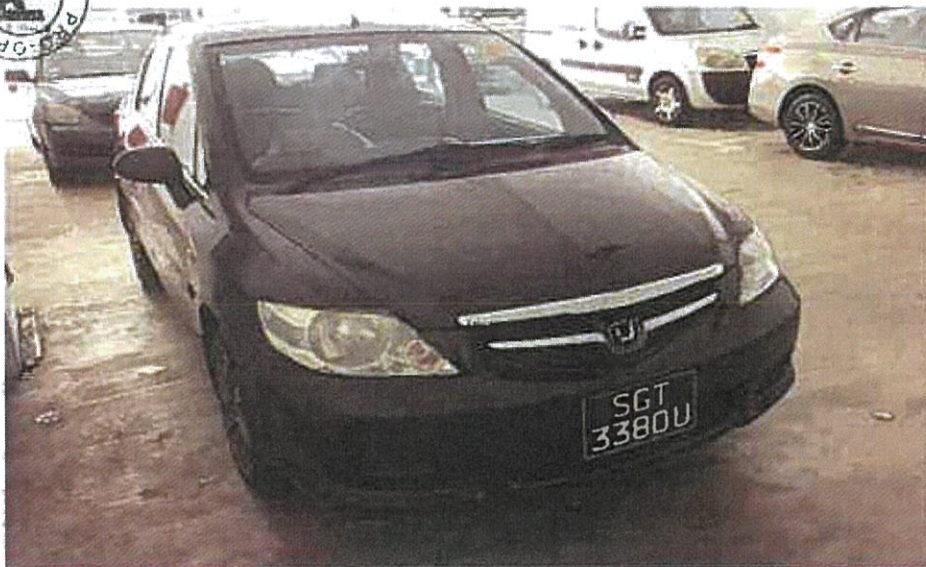
**POST REPAIR**
