ADJUSTMENT ON REPAIR COST FOR VEHICLE NO. SLW 6047M

PHOTOGRAPHS FOR VEHICLE NO. SLW 6047M

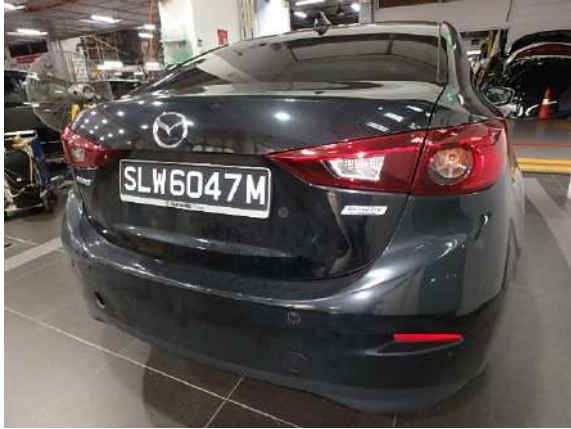
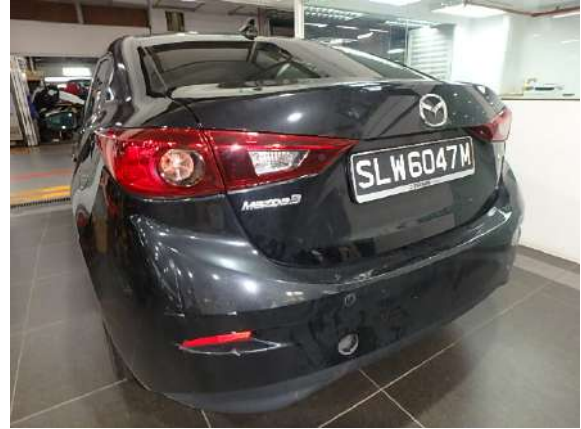
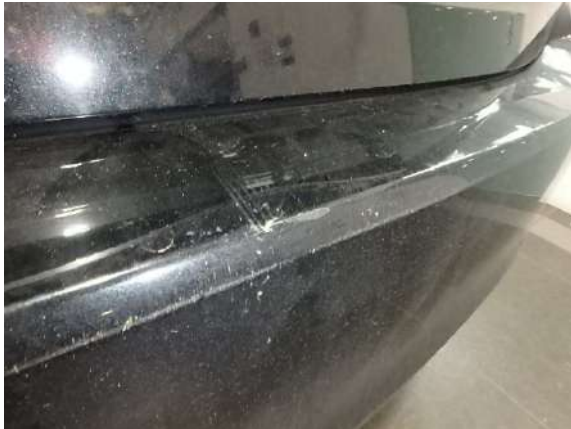
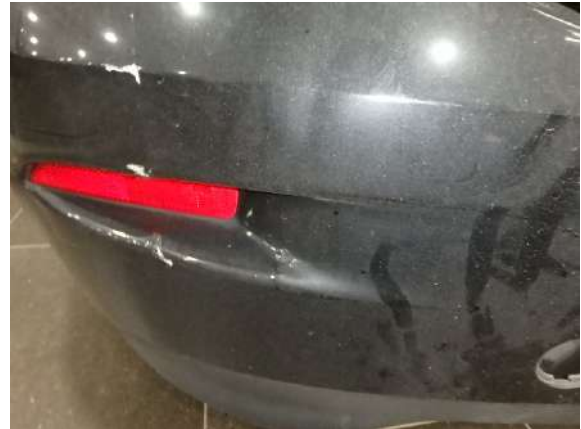
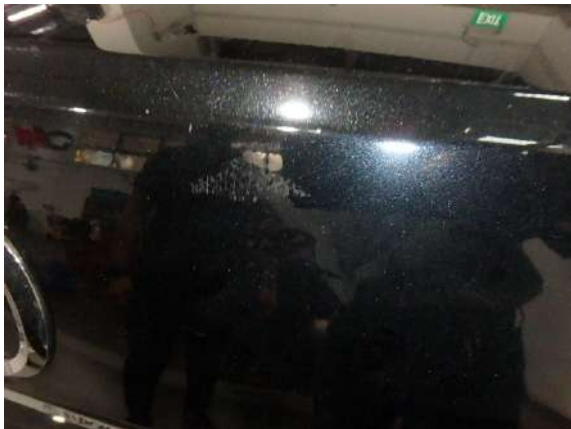
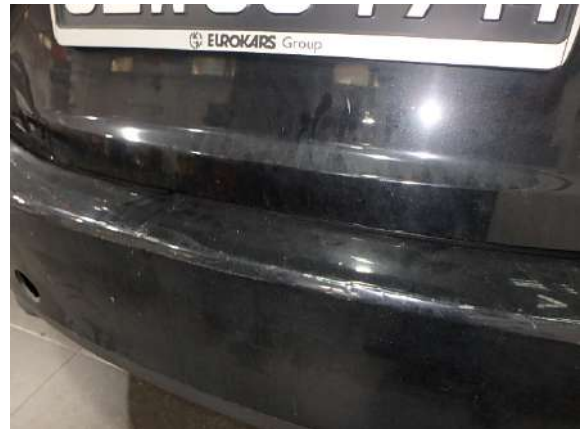
4. Description of Damages				
THE VEHICLE SUSTAINED DAMAGES AT THE REAR PORTION. DAMAGES SEE DETAILS.				
5. General Information				
Accident Date	07/09/2021	Inspection Date	10/09/2021	
Survey held at	OPTIMA WERKZ PTE LTD 9A SERANGOON NORTH AVE 5 SINGAPORE 554500			
5a. Remarks				
A)THE INSPECTION WAS CONDUCTED ON A"WITHOUT PREJUDICE" BASIS. B)IN ACCORDANCE TO YOUR INSTRUCTIONS, WE HAVE NOT AUTHORISED REPAIRS.				
5b. Estimate Days of Repair				
ESTIMATED NORMAL PERIOD FOR REPAIR:			3 Working Days
