## LKK Auto Consultants Pte Ltd

### PROFESSIONAL SERVICE FEE

Vehicle No. SLE 9835E  
Insured Veh. SKR 4615A  
Claim No. SNM21D205177/C02  
Policy No. DMHCSNW00007182100  
Accident Date 11/09/2021  
Inspection Date 13/09/2021

### ADJUSTMENT ON REPAIR COST FOR VEHICLE NO. SLE 9835E

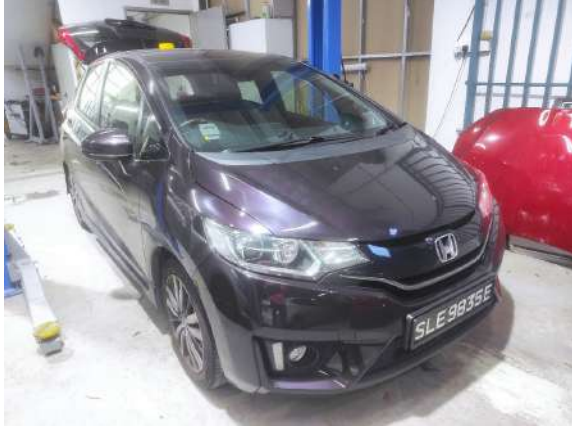
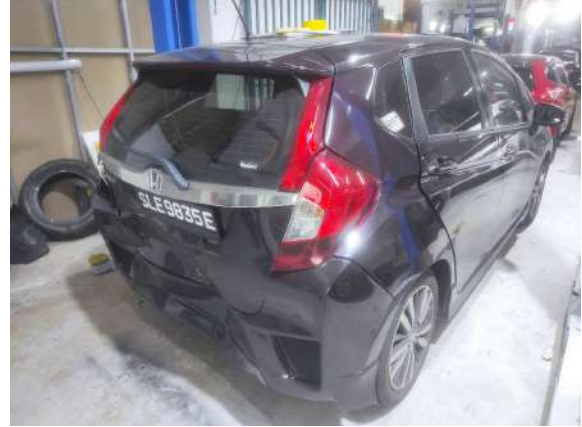
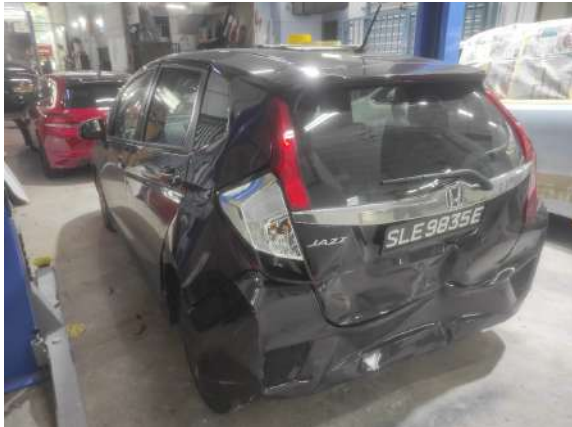
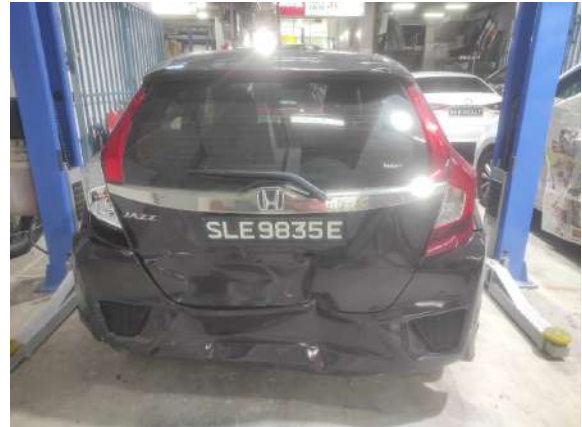
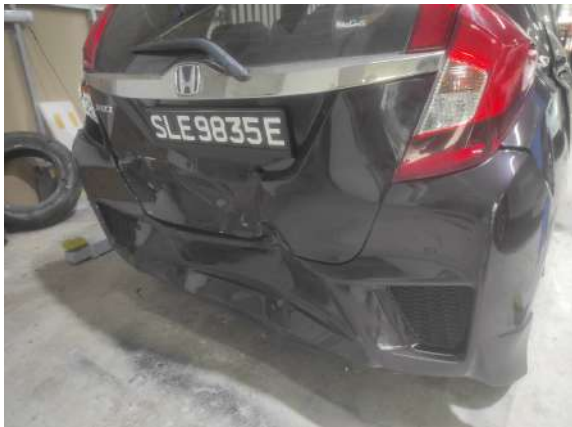
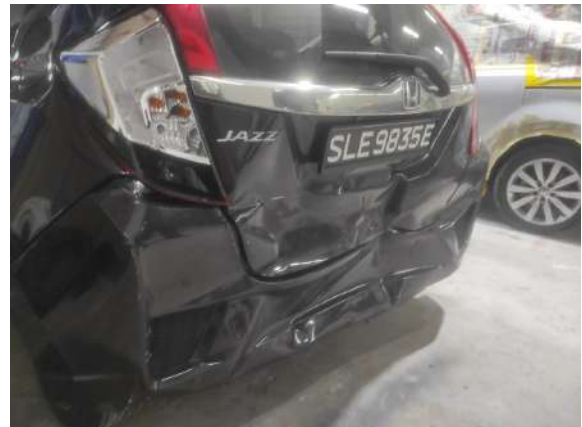
### PHOTOGRAPHS FOR VEHICLE NO. SLE 9835E

### INSPECTION

| Affiliated to Federation Internationale Des Experts En Automobile | | | | |
|---|---|---|---|---|
| THE VEHICLE SUSTAINED DAMAGES AT THE REAR PORTION. | | | | |

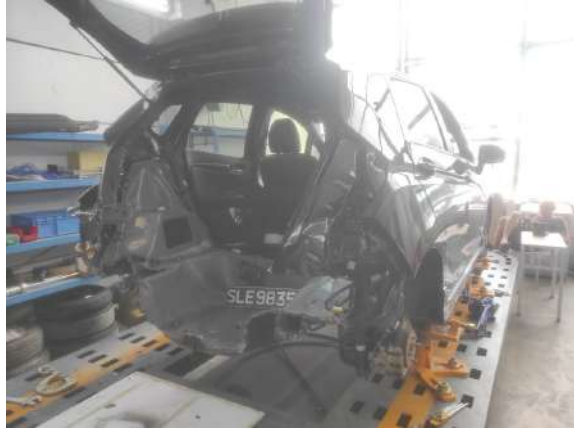
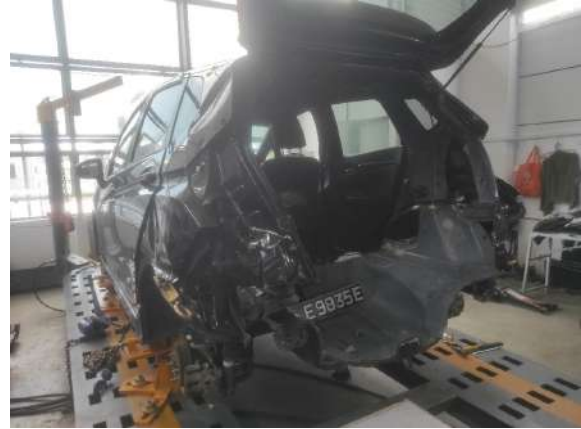
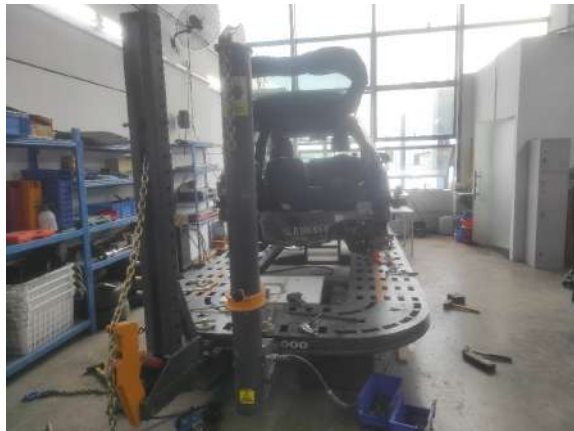
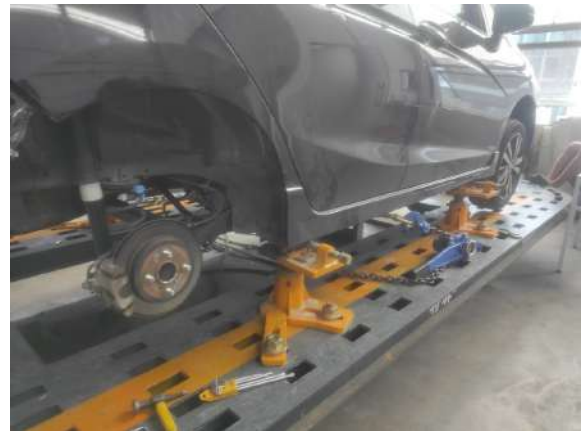
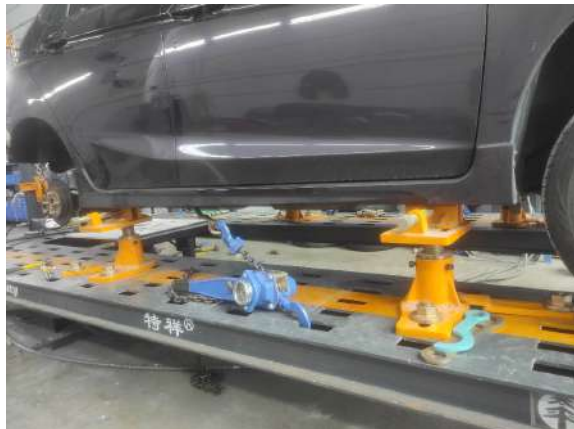
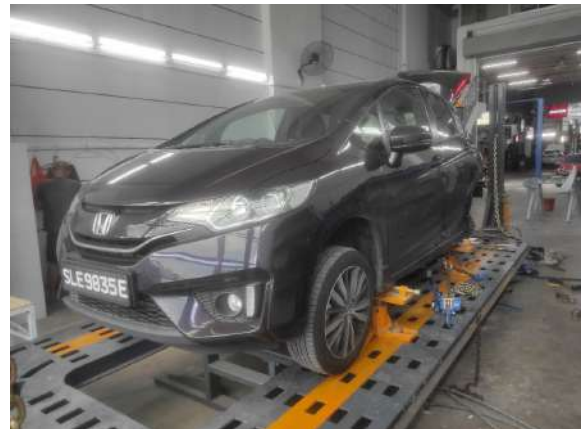
PHOTOGRAPHS FOR VEHICLE NO. SLE 9835E

RE-INSPECTION

| Affiliated to Federation Internationale Des Experts En Automobile | | | | |
|---|---|---|---|---|
| DAMAGES SEE DETAILS. | | | | |

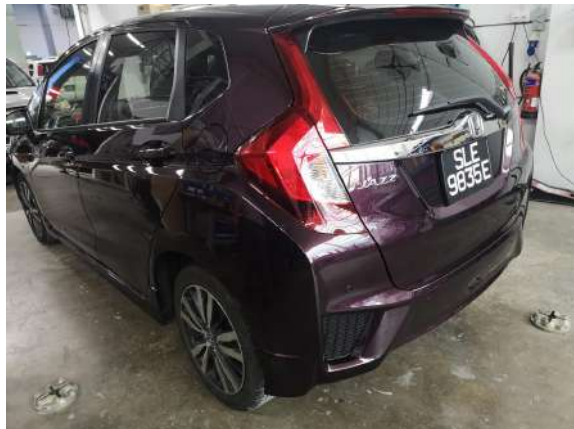
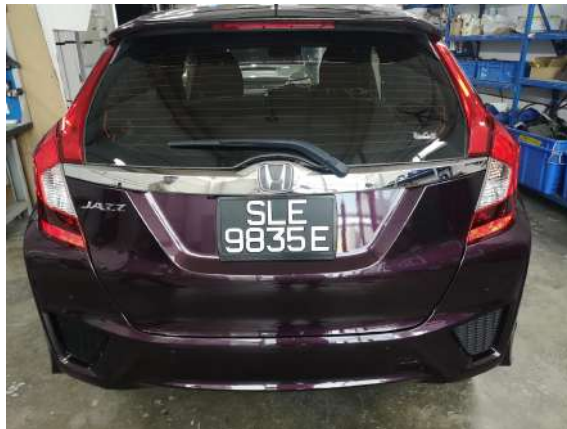
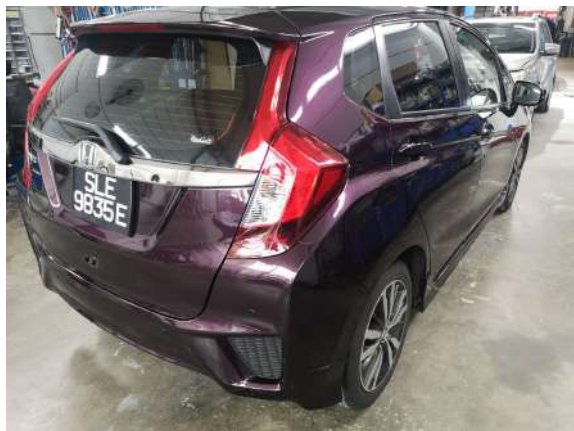
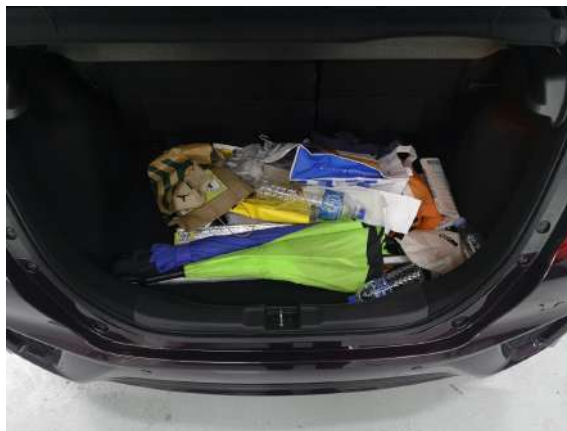
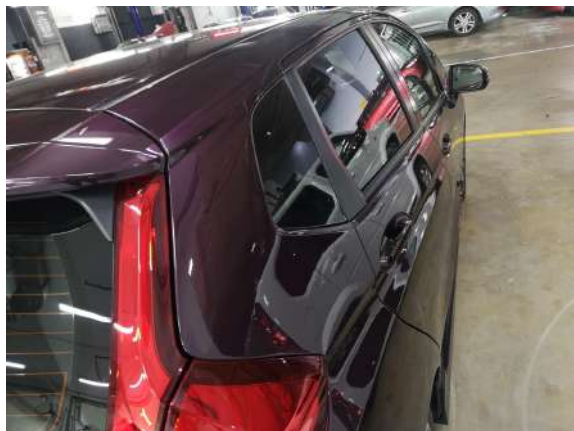
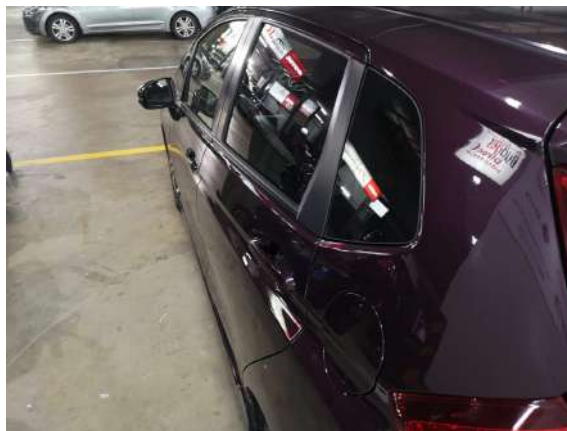
PHOTOGRAPHS FOR VEHICLE NO. SLE 9835E

RE-INSPECTION
