LKK Auto Consultants Pte Ltd

Vehicle No. GBC 9225U
Insured Veh. GBC 824A
Claim No. D21002662MFCV
Policy No. D-21097216MFCV
Accident Date 20/09/2021
Inspection Date 22/09/2021

ADJUSTMENT ON REPAIR COST FOR VEHICLE NO. GBC 9225U

PHOTOGRAPHS FOR VEHICLE NO. GBC 9225U

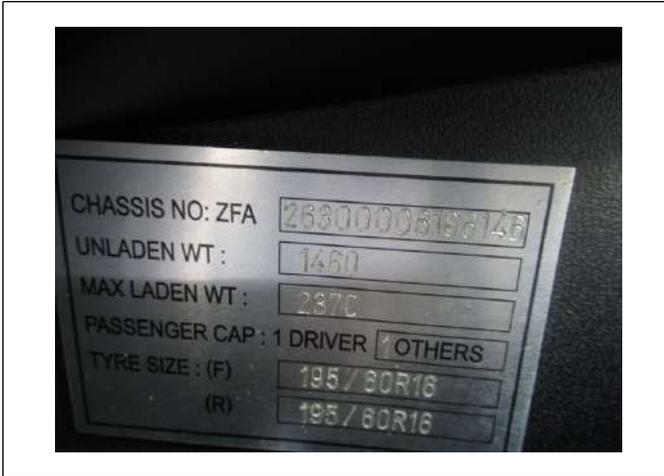
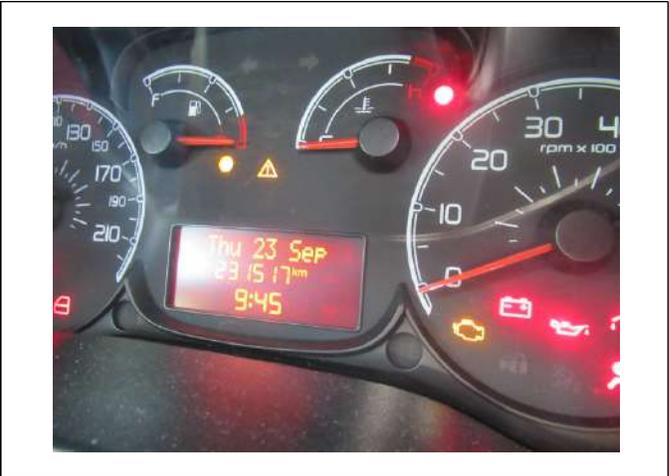
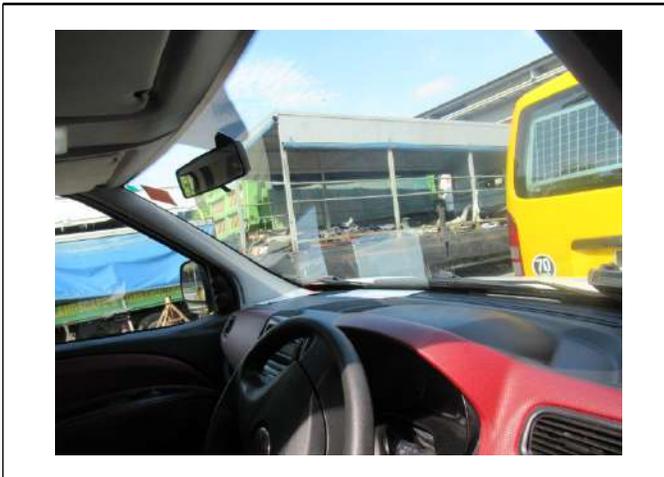
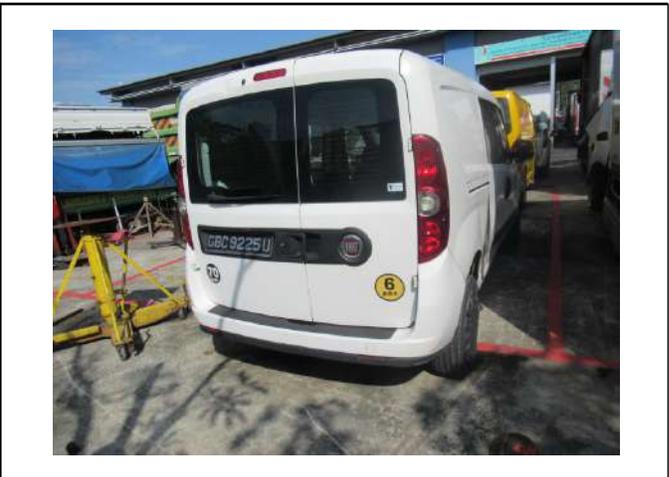
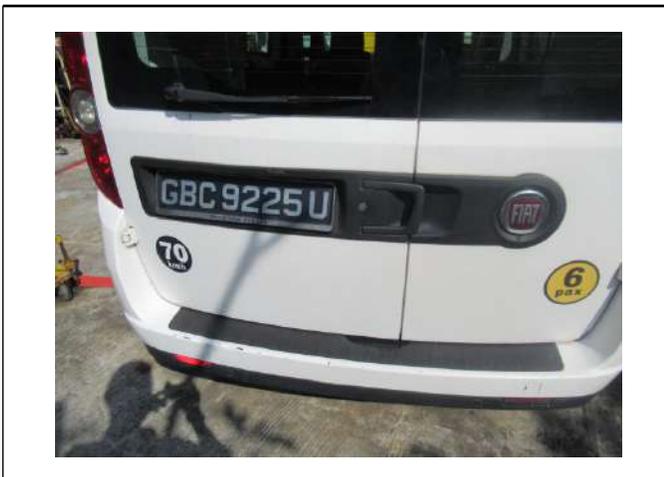
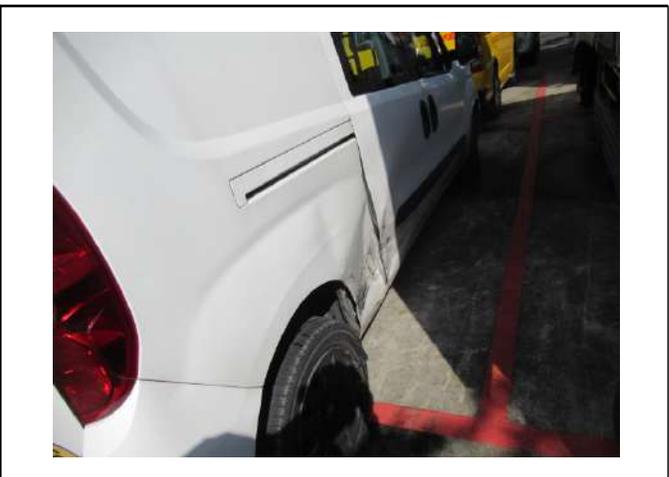
INSPECTION

| Affiliated to Federation Internationale Des Experts En Automobile | | | |
|--|--|---|---|
| THE VEHICLE SUSTAINED DAMAGES AT THE O/S REAR PORTION.THE UNDERCARRIAGE AFFECTED DUE TO COLLISION. DAMAGES SEE DETAILS. | | | |

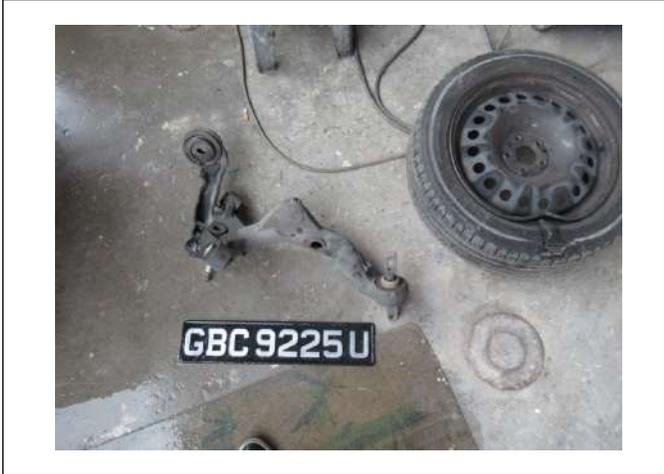
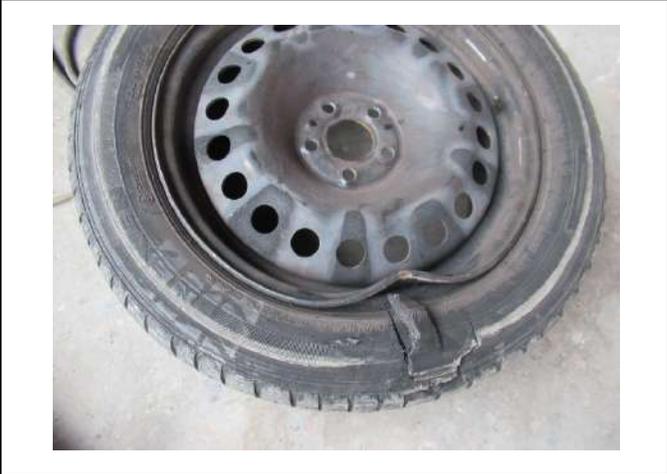
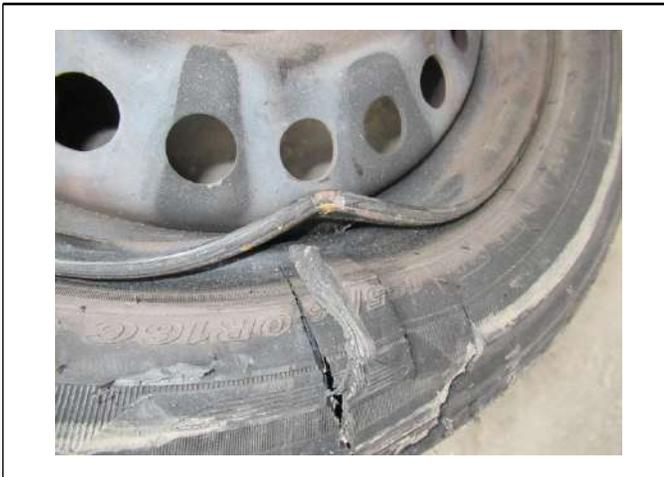
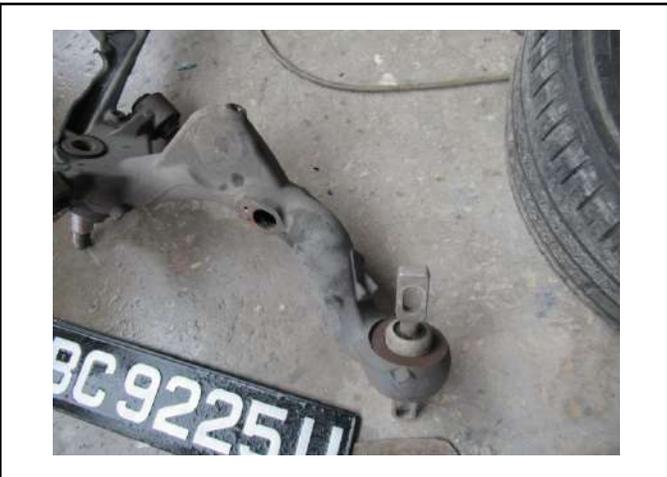
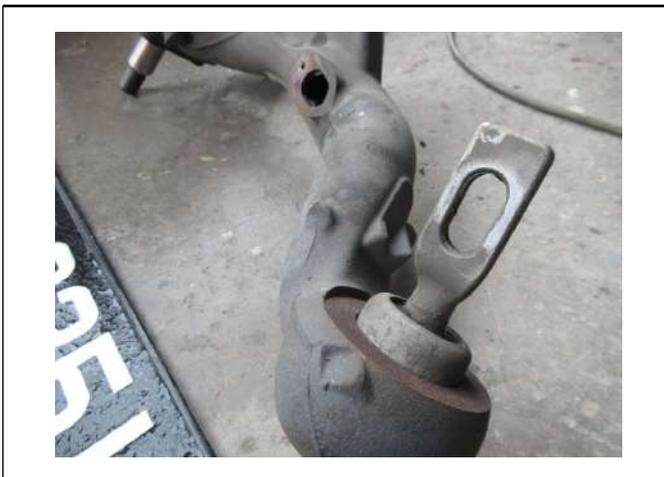
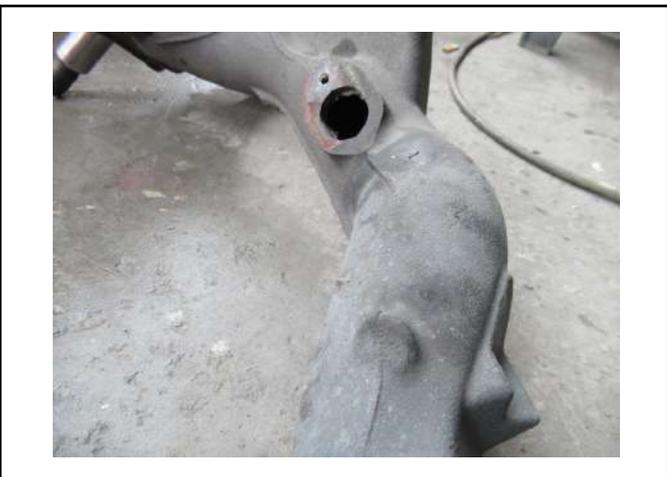
PHOTOGRAPHS FOR VEHICLE NO. GBC 9225U

RE-INSPECTION
