RE:

Road Traffic Accident on 23/10/2020

Vehicle details

Impact Direction & Area of Damage:

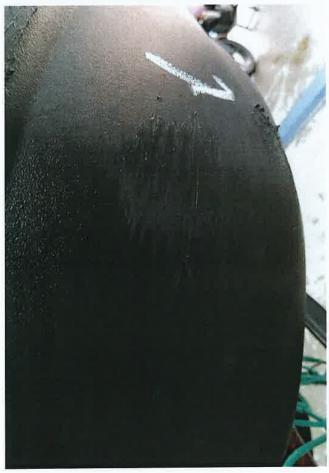
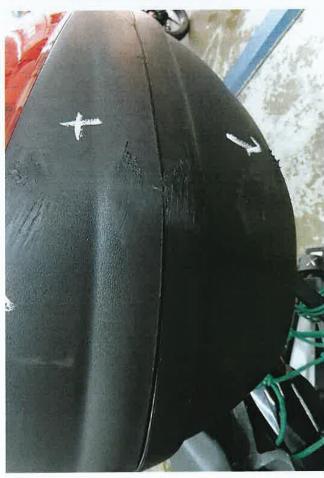
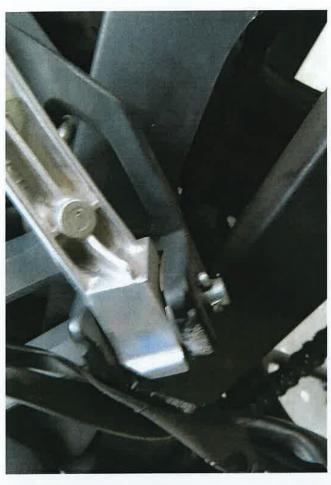
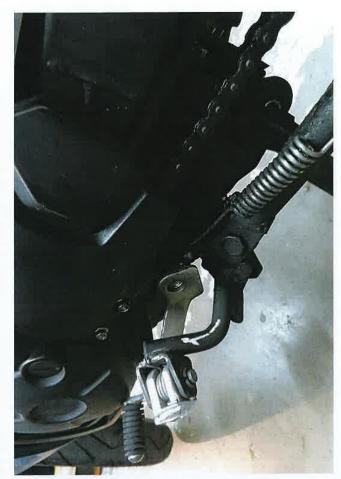
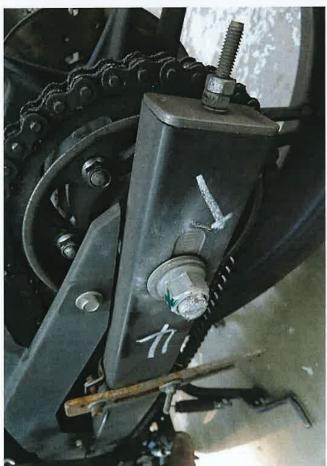
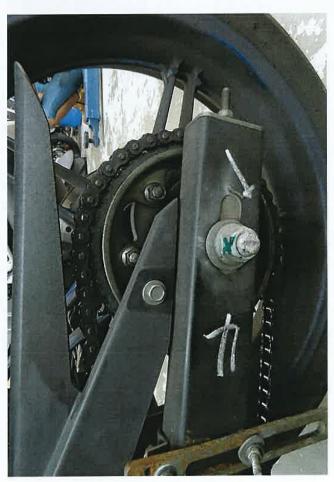
Refer to photographs

ction A. Damagea i	41 10 / 100 00011	CITC	
Part's Description	Qty	Condition As inspected	Repairer's Estimate	Our Adjustment
<u>List Items</u> :				
Cone bearing set	1	damaged	221.00	221.00
Front fork assy	set	damaged	854.10	854.10
Handle bar	1	damaged	121.00	121.00 -
Handle grip	2	damaged	75.00	75.00
Gear pedal assy	1	damaged	92.00	92.00
Foot rest kit right	1	damaged	65.00	65.00 🔀
Side mirror right	1	damaged	75.00	75.00 -
Side mirror left	1	damaged	75.00	75.00 -
Front signal light right	1	damaged	94.50	94.50 -
Panel front inner	1	damaged	122.00	122.00
Foot rest kit left	1	damaged	78.90	78.90 l
Clutch lever	1	damaged	82.00	82.00
Balancer	1	damaged	100.00	100.00 7
ront headlamp	1	damaged	450.00	450.00
riple cone	1	damaged	296.00	296.00
Brake lever	1	damaged	88.00	88.00 🙏
Rear signal light right	1	damaged	84.00	84.00
Rear mud guard c/w bracket	1	damaged	215.00	215.00
Front fairing left	1	damaged	298.40	298.40
Headlamp cover set	1	damaged	201.50	201.50 /
